October 8, 2020

18-027(a).R01

Re: Slope Assessment
Saugeen Cedar Heights West
Hanover, Ontario

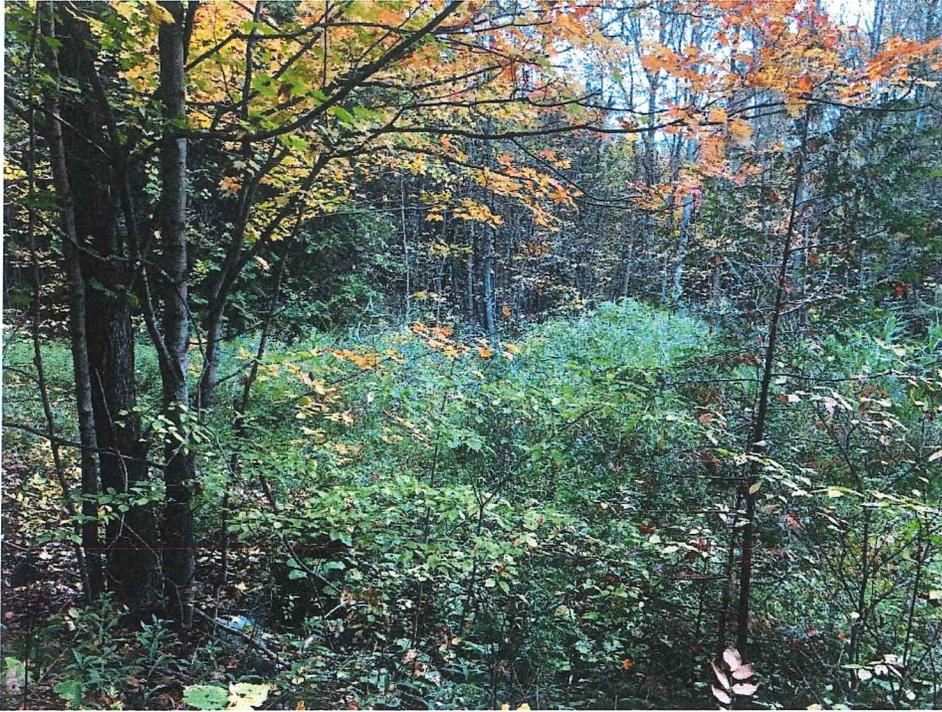
Photograph 1: Site photo facing north west showing existing culvert and Section B-B. Photograph taken September 29, 2020.

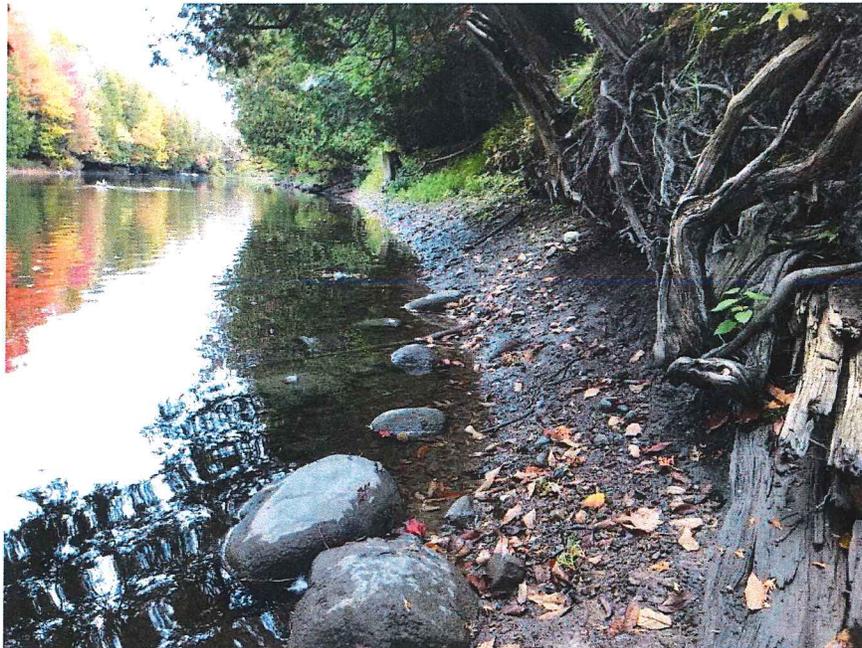
The bankfull width of the Saugeen River at the project location appeared to be greater than 30.0 m. The bank of the lake at the subject site showed signs of active erosion at the banks (Photographs 8, 9, 10, 20, 21, 22, and 30). CVD reported in 2007 that there were no signs of active bank erosion. However, water levels were higher and access to the bank was not feasible at the time of the CVD report. CVD Reported in Section 7.6.4. that the Toe Erosion Allowance was assessed to be 4.0 m in Cross-section A-A.

Photograph 8: Site photo facing east near the bank at Section D-D. Photograph taken September 29, 2020.

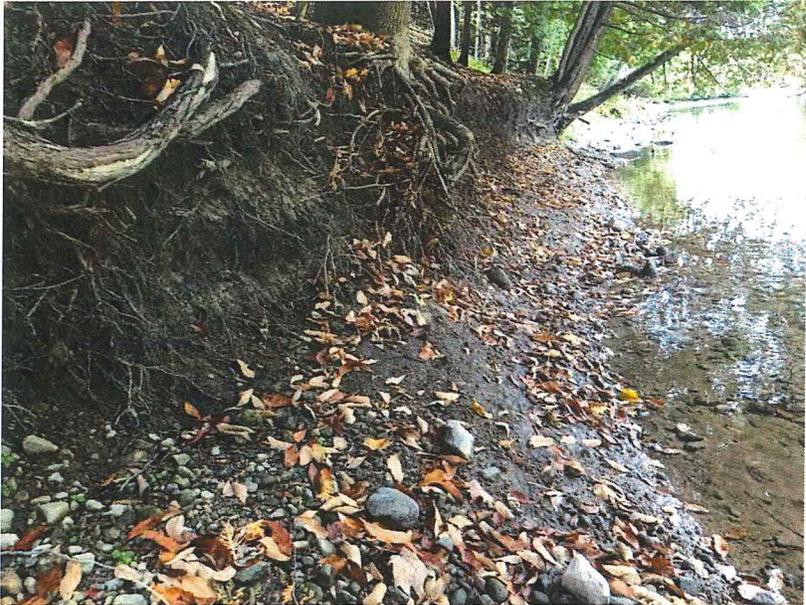
Photograph 9: Site photo facing west near the bank of Section D-D. Photograph taken September 29, 2020.

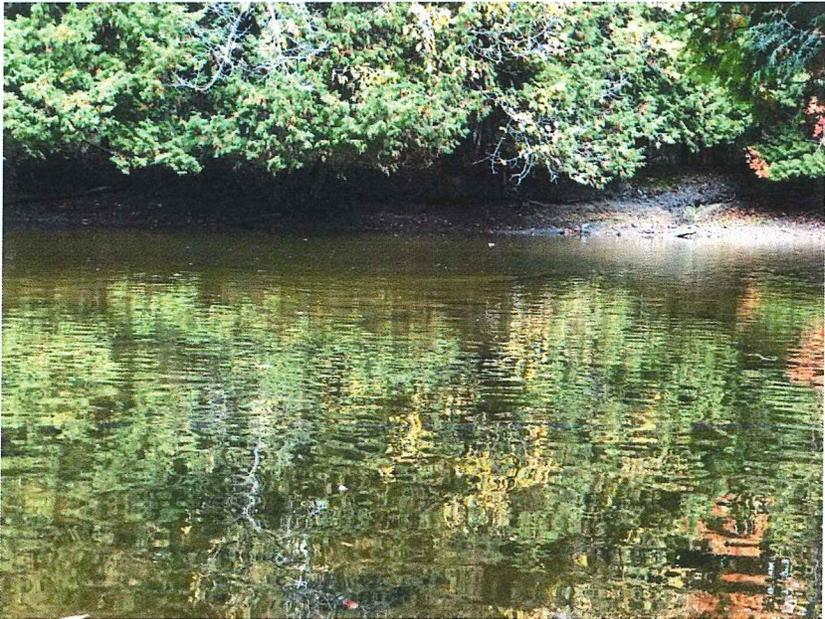
Photograph 10: Site photo facing north near the base of section D-D showing the north bank of the Saugen River. Photograph taken September 29, 2020.

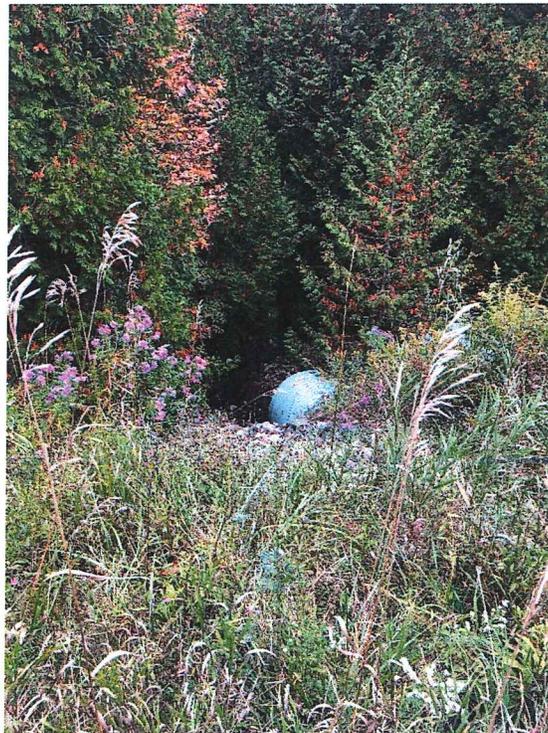
Photograph 12: Site photo facing north east to the west of section E-E near the top of slope showing the existing culvert. Taken on the pedestrian trail located at the western extent of the site, showing the existing culvert. Photograph taken September 29, 2020.

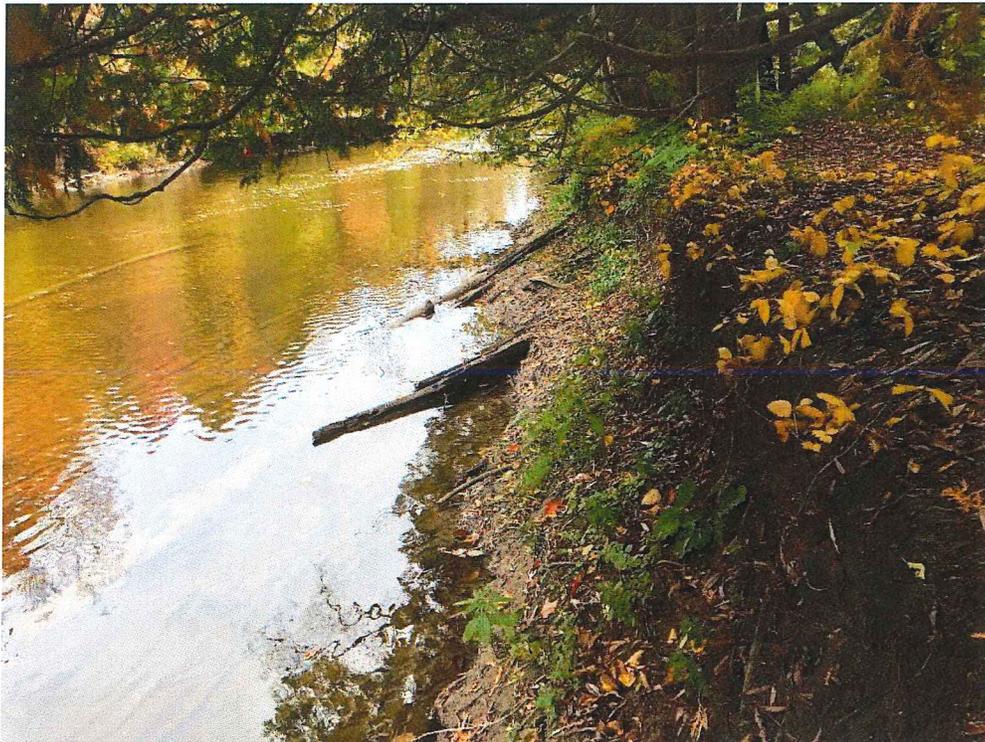
Photograph 20: Site photo facing east near the bank of Section C-C. Photograph taken September 29, 2020.

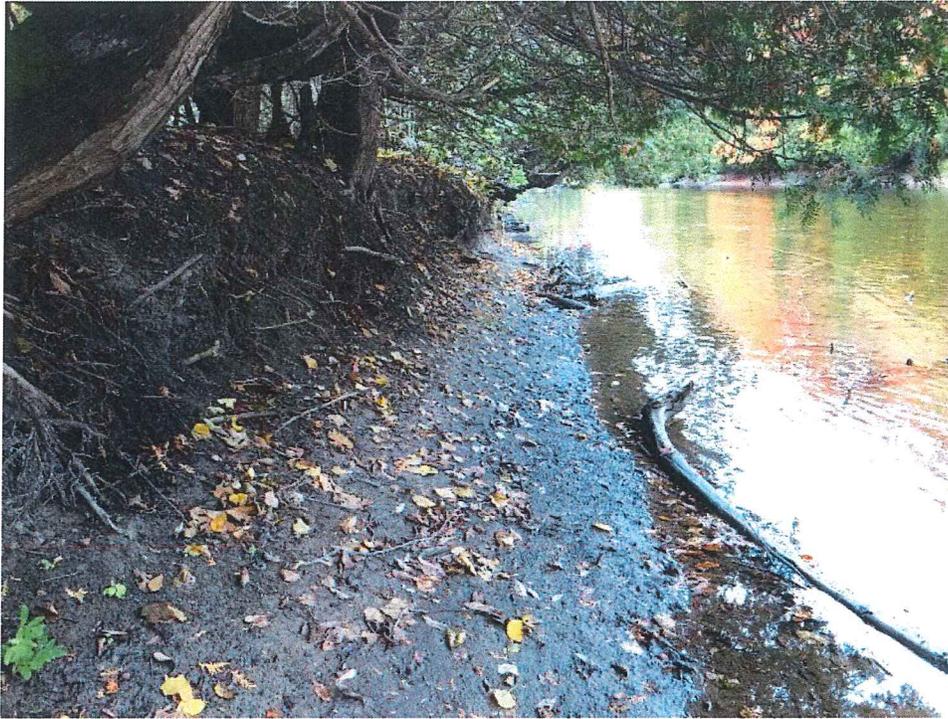
Photograph 21: Site photo facing west near the bank of Section B-B. Photograph taken September 29, 2020.

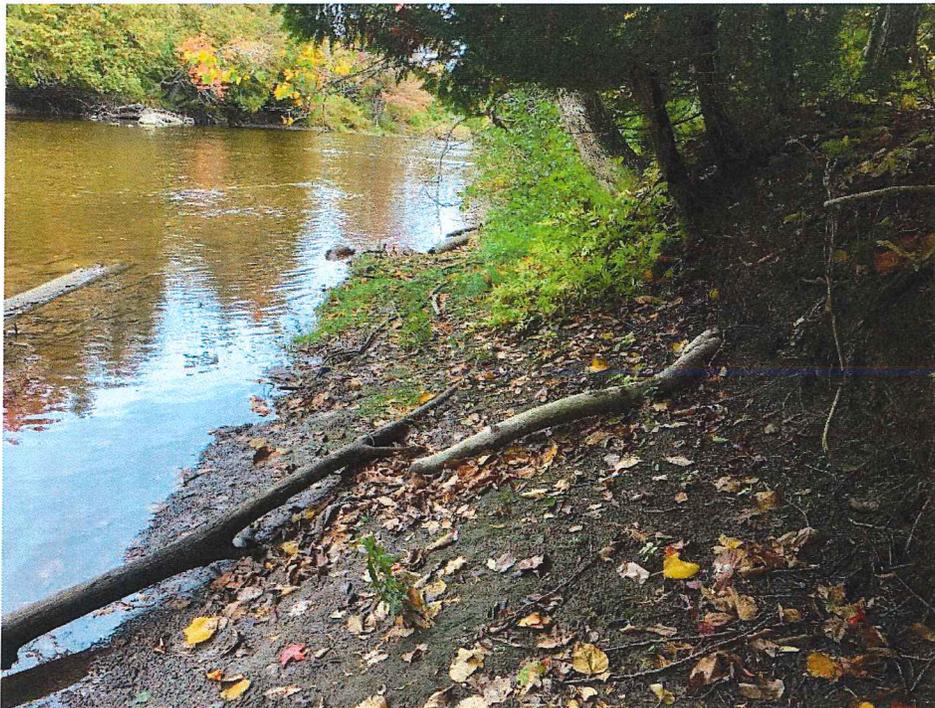
Photograph 22: Site photo facing east near the bottom of Section B-B. Photograph taken September 29, 2020.

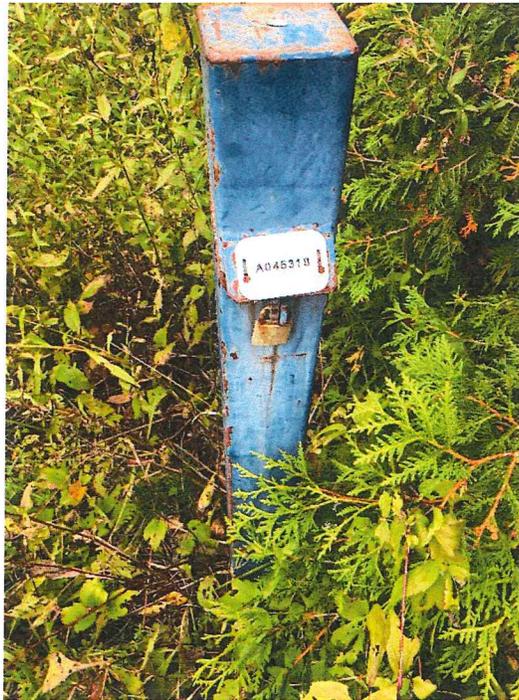
Photograph 29: Site photo near the top of Section A-A showing the existing well and well tag. Photograph taken September 29, 2020.

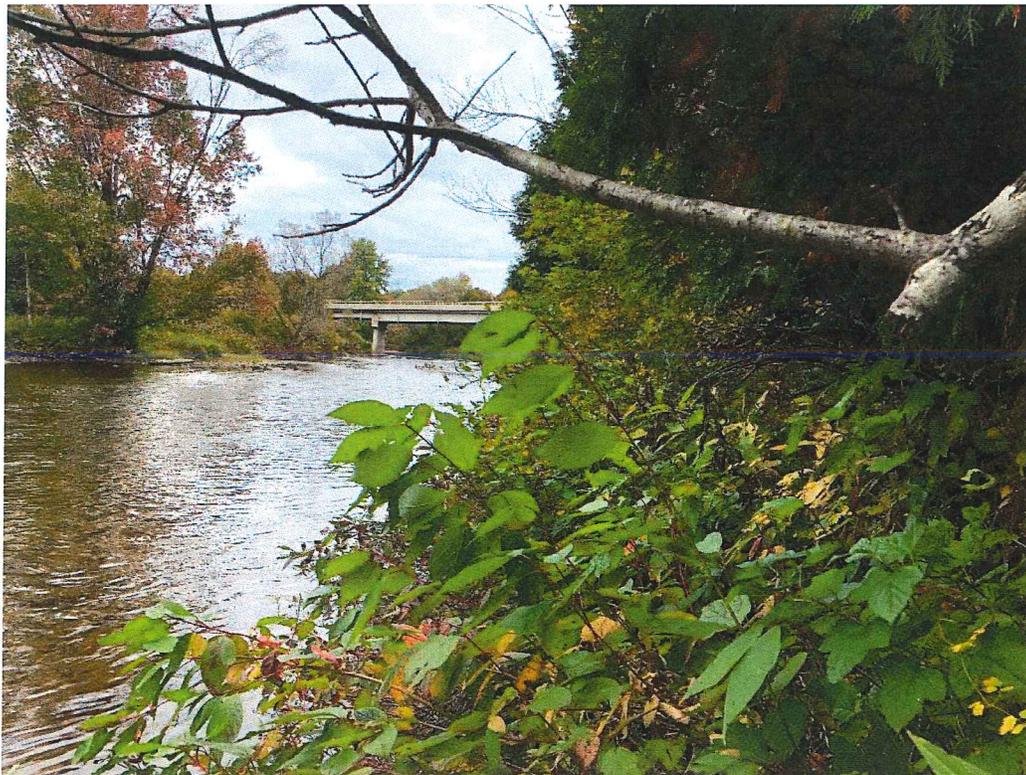
Photograph 30: Site photo facing east near the bottom of Section A-A. Photograph taken September 29, 2020.
