Slope Stability Report

Alta Subdivision Phase 2

Town of the Blue Mountains, Ontario

Project No. 2101271

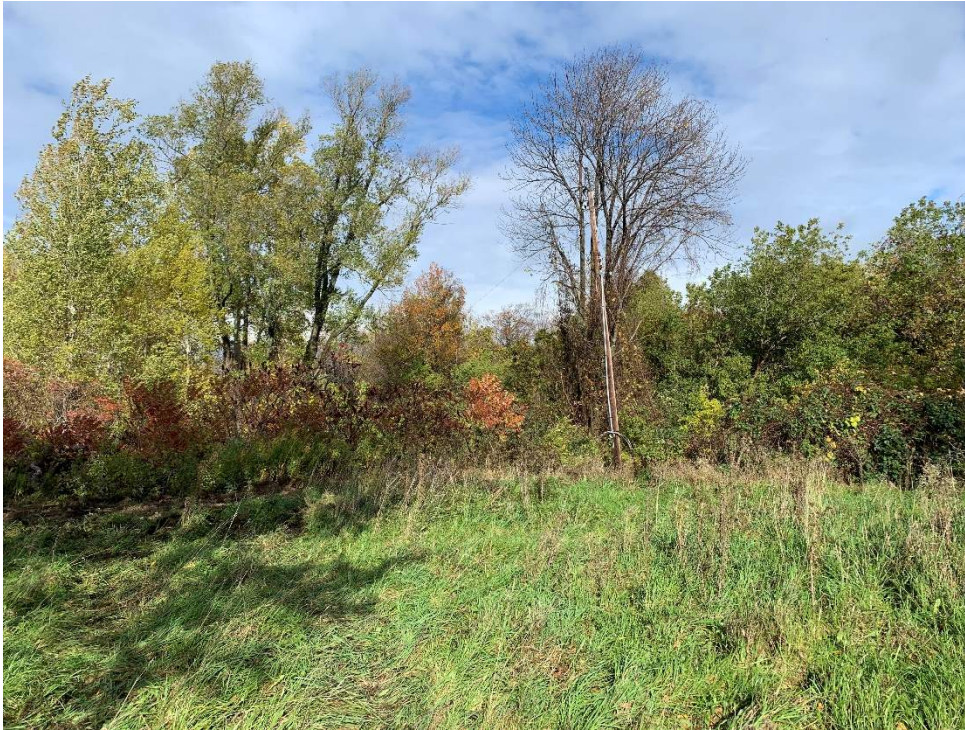
PHOTOGRAPH 1

A view of the tableland facing the slope crest near the western drainage gully. The slope is well vegetated.

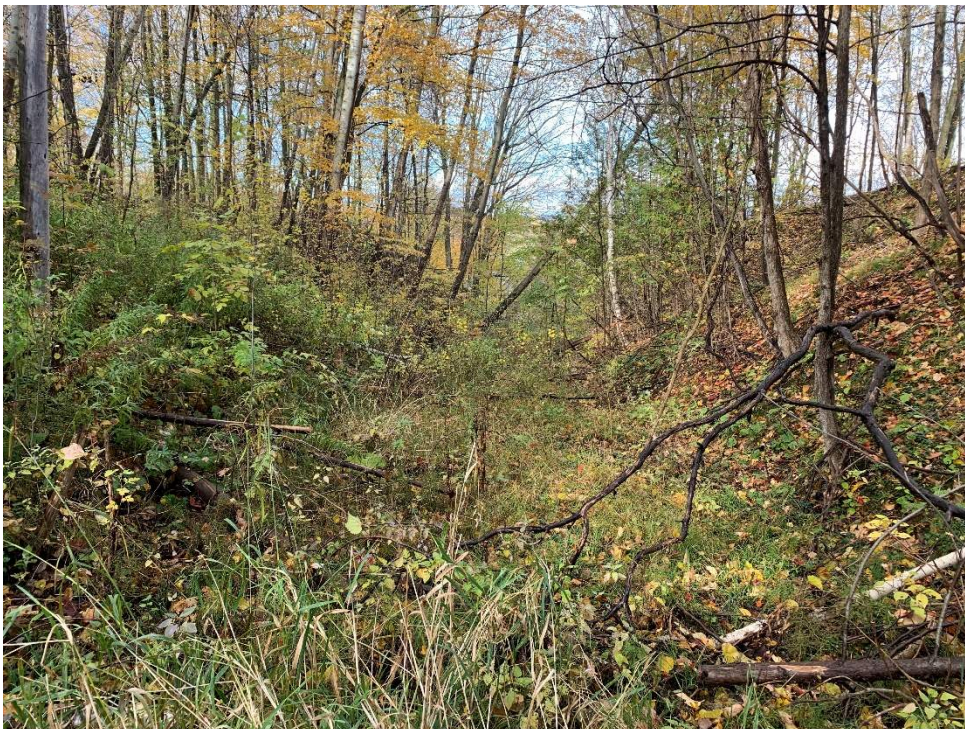
PHOTOGRAPH 2

A view of the well vegetated slope from within the western drainage gully. No water was observed in the western gully. A few localized areas of minor erosion were observed.

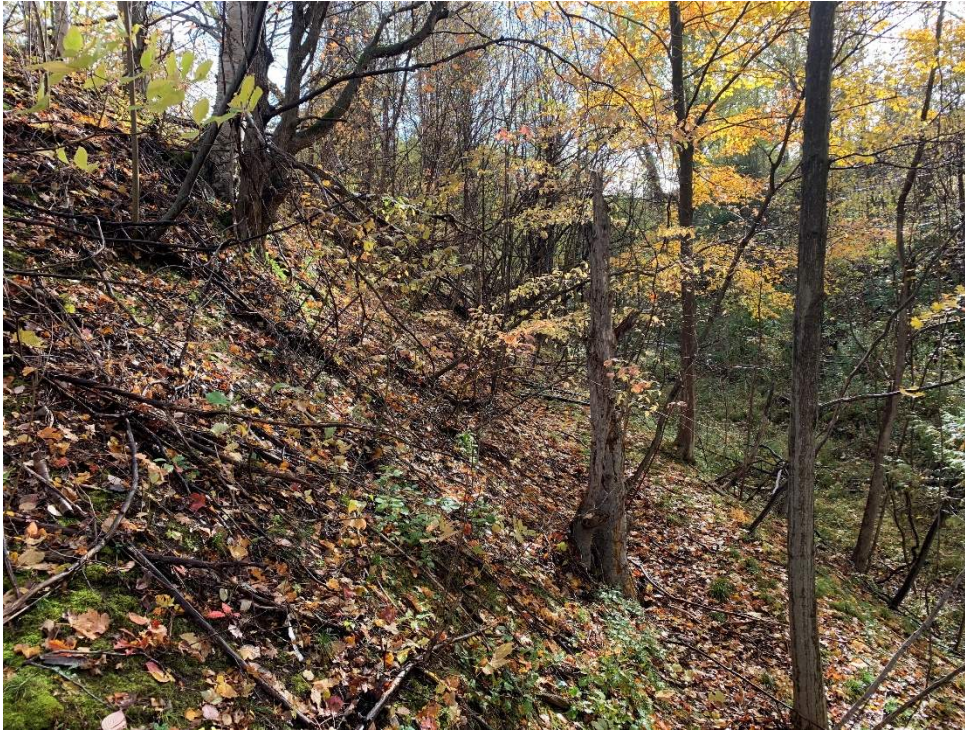
PHOTOGRAPH 3

A view of the well vegetated slope profile along the western drainage gully.

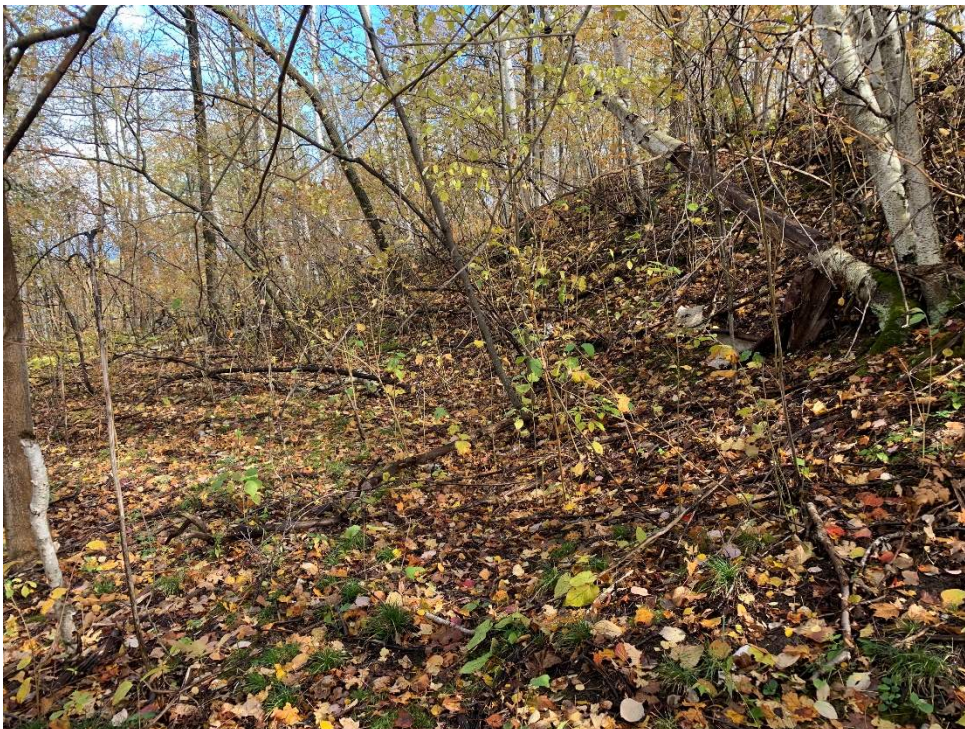
PHOTOGRAPH 4

A general view of the typical slope profile.

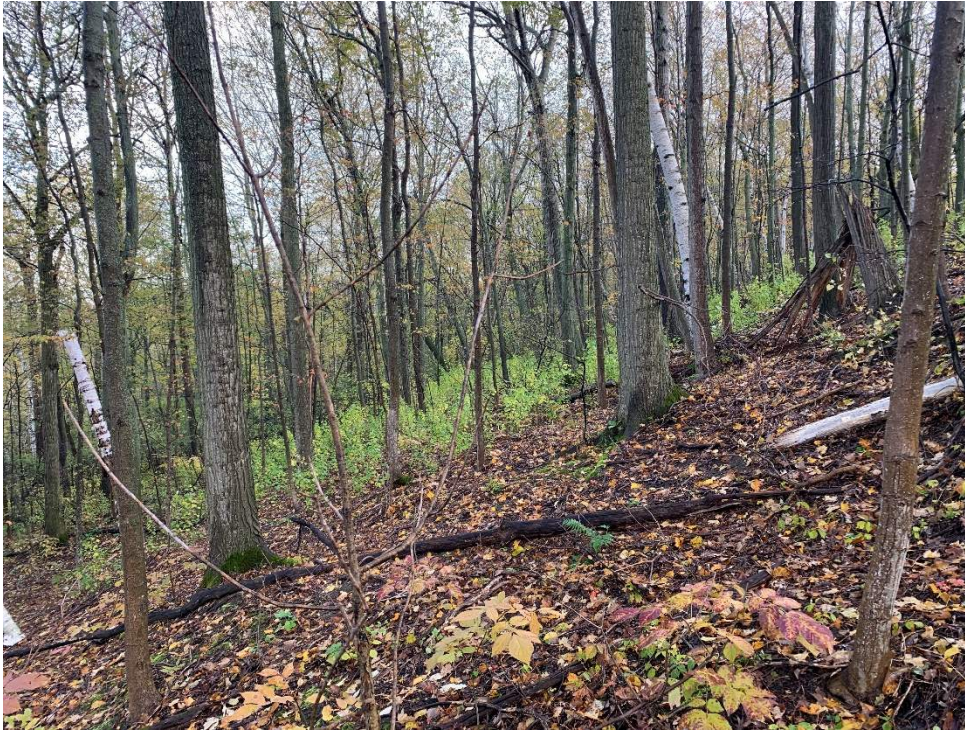
PHOTOGRAPH 5

A view of the well vegetated slope crest and upper slope face to the east of the eastern gully. No signs of slope instability were observed.

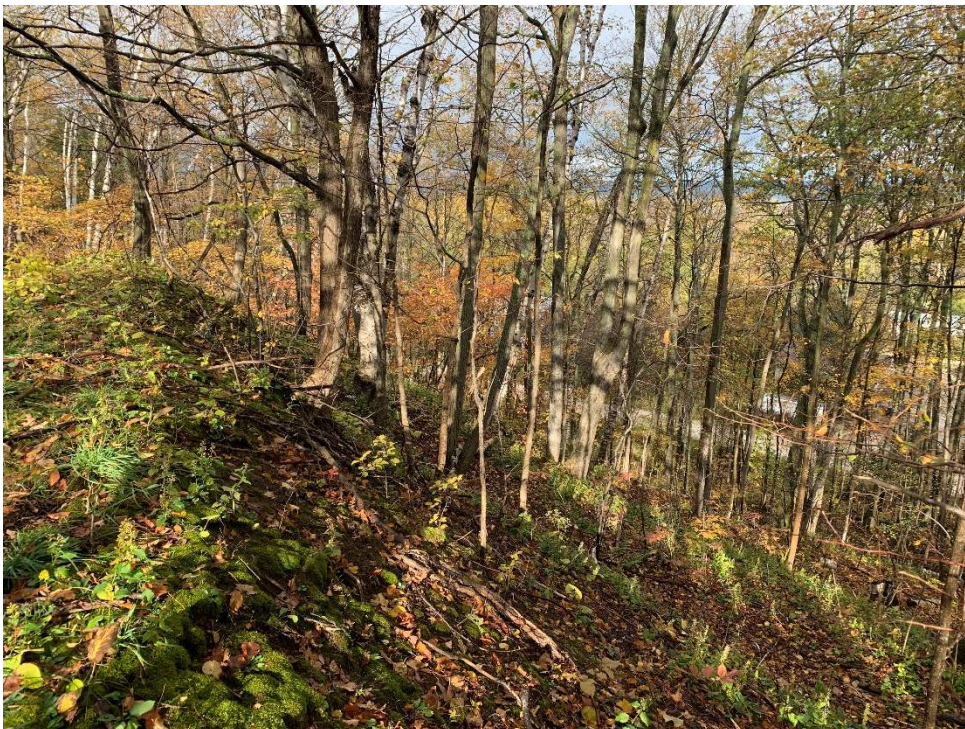
PHOTOGRAPH 6

Another view of the slope. Hidden Lake Road is visible through the trees at the bottom of the slope.

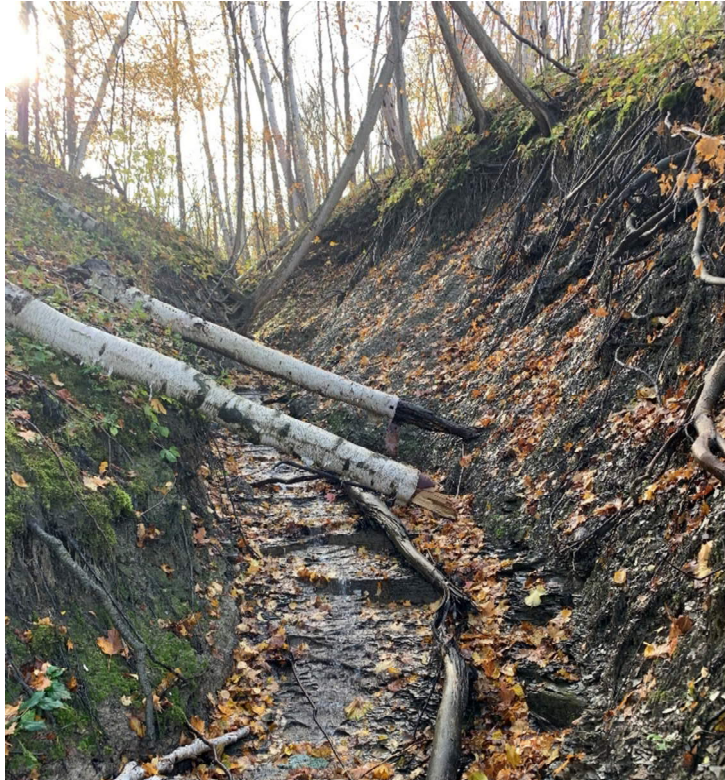
PHOTOGRAPH 7

The eastern gully is smaller in width but contains flowing water and active erosion, consisting of undercutting, scarps, exposed soil and roots, and exposed bedrock along the bottom of the channel. The side slopes and scarps are near vertical in some localized areas. It appears that concentrated runoff from the tableland flows over the slope and down the eastern gully. Some slumping of soil was observed from the over-steepened scarp faces.

The borehole results and visual slope inspection indicate that the sidewalls of the eastern drainage gully consist of stiff silt and clay, underlain by bedrock. Flowing water and active erosion were observed during the inspection, which suggests a toe erosion allowance of 5 to 8 metres. It is assumed that the drainage feature contains intermittent flows and is not a permanent watercourse feature, therefore a 5 metre toe erosion allowance (the lower end of the range) was selected.

Looking up the slope from the bottom of the eastern drainage gully. Flowing water and active erosion are visible. The sidewalls consist of silty sand, then silt and clay, then bedrock (visible along the bottom of the channel).

protection measures such as rip rap lining within the gullies and at any proposed SWMP outlet locations depending on the final stormwater system configuration, to ensure long-term erosion is prevented. A monitoring plan is recommended at the gully and outlet locations to ensure erosion will be controlled.

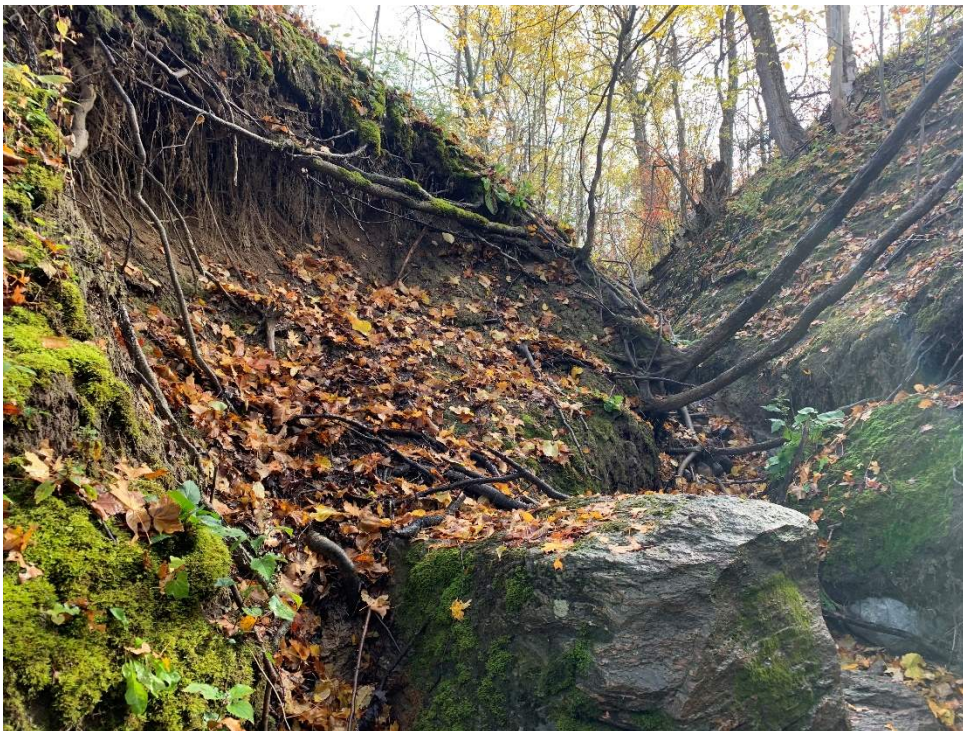
PHOTOGRAPH 8

Another view of the eastern drainage gully, which is extending into the tableland.

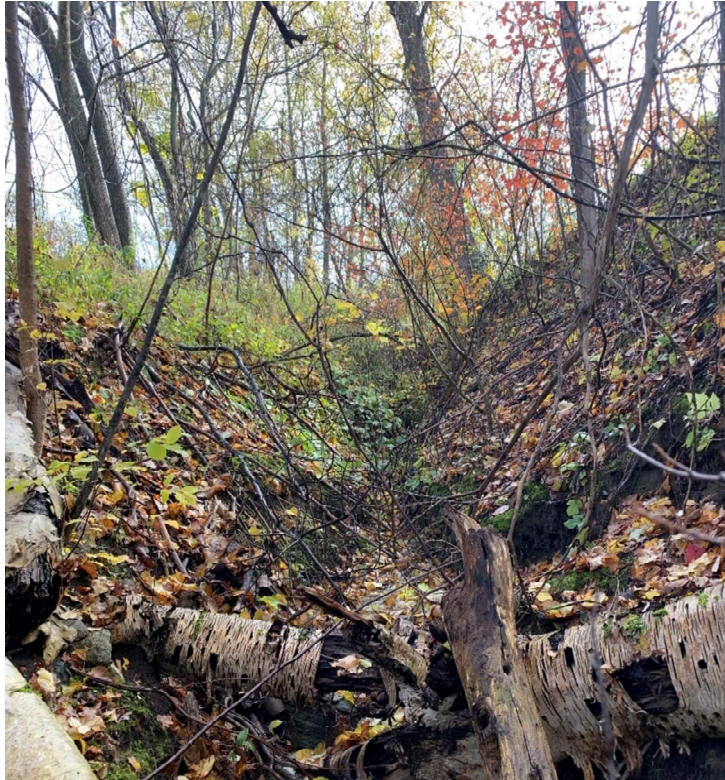
PHOTOGRAPH 9

A view of the eastern drainage gully looking south toward the southern extent where the gully extends back into the tableland.

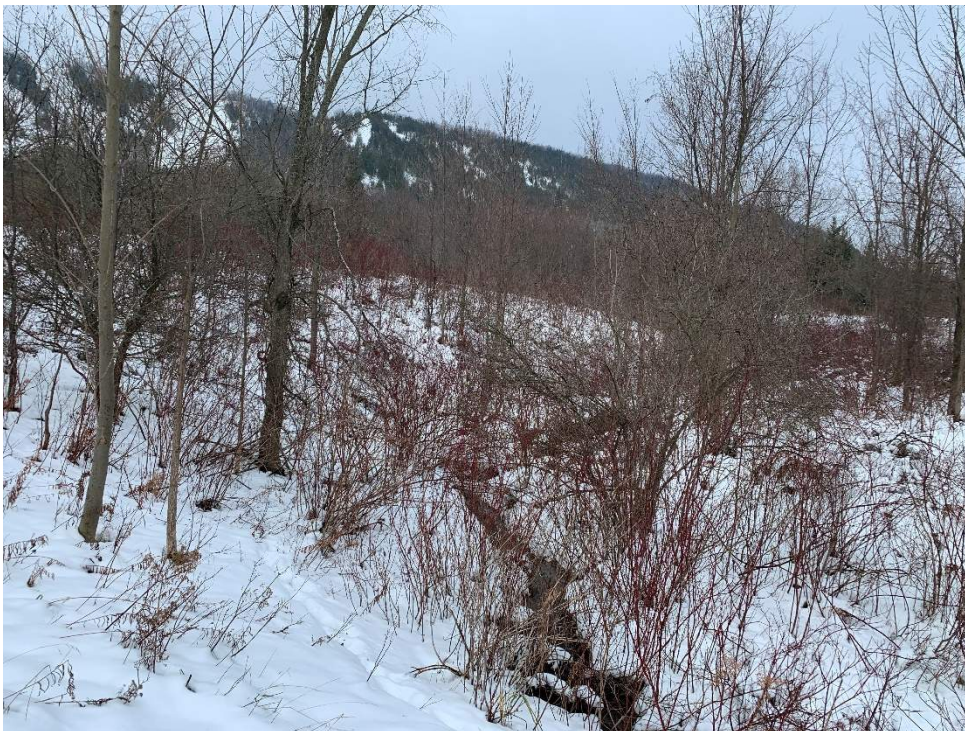
PHOTOGRAPH 10

A view of the southern channel and small slope associated with a small watercourse. The slope has relatively flat side slopes and no erosion was observed.

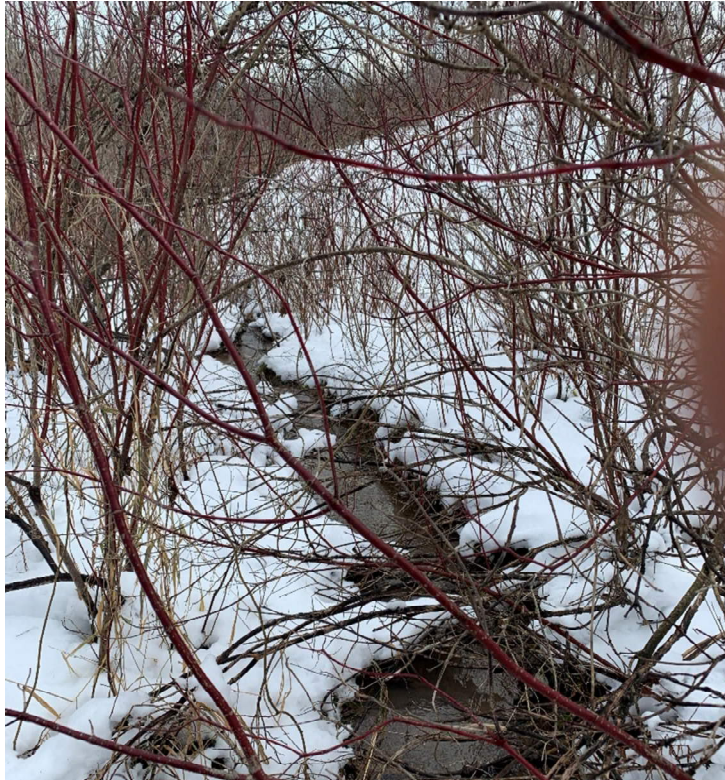
PHOTOGRAPH 11

A view of the small stream at the bottom of the channel. Flows are restricted by an upstream culvert.
