June 21, 2019

PML Ref.: 19CF004
Report: 2

Slope Assessment – Block 51
Proposed Peaks Meadows Subdivision – Block 46
Town of The Blue Mountains, Ontario

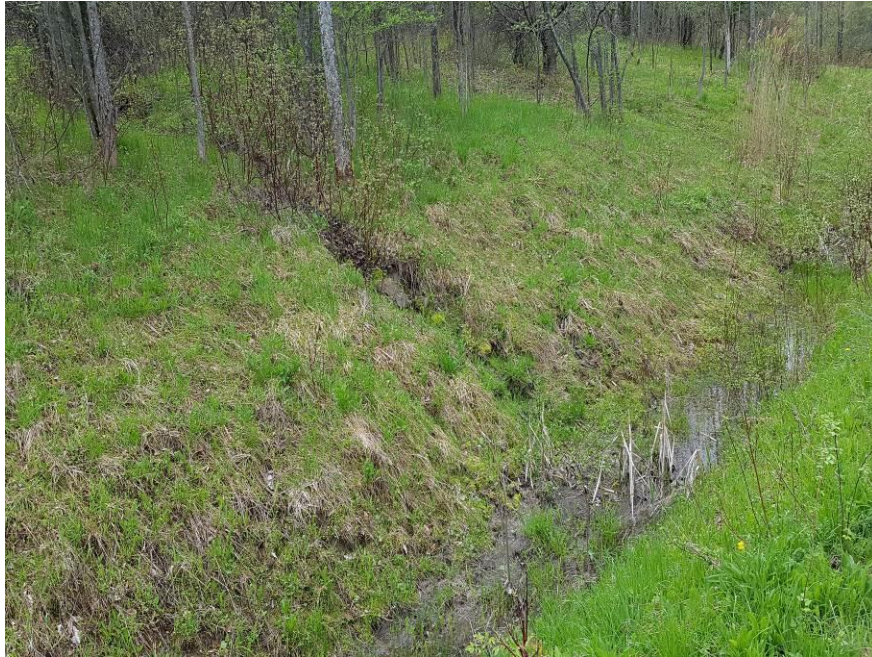
The slope on Block 51 is typically about three horizontal to one vertical, (3H:1V) or flatter and rises up about 35 m above Block 46. A ditch was cut along the Block 46/Block 51 property line, about ten years ago, to capture seepage and surface water runoff.

Photograph 1: Ditch at the base of the slope.

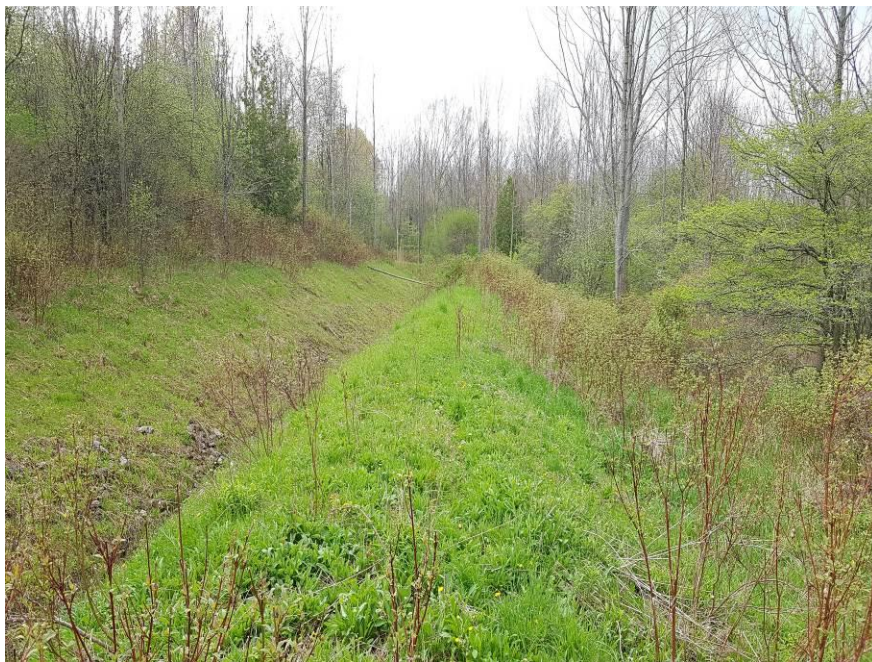
Seepage from the slope face appears about midway down the slope within Block 51, with areas of overland drainage down the slope present. No active erosion is present on the slope, with the exception of very minor erosion at the base near the ditch along the south property line, in the form of a minor gully.

Photograph 2: Ditch at the base of the slope.

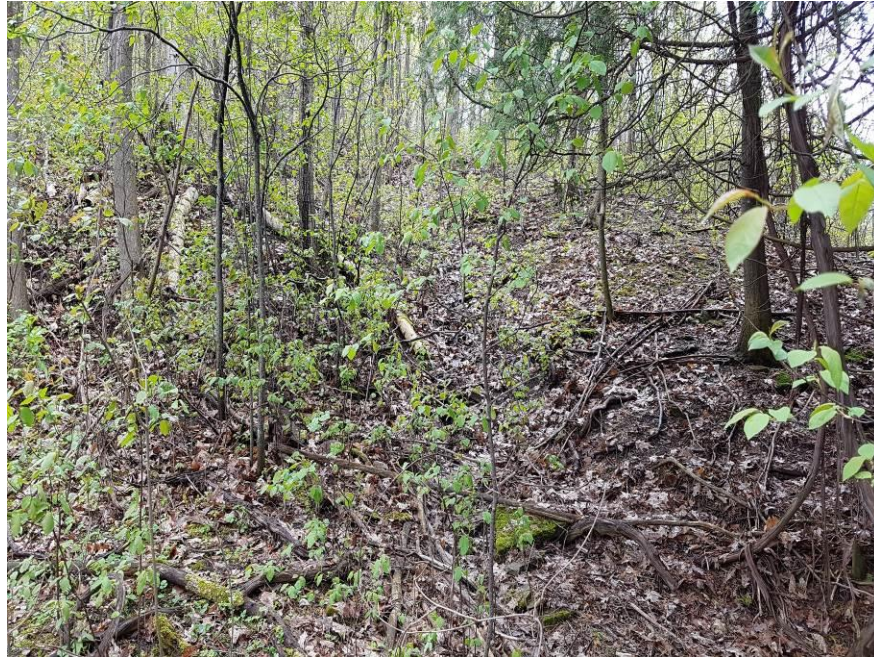
The slope is predominately covered with heavy shrubs and mature trees (well vegetated).

No signs of slope failure were present on Block 51 at the time of our site visit.

Photograph 3: General slope conditions.

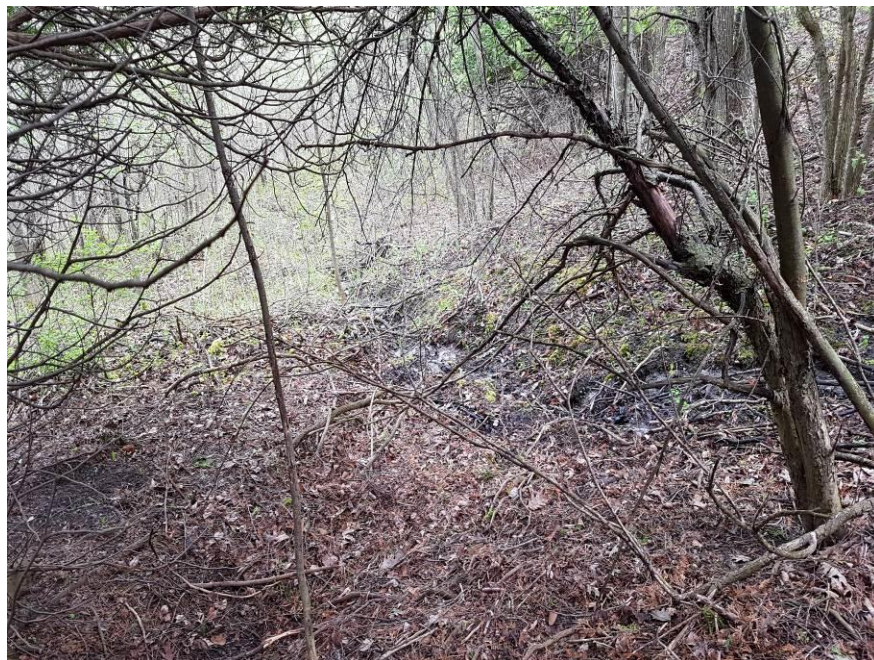
Photograph 4: General slope conditions.
