Re: Karst Investigative Study - Kurita Property
584022 Sideroad 60 - Lot 28, Concession 7
Former Holland Township
Township of Chatsworth

Karst Investigative Study—Proposed Bumstead Pit

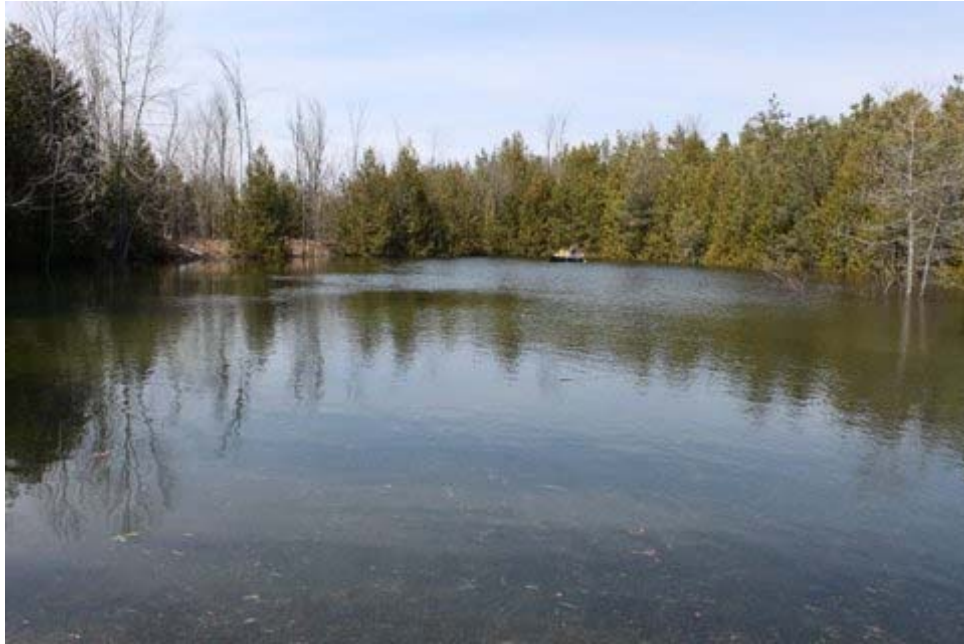
Photo 1 - View of Pond of Interest during flooded conditions (photo provided by Kurita).

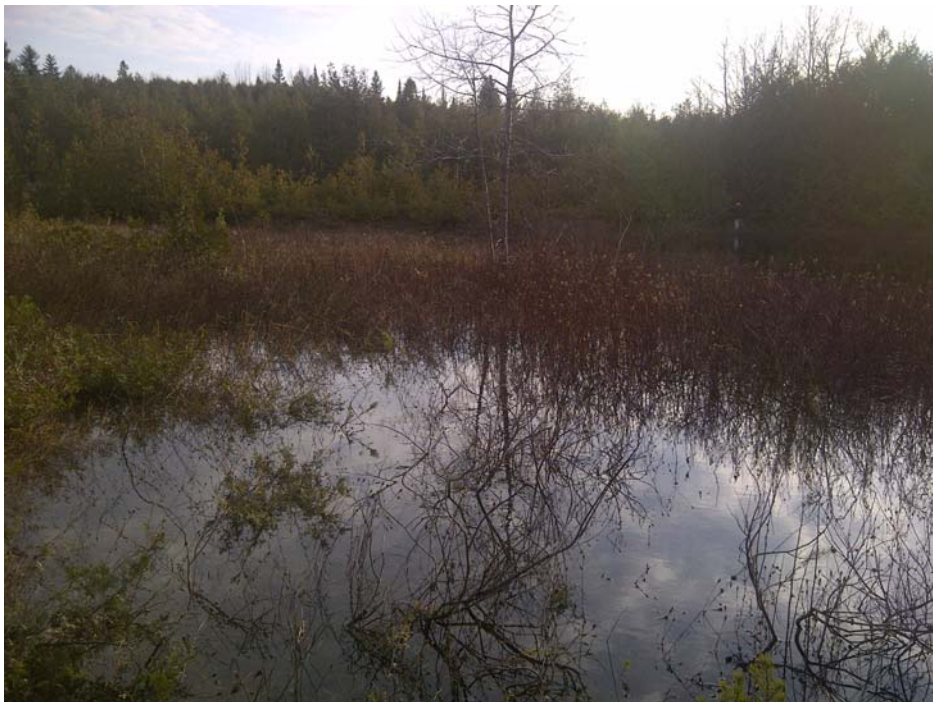
Photo 2 - Looking southwesterly at pond of interest under “partially” flooded conditions (November 11, 2014).

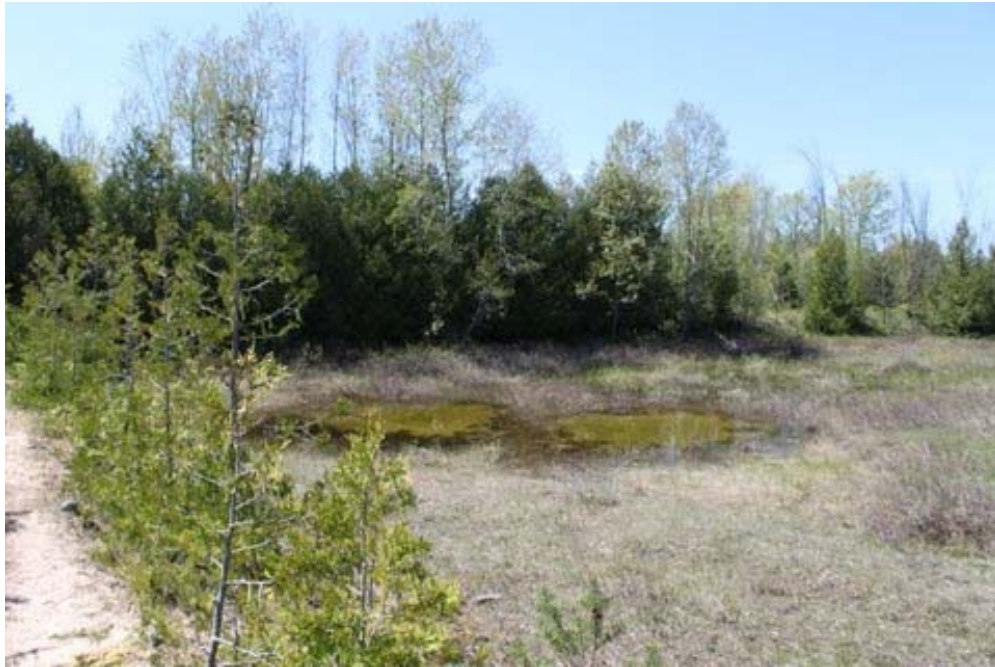
Based on comparison to the physiographic mapping, the three most easterly ponds are situated within the drumlinized feature and are generally separated by a series of berms. The two northwesterly ponds, separated from each other by a berm, are located approximately 40 meters west of the three upper ponds and appear to be, at least in part, situated within the spillway feature rather than the drumlin. During the site visit, no exposed bedrock, or bedrock outcropping was noted. The specific areas of interest were located at the deepest areas of the pond and were evident by the lack of vegetation, noted to exist within these features (refer to Photo 3).

The areas of interest are shown on the attached photographs. These areas are evident as low-lying areas within the pond of interest and are void of grassy vegetation noted within other areas of the pond bottom. During the site investigation, the pond of interest contained standing water. To assist the investigation, some of the bottom areas with suspected Karst, were probed manually with a steel push probe. These areas suggested the existence of soils containing sand and gravel to a depth of at least 0.3 m below the bottom of the pond. Although these features appear to be lower in elevation than the rest of the pond, no evidence of subsidence, or 'sinking' was noted. The surface water in the area of interest appeared to be stagnant, with no evidence of water currents or rapid surface water infiltration (even upon disruption of bottom sediment in pond).

Photo 3 - Looking Westerly: View of Pond of Interest. The low-lying circular features that contain water are those suspected to contain karst. (Photo provided by Kurita)

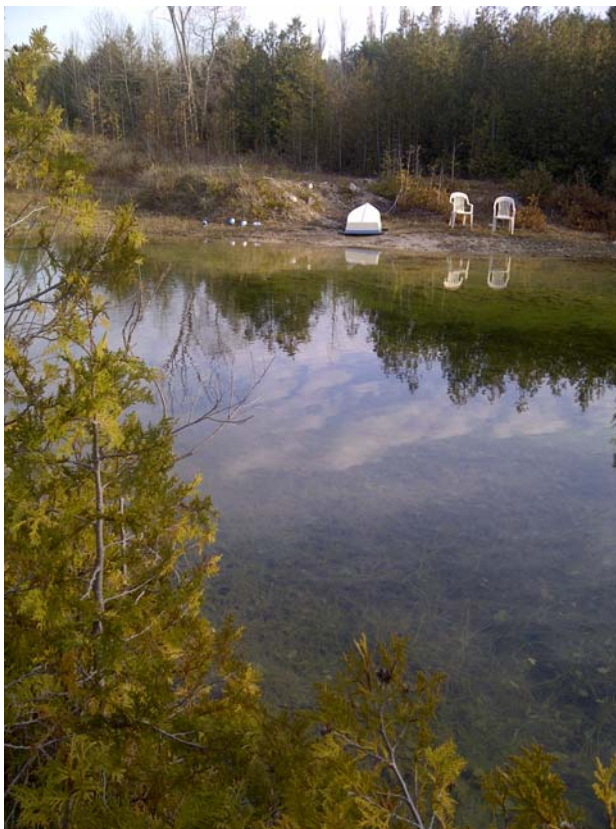
Photo 4 - Looking Southerly: View of Pond directly south of Pond of Interest. This pond is reported to maintain water throughout year.

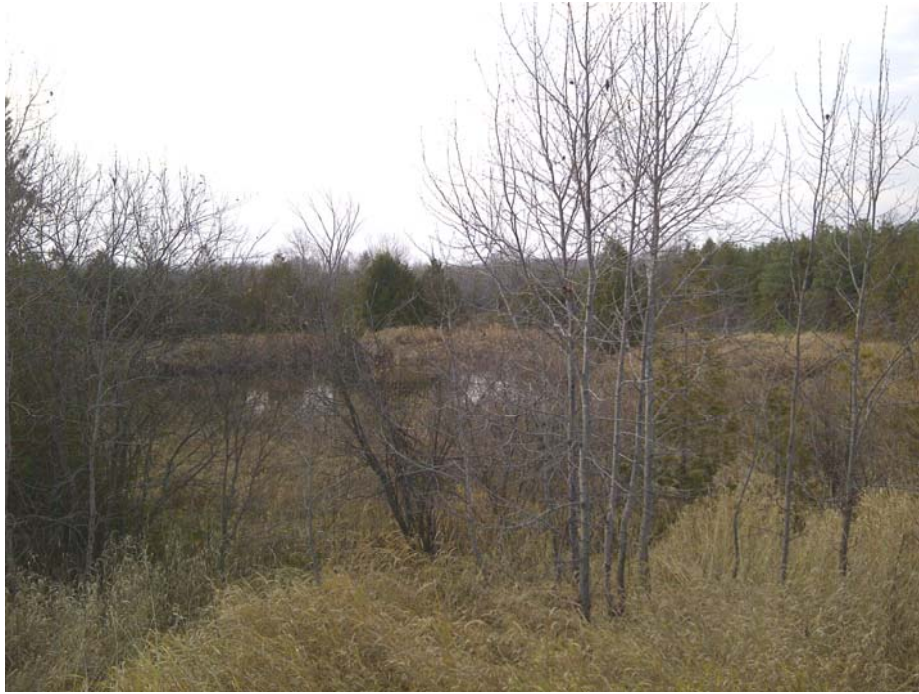
Photo 5 - Looking Northwesterly: View from NW edge of upper pond showing fall towards northwest (November 11, 2014).

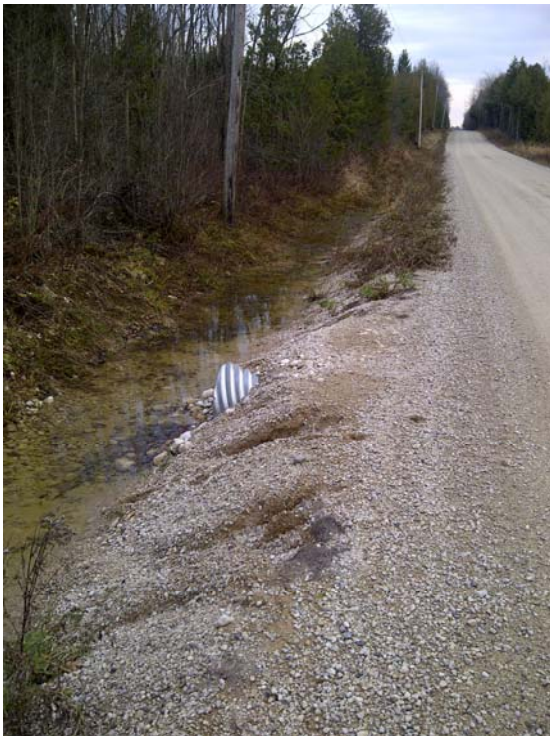
Photo 6 - Looking Southerly: View of Veteran's Road South showing swale. Pond of interest is approximately 20 to 30 m left (east) of swale (November 11, 2014).
