**Third Party Karst Peer Review
Proposed Bumstead Gravel Pit
584015 Sideroad 60 Township of Chatsworth**

**Daryl W. Cowell & Associates Inc.
27 Rita Crescent, RR1 Tobermory ON**

May 7, 2015

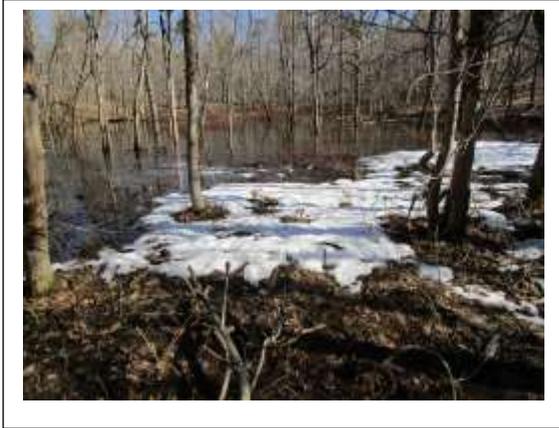
The first three entries in Table 1 provide temperature and conductivity of the lake and its two downstream overflow ponds. The low temperatures in the downstream ponds are indicative of direct snowmelt from the surrounding wooded area (discontinuous cover of snow was present in the area of the ponds, Photo 1). The higher temperature in the Lake reflects direct warming from the sun which can have relatively rapid responses as the lake is shallow and has little circulation. Low conductivity measurements are also consistent with snowmelt. Slightly higher levels in the downstream overflow pond likely reflect some dissolution of carbonate as the meltwater contacts carbonate boulders and cobbles of the surface deposits.

Photo 1. Downstream pond fed by snowmelt and overflow from Walker Lake. This pond typically dries out by the end of April (D. Crocker, pers. comm.)

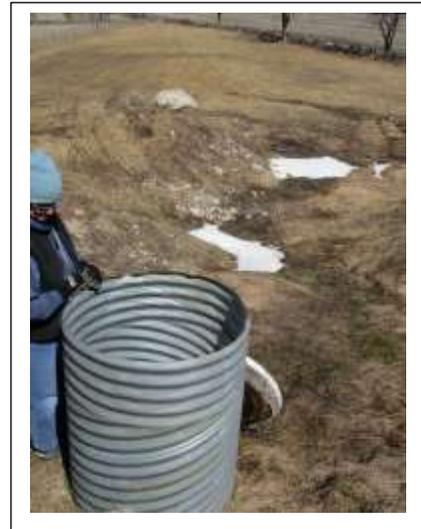
The “spring” described in Gamsby and Mannerow (2013) is a broad area of seepage emanating from glacial deposits on the side of the drumlin. It is located immediately below the road (Sideroad 60, Figure 2). Some of the seepage is captured in a stilling well (galvanized pipe) for agricultural uses (Photo 2). Overflow water drains down the side of the drumlin onto the surrounding meltwater plain where the flow infiltrates into the coarse cobble and gravel material. There is no ponding at this location and the sands and gravels are known to be over 5 m deep in this area¹.

The conductivity of the water is amongst the highest of all those sampled likely reflecting some interaction with carbonate materials in the stony silty to silty sand till composing the drumlin. The chemistry of this spring could also be affected by winter salting of the adjacent Sideroad. The low temperature indicates that the water is not sourced from deep flow, being characteristic of local snowmelt.

Photo 2. Stilling well and seepage flow channel leading toward meltwater channel gravels.

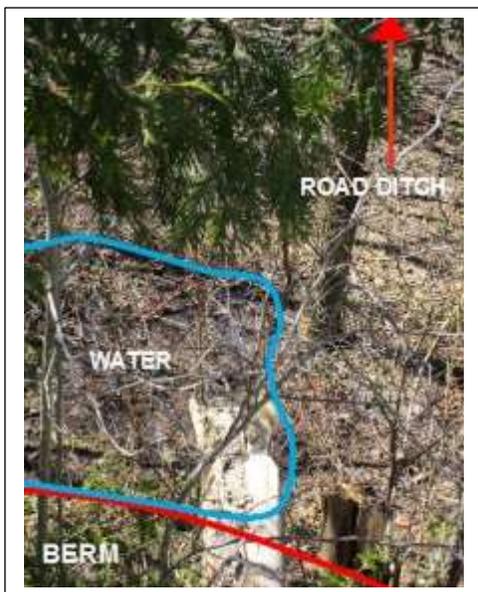
A portion of the berm holding this lower pond roughly parallels Veterans Road South and is notched to control the water level in the pond. At the time of the site visit, the pond surface had dropped below the notch but some flow/seepage was still occurring through the berm immediately below the notch. A recently deepened ditch along the road eventually directs runoff to a new culvert under Veterans Road South immediately to the south (flowing toward the west). The berm sat on a flat surface that was collecting water at a level approximately 50 cm or so above the base of the road ditch. It was evident that this water at the front of the berm was being fed, at least in part, by seepage through the berm. Evidence for this included ponded water along the foot of the berm, an absence of residual snow and visible laminar movement suggesting some active seepage from the berm (Photo 3).

In regards to the suspected karst draining of the lower pond on the Kurita property, it is my opinion that drainage from this pond is not due to karst. If a bedrock karst cave existed beneath this pond and this cave was hydraulically connected to a karst aquifer, drainage from the pond would be more rapid and obvious signs of sinking would be observed. The pond slowly drains ever year with no apparent change in the form of the basin. Continual drainage into a bedrock crevice even over a fifty year period would have gradually resulted in the development of true flowing sinkhole with an actively eroding/deepening depression as a result of receiving flowing water similar to those found west of Veterans Road South (*e.g.*, Photo 4). The bottom of the pond retains its form and the lowering of the pond’s level is described as always being gradual without evidence of surface “flow” into any part (Anne Kurita, pers. comm.). Further, if the two lowest shallow depressions in the bottom of the pond were feeding karst, one or both of these depressions would completely dry out during the dry part of the hydrological year and not remain “damp” as reported.

Water levels in this pond are controlled by flow over a V-shaped notch in the berm, percolation through the berm), stoppage of surface flow into the pond, evaporation, and seepage into sediments below the pond. It should be noted that this pond, unlike the upper ponds lies at the intersection of the till and an overlying glaciolacustrine deposit (Figure 1 in GM BluePlan Engineering 2014 and Feenstra 1994 – see

Photo 3. Lowest pond on the Kurita property showing position of the berm relative to the road ditch and percolating seepage.

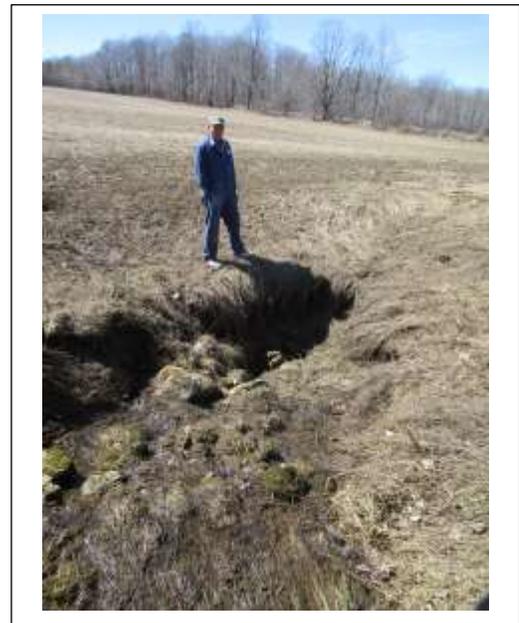
Two active karst streamsinks (sinkhole draining a surface stream) were observed in the meltwater system to the west of the Veterans Road South (Figure 2). These are small karst systems typical of post-glacial karst in the Guelph Formation as observed by the author elsewhere. The streamsink immediately west of Veterans Road South was flowing approximately 2 L/sec (estimated) with water derived from a wetland pond to the southeast (Photo 4). The streamsink west of Concession Road 3B was taking a higher flow sourced from a dug-out pond located on the north side of Sideroad 60.

In both cases, surface water collects on the till plain then overflows via a stream channel that eventually sinks. The sinking point is opportunistic usually relating to a zone of higher permeability in relatively shallower soil. Fracture plains within the upper bedrock were opened by late glacial isostatic rebound and the water follows these fractures, expanding them by solution forming small caves. The fact that the water was free-flowing into the bedrock and not ponding/infiltrating indicates that the fracture system/cave is not controlled by the bedrock groundwater table but is in vadose zone (partly air-filled) forming a karst flow regime within the bedrock to a lower base level.

Soil and debris obscured the bedrock-till interface so the actual bedrock elevation is difficult to determine. Surface elevations are about 405 m asl at the sink nearest Veterans Road South and closer to 400 m asl at the sink west of Concession Road 3B. Assuming at least 2 – 3 m of till, the bedrock surface at these sinkpoints would be in the range of about 398 to 402 m asl. This is consistent with the highest bedrock elevations observed in well logs and the bedrock high on the Bumstead property. Neither of the sinkpoints were associated with visible bedrock highs but located on the gently rolling till plain.

Photo 4. Streamsink on till plain immediately west of Veterans Road. Water enters from bottom left and Disappears into bedrock below figure.
