# VISUAL IMPACT STUDY (VIS)

# WILDER LAKE ESTATE RESIDENTIAL DEVELOPMENT

Prepared for H. Bye Construction Limited  
Revised December 10, 2019

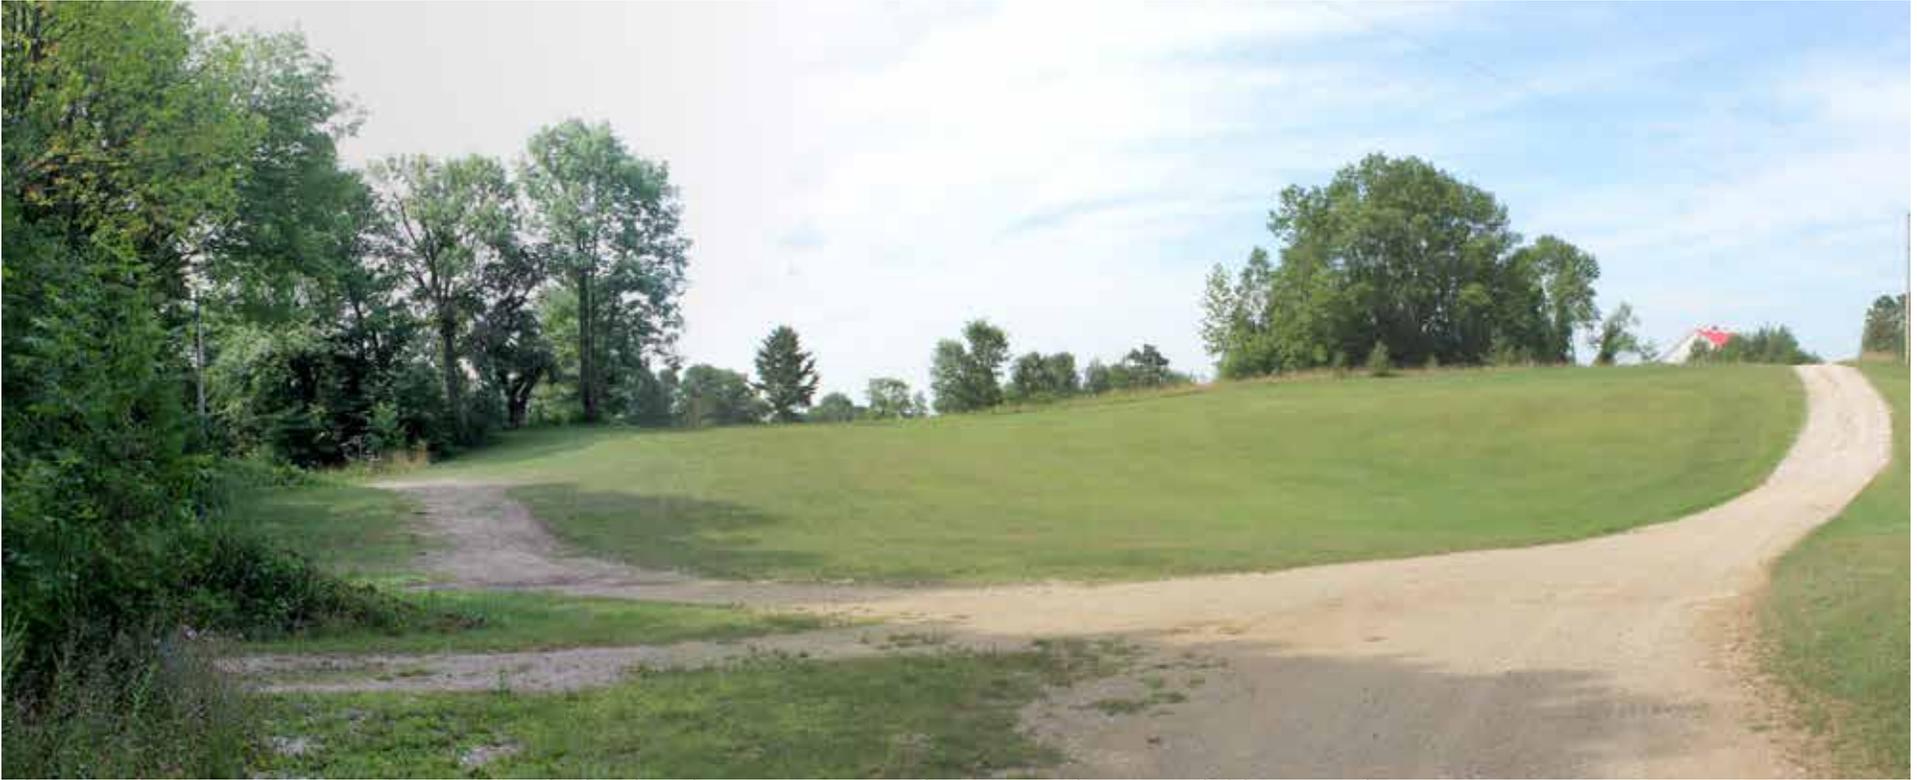
Photograph #1 - Looking southwest towards the shoreline vegetation and Homestead Resort Clubhouse and Restaurant

This photo demonstrates the grade difference between the Lake Wilder shoreline and the eastern edge of the development adjacent the clubhouse. The elevation changes would likely result in homes being built at a higher elevation than the shoreline; however, based on an assessment of the existing Ecological Land Classification (ELC) species, the height of the existing vegetation could be reasonably expected to reach and sustain a height of 20-30 metres, with the most dense vegetative screening occurring between 0-15 metres above ground level. Provided development can follow some mitigation measures where feasible, visibility of the homes will likely remain low to negligible.

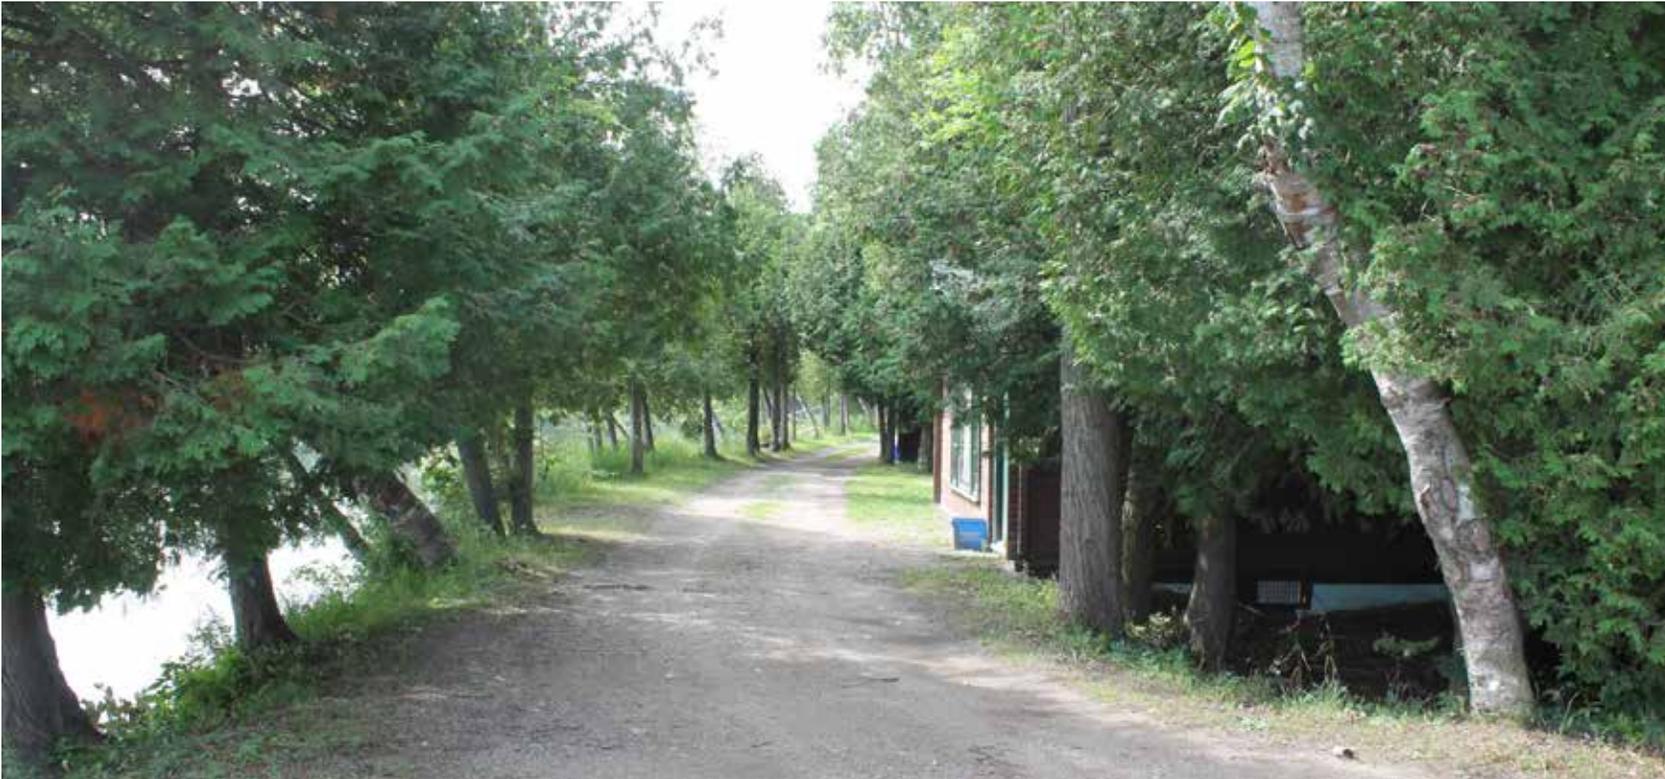
Photograph #2 - Looking south down the cottage access road

A laneway currently runs through the middle of the screening buffer between the site and Wilder Lake. Vegetation is present on either side and extends to the edge of the lake. The lake side vegetation east of the laneway is generally lacking a significant understorey leading to more open visibility between 0 and 3 metres above grade. The west side contains far more understorey shrub species and generally larger, more mature trees. Eight cottages are also present along the length of the laneway; however, these are to be removed during site development, providing space for significant infill planting to assist in screening views of the development, both in leaf-on and leaf-off conditions. A mix of coniferous and deciduous trees and shrubs similar to existing species composition would be most beneficial in screening views.

- The dock will remain in its existing location; however, views from the lake through to the site via the dock access road could be mitigated further by restoring demolished cottage sites and planting vegetation on either side of the laneway where feasible to close any visual gaps in the shoreline vegetation.

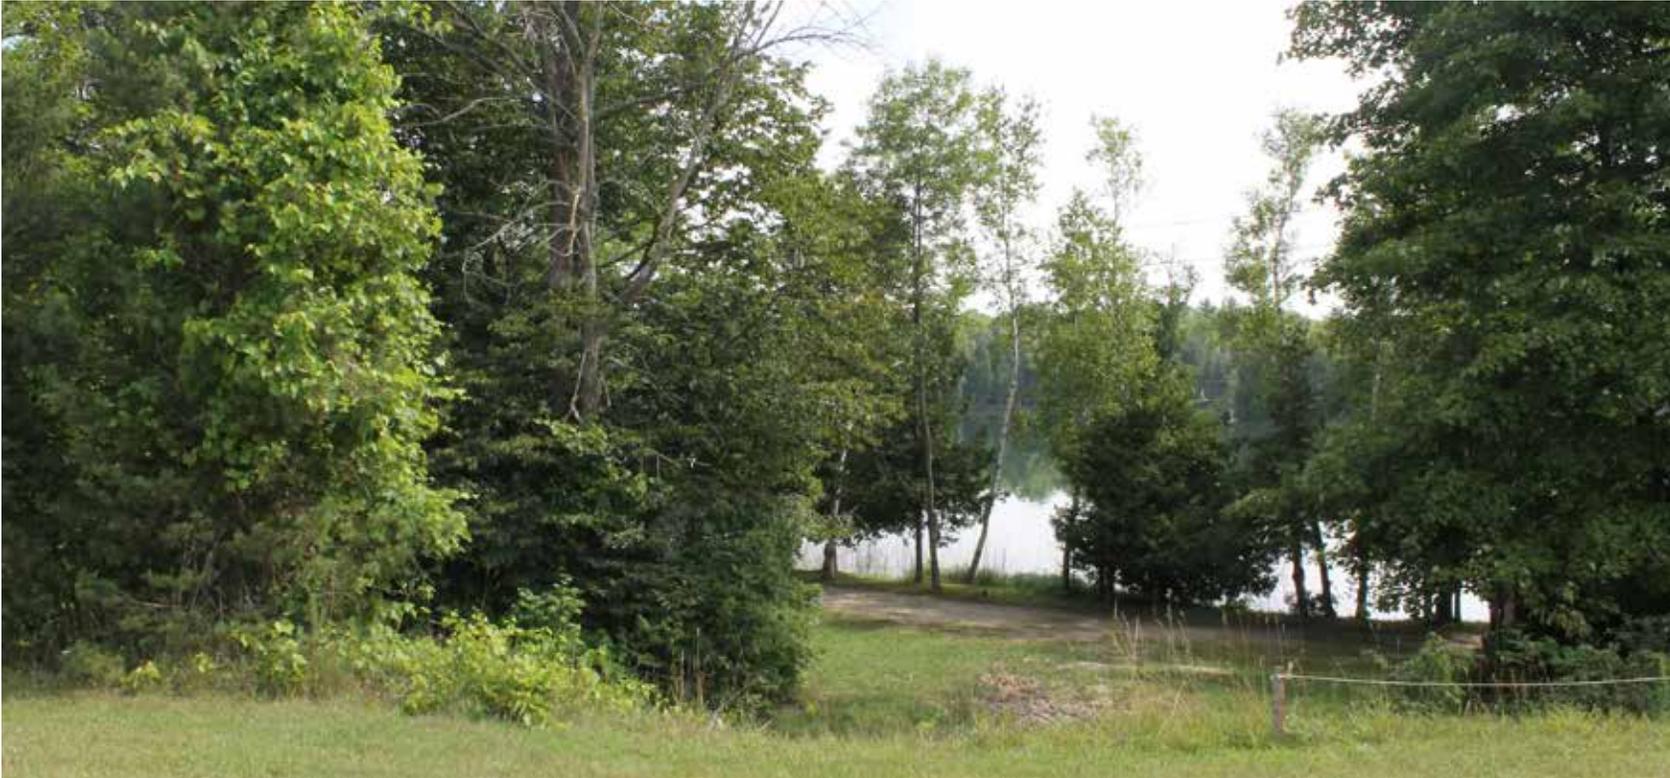
Photograph #3 - Looking east towards gaps in shoreline vegetation

There are a few locations along the shoreline within the Hazard Lands screening buffer where vegetation is sparser and gaps in the existing woodland are evident. Despite these gaps, visibility through to the site remains minimal due to angle of views and distance of receptors across the lake. Restoration plantings within these gaps, including fast growing deciduous and coniferous trees and shrubs would help to decrease visibility from receptors across the lake.

- Where gaps in vegetation are present within the screening buffer, infill with a mix of fast growing, complimentary deciduous and coniferous trees and shrubs;
- White Cedar, Poplar tree species and shrubs such as Viburnum and Chokecherry should be used where feasible.

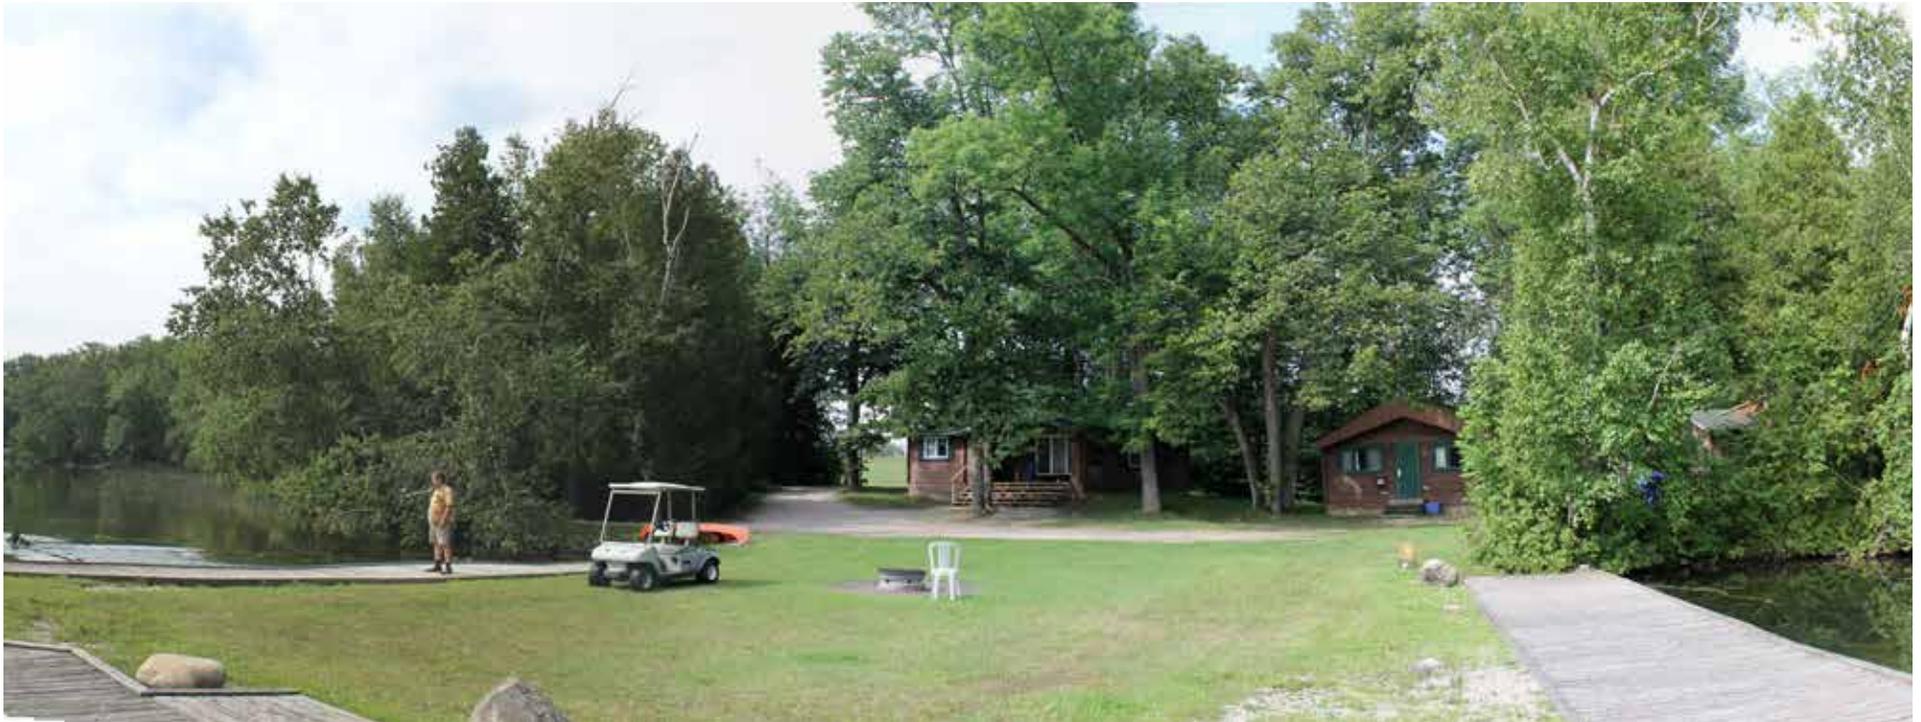
Photograph #4 - Looking west towards the dock, existing cottages and shoreline vegetation

Wilder Lake shoreline vegetation along the frontage of the property extends to the lake edge creating a dense vegetation buffer from ground level upwards as viewed from on and across the lake. The existing dock on site is to remain; however existing cottages visible from on the lake are to be removed, leaving empty space along the waterfront. These locations would be prime candidates for infill planting using species which tolerate the given conditions and will grow rapidly creating additional visual screening. A combination of coniferous and deciduous trees and shrubs could be used to eventually create a dense canopy and understorey providing maximum visual screening.

- Remove cottage structures
- Restoration of demolished cottage sites with plantings consistent with, or complimentary to existing species within the shoreline ELC;
- White Cedar, Poplar tree species and shrubs such as Viburnum and Chokecherry should be used where feasible.

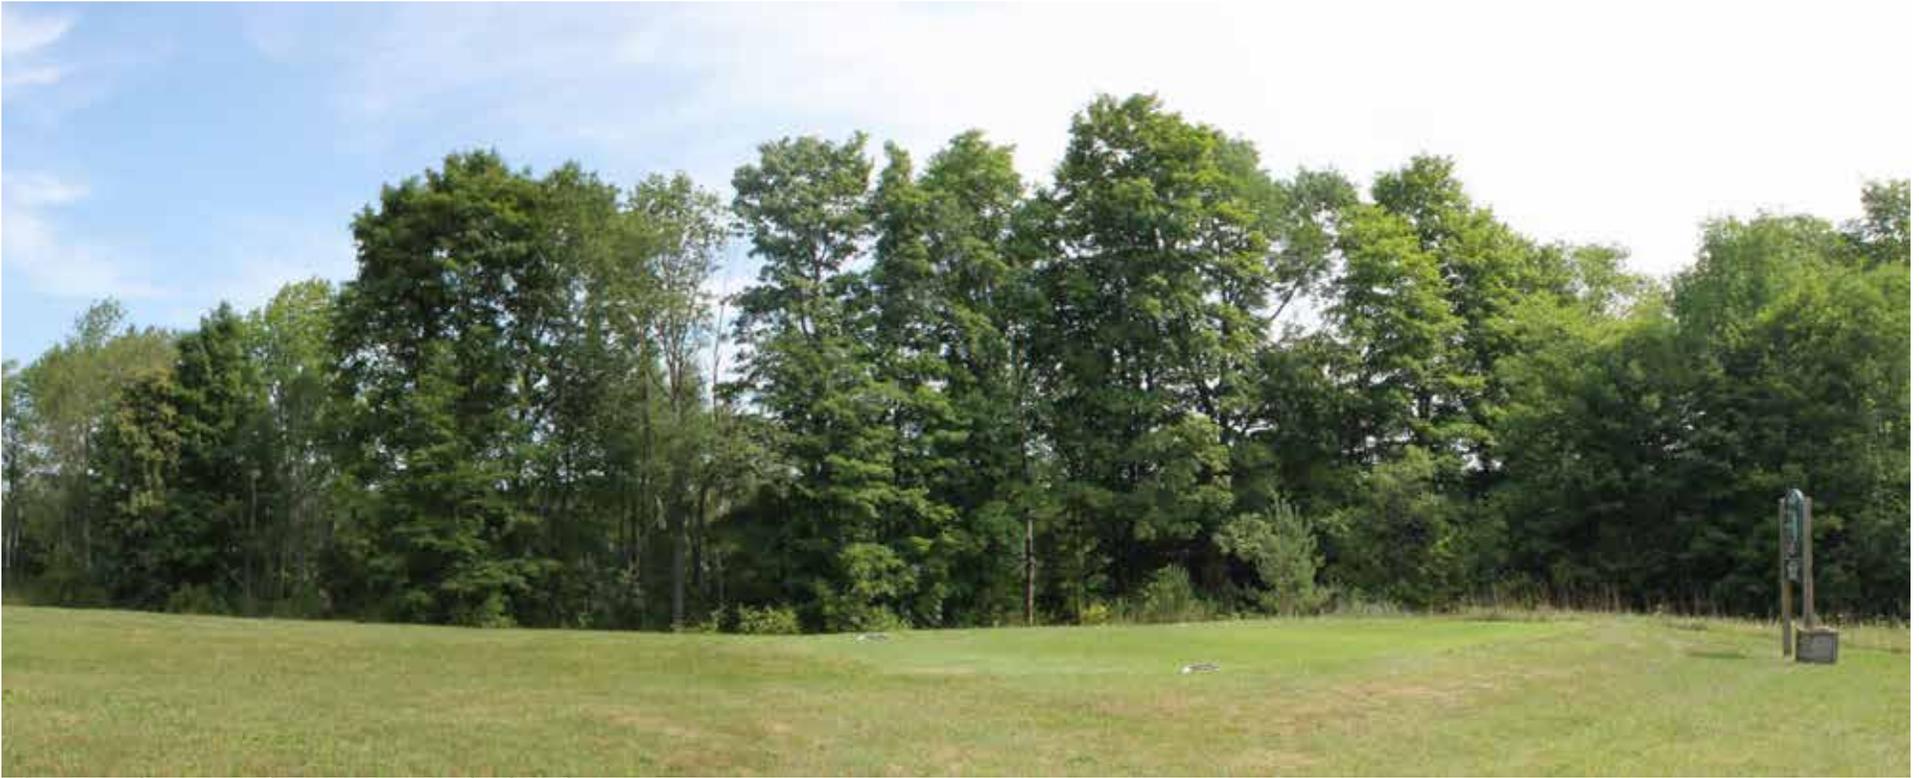
Photograph #5 - Looking east towards shoreline vegetation

The south end of the property does not have any cottages located along the lake edge, so vegetation is much denser and mature (taller) in this location, with increased understorey species. The heights of trees here appear to reach over 30m in height with the visual screening concentrated between ground level and 15m. Visibility through this screening buffer will remain minimal; however, where space allows some infill conifer planting could be used to assist in screening views during leaf-off conditions.

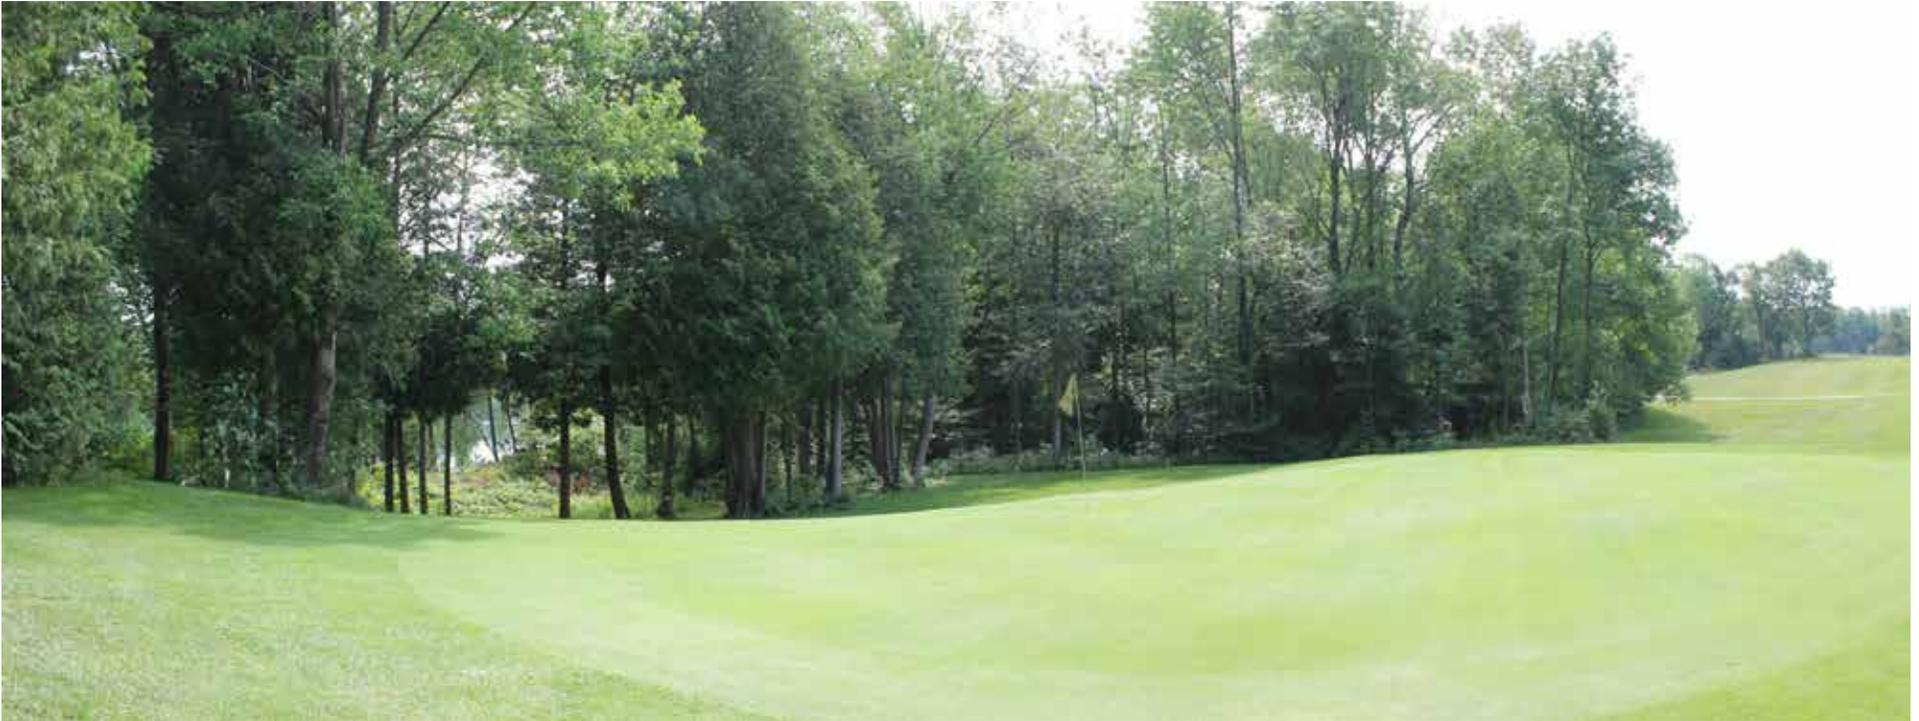
Photograph #6 - Looking southeast towards gaps in shoreline vegetation

The north end of the property is generally lower than the south and contains more wet areas both inland and along the edge of the lake, preventing large-growing understorey species from establishing. Where gaps exist in the screening vegetation, infill planting with appropriate species, adapted to the given conditions could be used to increase the density of the screening as much as possible. Strategic placement of homes around these gaps in vegetation could also play an important role in reducing visibility from across the lake.

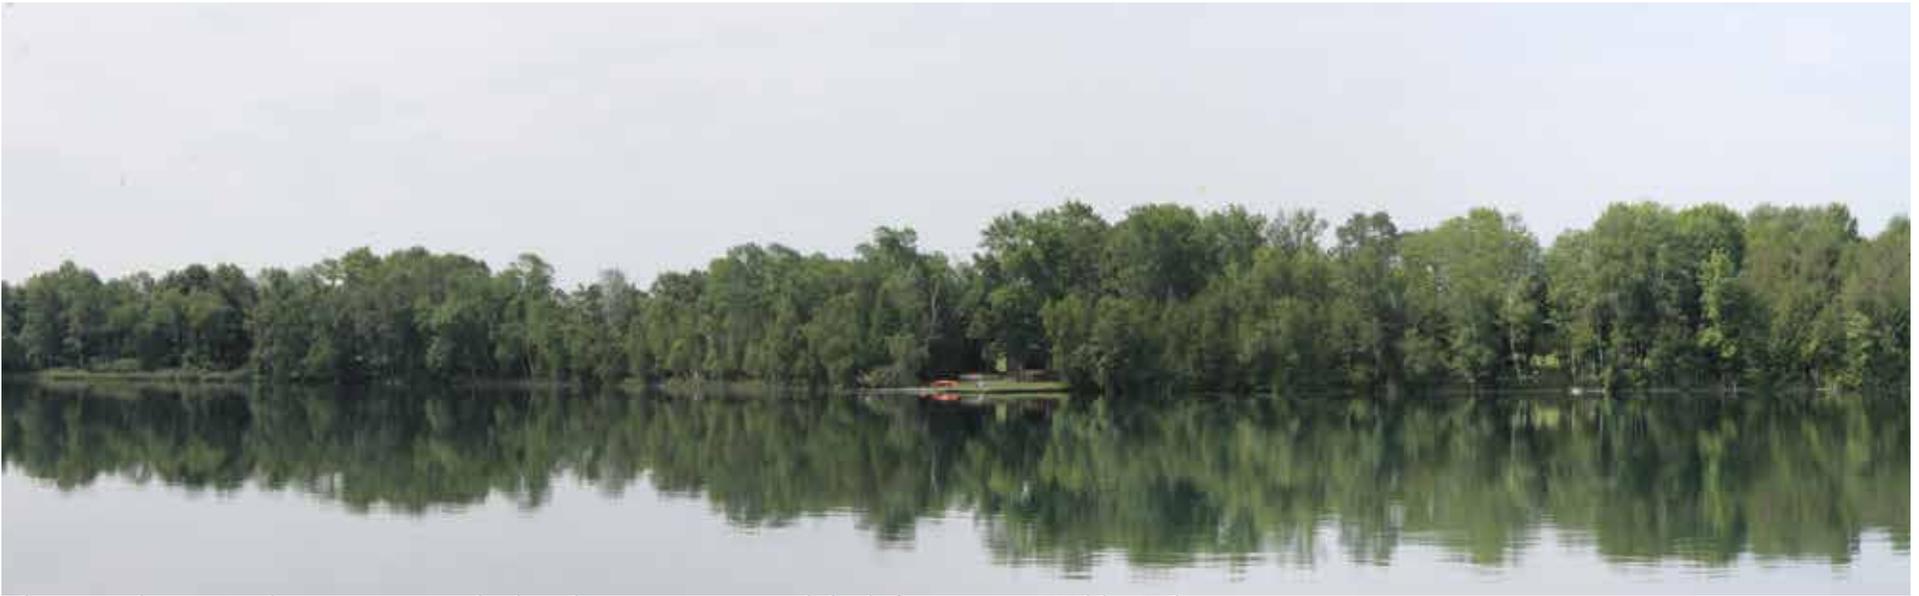
Photograph #7 - Looking west towards shoreline vegetation and dock from across Wilder Lake

Distance from receptor (Lake Rd dead end) to the site (dock) is approximately 300m in this photograph. Views from across the lake demonstrate the extent of vegetation along the shoreline of the subject property. There is generally consistent vegetation along the entire shoreline with a mix of deciduous and coniferous vegetation. Several gaps can be seen at the dock and approximately 100m north of the dock where a lack of understorey vegetation allows views into the subject property approximately 5-10 m above ground level. In these locations the planting of coniferous trees and shrubs, where feasible, would help in reducing visibility. From the dock southward, the angle of the shoreline as viewed from select receptors across the lake compounds the effectiveness of the screening buffer. Currently, a number of the cottages along the lake are visible from this location. The club house, the tallest feature on the subject property is not visible from this location.

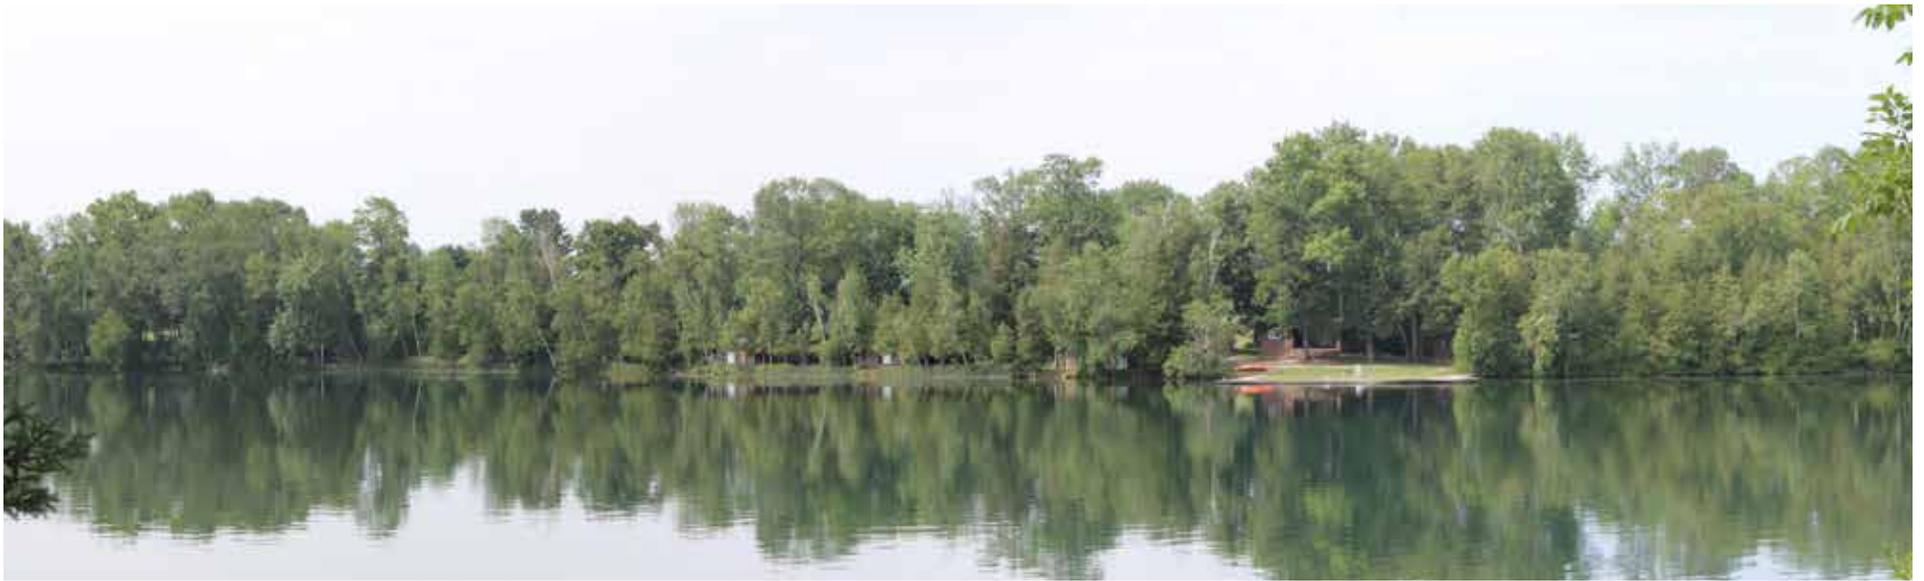
Photograph #8 - Looking towards the shoreline vegetation, dock and cottages from across Wilder Lake

Distance from receptor (118 Lake Rd) to the site (dock) is approximately 200m in this photograph. Views from this receptor across the lake demonstrate the extent of vegetation along the shoreline of the subject property. Similar to Photograph #7, there is fairly consistent screening along the entire shoreline. Cottages south of the dock are distinctly visible from this location, as well as gaps at the dock and at the southern end of the property approximately 5-10m above ground level. Once cottages are removed these features will no longer be visible creating a more natural shoreline. Where gaps exist, the planting of coniferous trees and shrubs, where feasible, would assist in reducing the porosity of the vegetation in these locations.

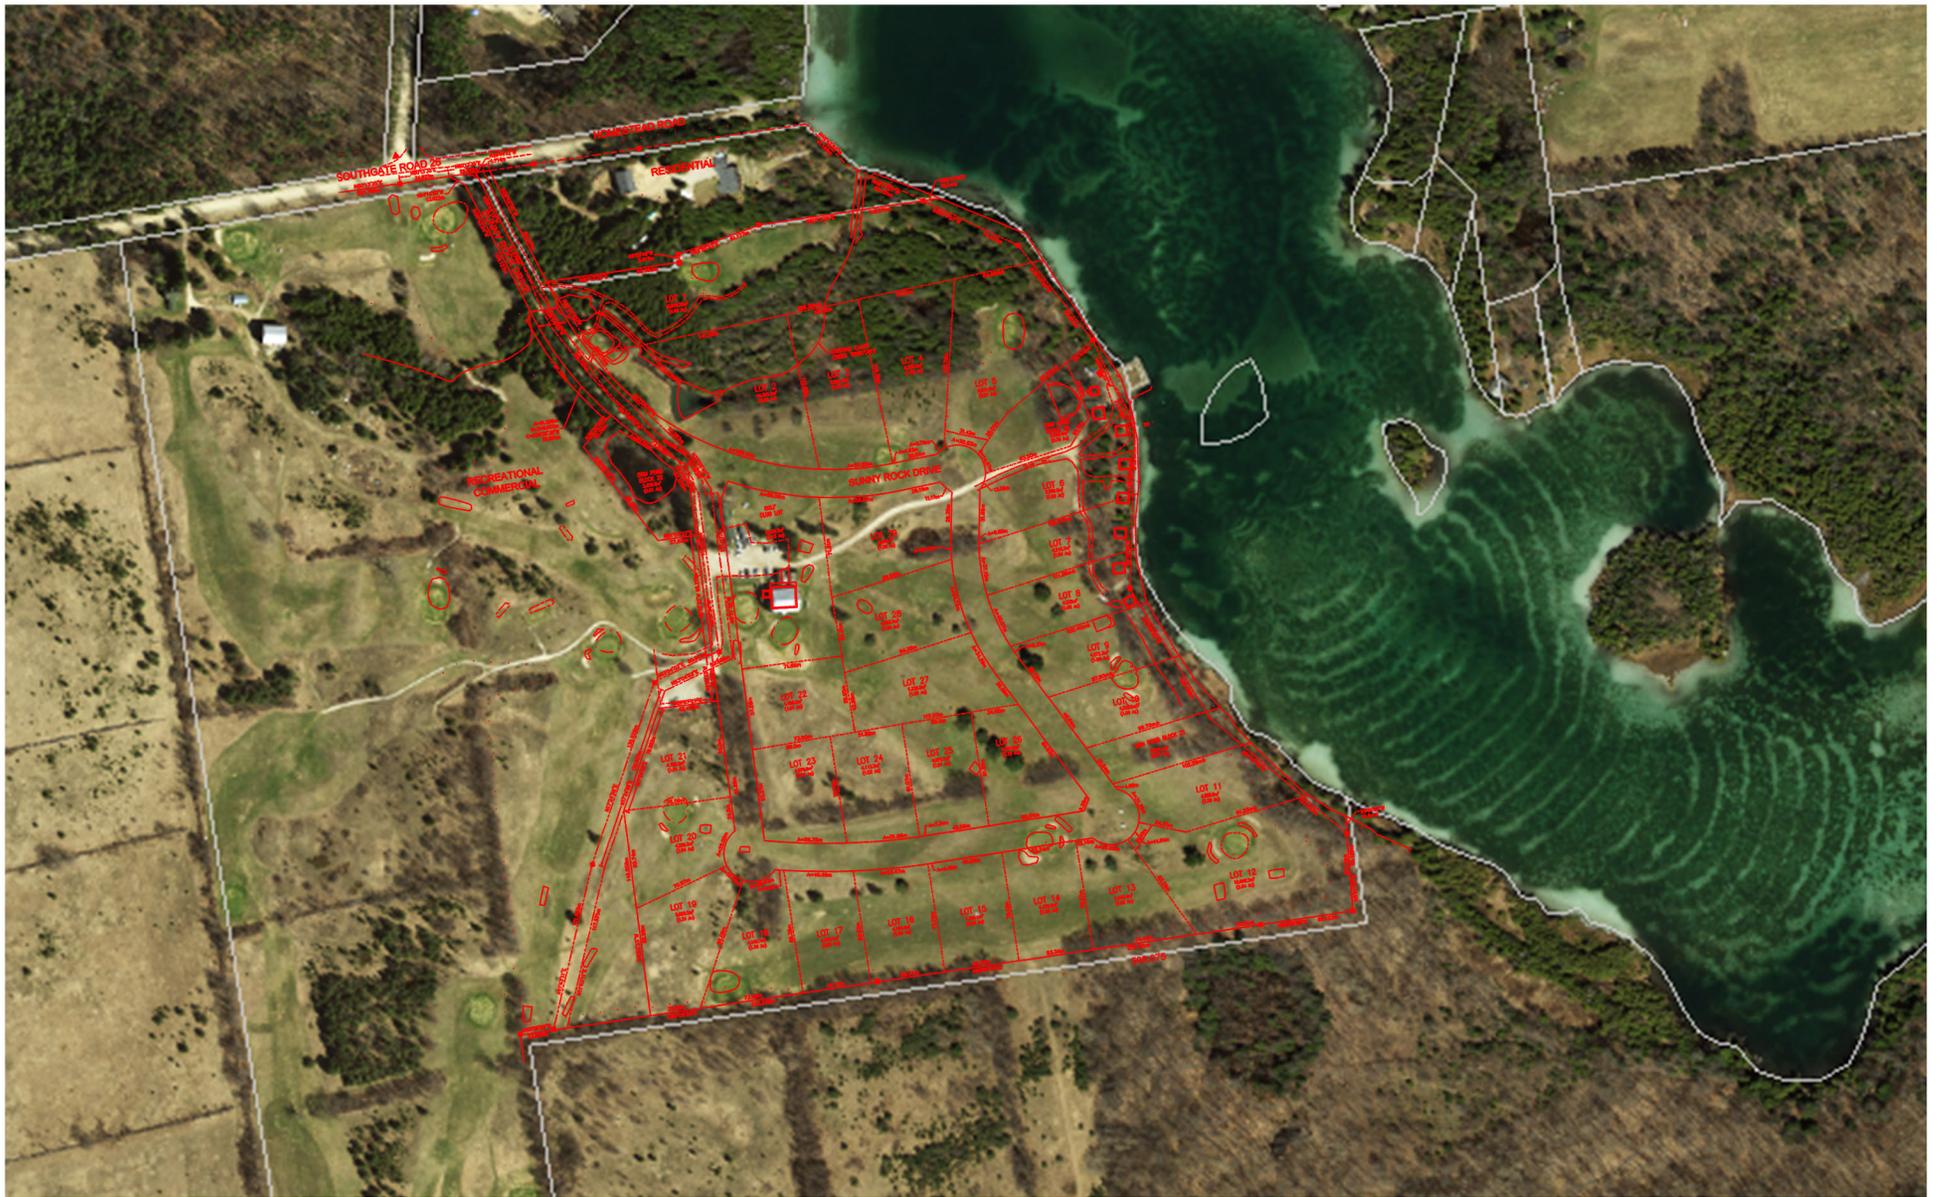
**Figure 2:**  
**Proposed Wilder Lake Estate Residential Development**

FIGURE INFORMATION:  
 REVISED SITE PLAN SUPPLIED BY CUESTA PLANNING  
 CONSULTANTS INC. DATED DECEMBER 10, 2019

Aboud & Associates Inc. was retained by H. Bye Construction Limited to conduct a Visual Impact Study (VIS) in support of a proposed residential development on Wilder Lake. The proposed development is located within the Township of Southgate in Grey County, southeast of Durham, Ontario, see **Figure 1**. The property occupies the east half of an existing golf course and is approximately 20 hectares in size. The development is comprised of twenty-nine lots, with 10 having frontage on Lake Wilder (1 & 5 through 12). Homes must be offset a minimum 30m from the edge of Saugeen Valley Conservation Authority designated Hazard Lands. See **Figure 2** for preliminary development site plan.

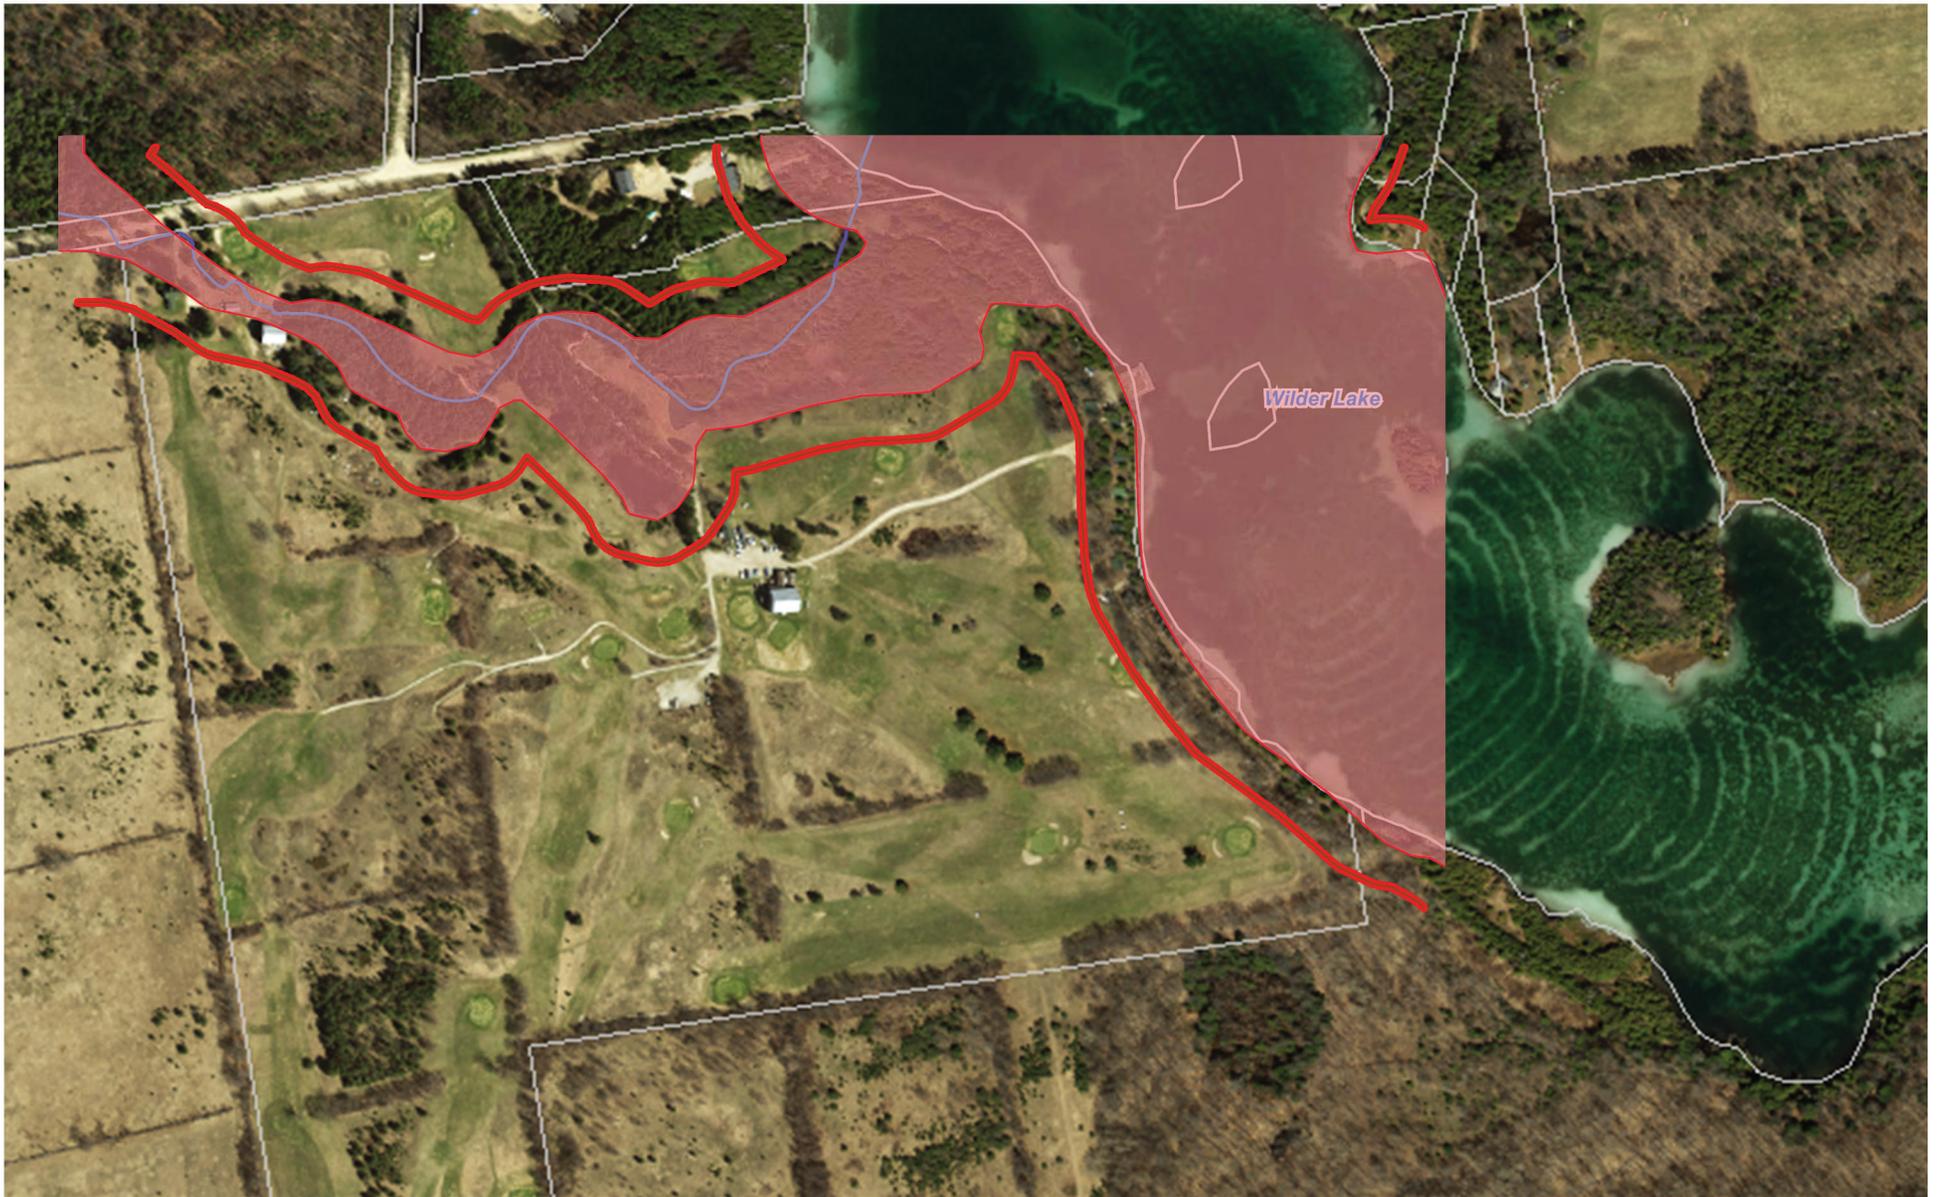
**Figure 3:**  
Saugeen Valley Conservation Authority Hazard Lands

Hazard lands have been identified by the Saugeen Valley Conservation Authority (SVCA) which typically follow the shoreline of Wilder Lake, as well as including the woodland buffering the existing watercourse running through the property. These hazard lands include a screening buffer of approximately thirty metres from the limits of the Hazard Lands, see [Figure 3](#).

- SCVA Hazard Lands
- 30m Screening Buffer

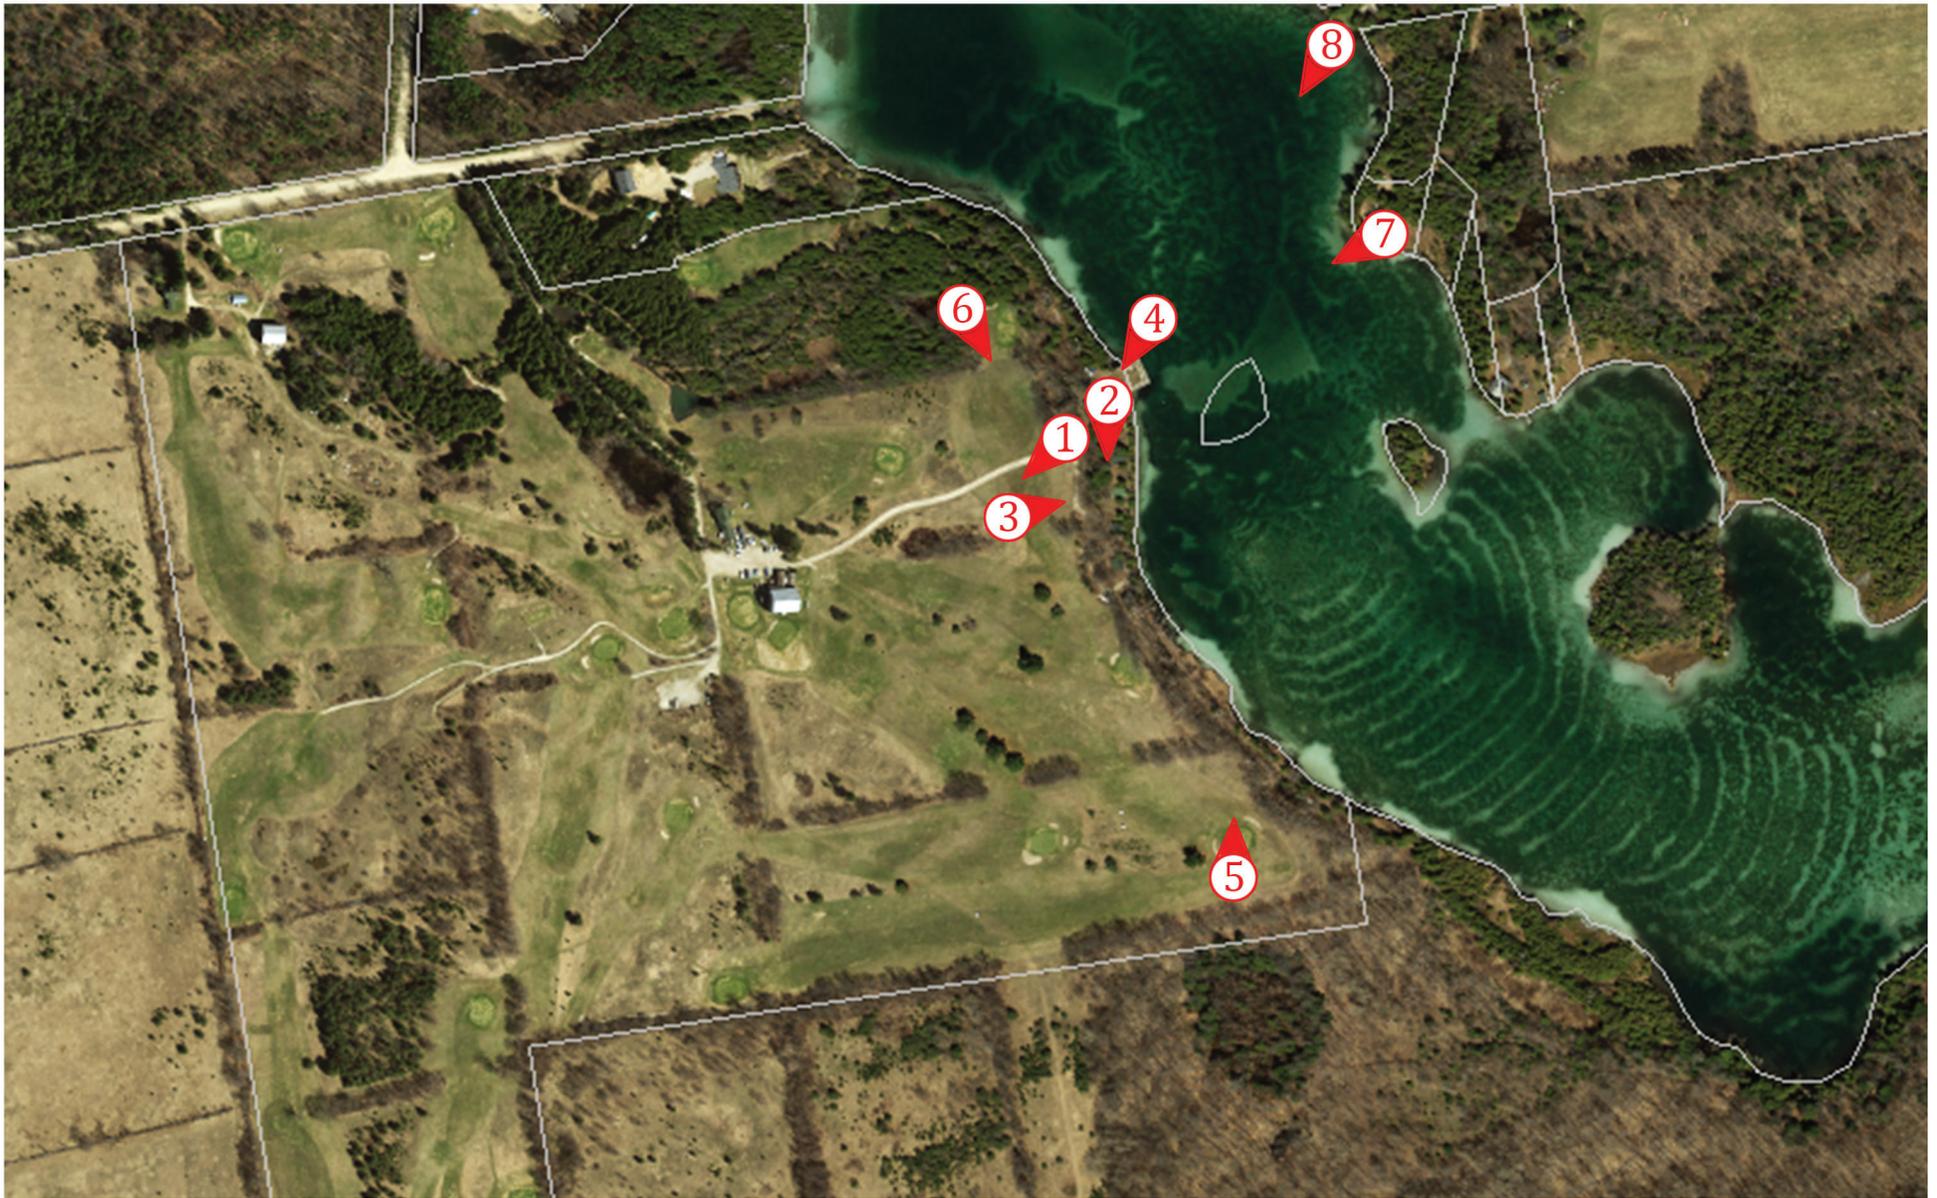
Figure 4:  
Photograph Locations

Our field work was conducted on August 2, 2018. The weather conditions were sunny, warm with excellent visibility for photographs. Photographs were taken at numerous locations on the property toward Wilder Lake, as well as from across the lake towards the subject property where permission to access private property was granted by residents. These photographs are used to confirm and analyze visual impact of the proposed development. Locations and directions of photographs are noted on [Figure 4](#).

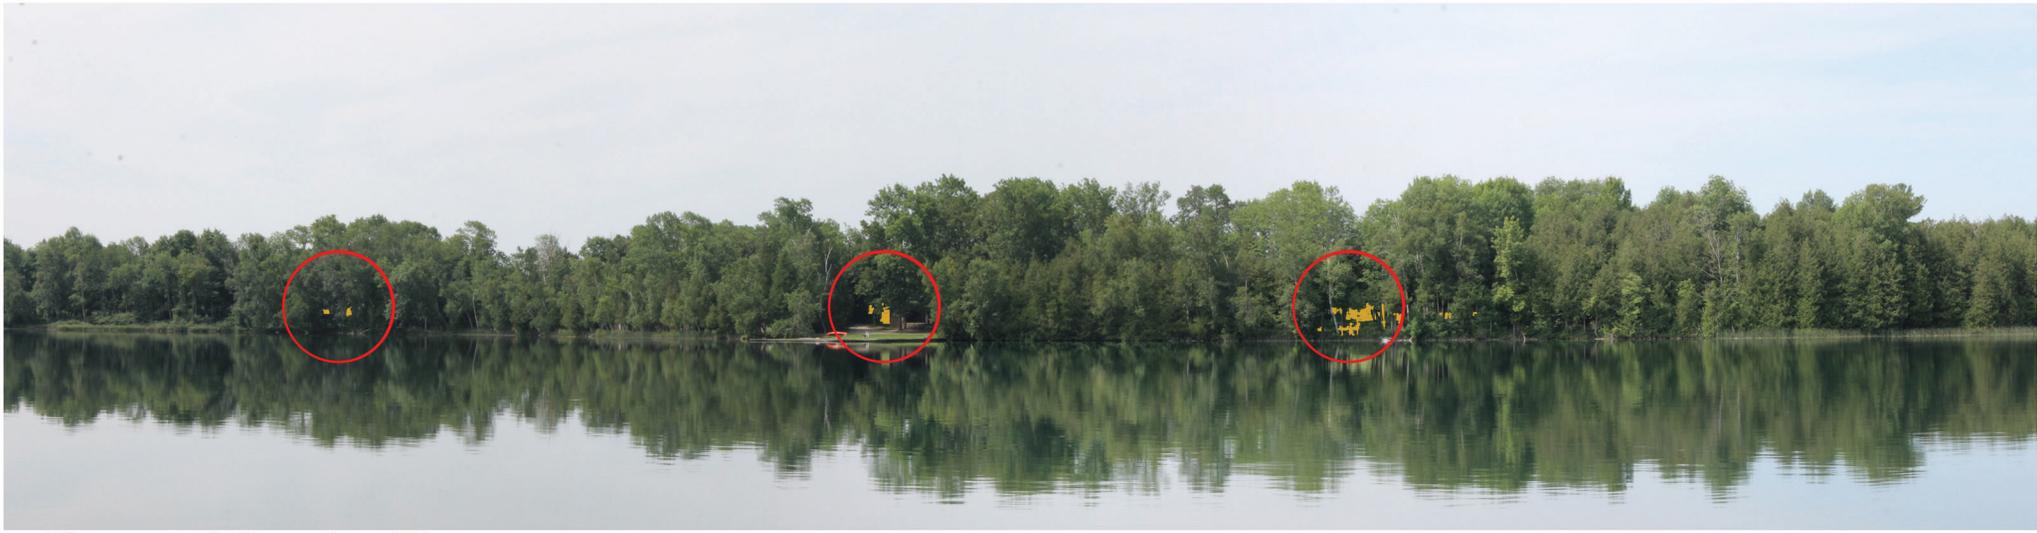
Photograph Location #7

## Figure 5: Visibility of Development Site from Across Wilder Lake

- Visibility Through Existing Vegetation in Leaf-on Conditions
- General Area of Visibility
