**Re: D-4 Guideline Landfill Impact Assessment, 125 Arthur Street West and 123 Louisa Street West, Thornbury, ON**  
**Project #: 2105901**

## 1. Introduction

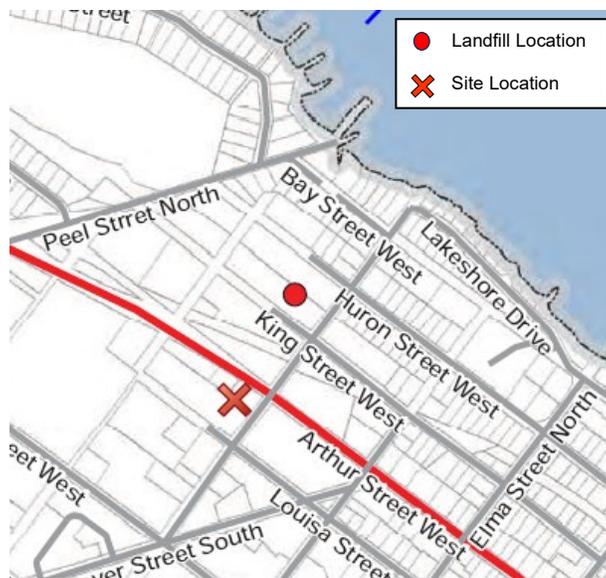
**Figure 1. Landfill Location Map**

**Table 1** and **Figure 1** below identifies the landfill operations located within 500 m of the Site.

MECP Landfill ID Number	Municipality	Distance to Site	Status
X2090	Blue Mountains	152 m north	Closed in 1983

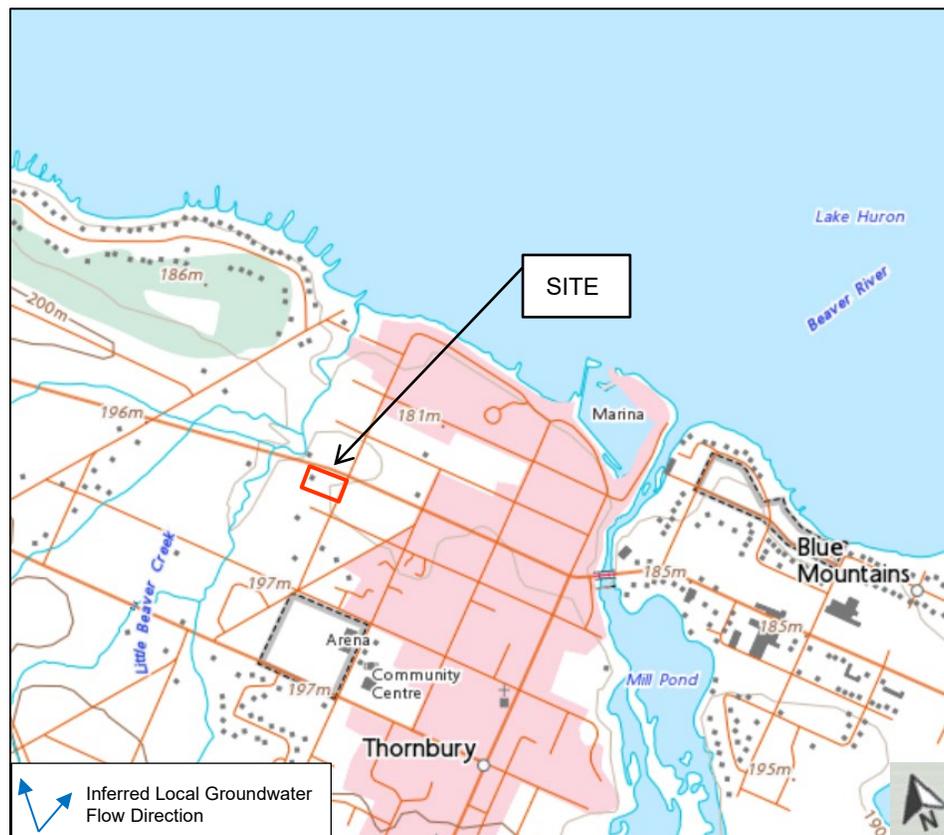
**Figure 2. Topographic Map**

The Site location is shown on the Atlas of Canada Topographic Map, as presented in **Figure 2** below. The surface elevation of the Site is approximately 190 metres above mean sea level (amsl). Topography across the Site is relatively flat, and the topography in the vicinity of the Site slopes gradually downward to the north and east.

The nearest surface water body is the Little Beaver Creek, located approximately 30 m northwest of the Site.

Based on surface topography and nearby surface water features, the horizontal ground water flow direction at the Site is anticipated to be to the north-northeast towards Little Beaver Creek and Lake Huron. Ground water depth is estimated to be approximately 1.52 metres below grade (mbg) based on well records in the vicinity of the Site.
