Re: Karst Topography Assessment  
Part Lot 16, Concession 5, Derby  
Township of Georgian Bluffs

**221051-1**  
**Karst Topography Assessment**  
**Part Lot 16, Concession 5, Derby**  
**Township of Georgian Bluffs**

# KARST TOPOGRAPHY ASSESSMENT

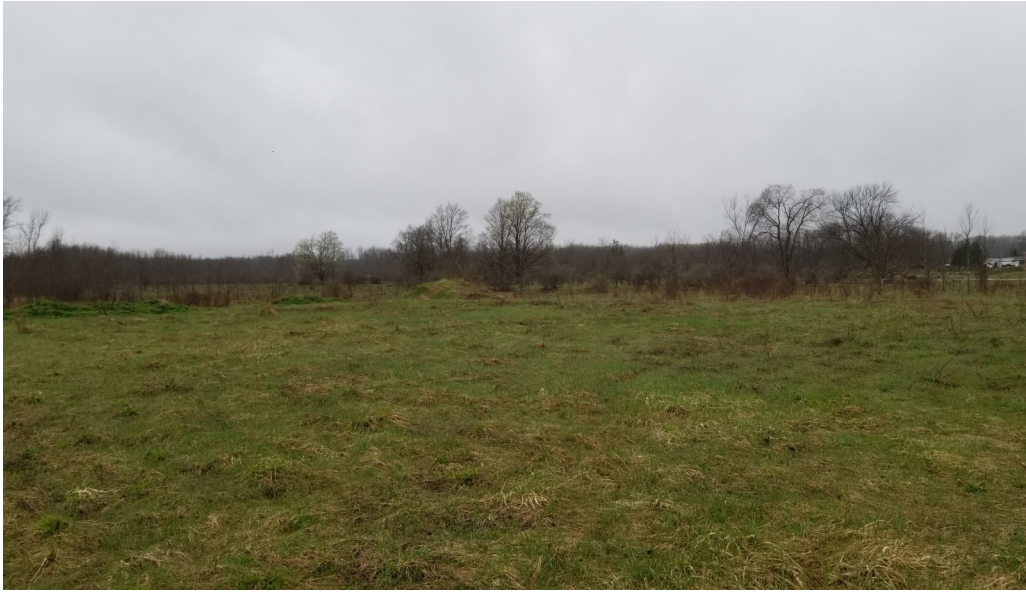
**Photo 1:** Area of proposed development on the east side of the subject property.

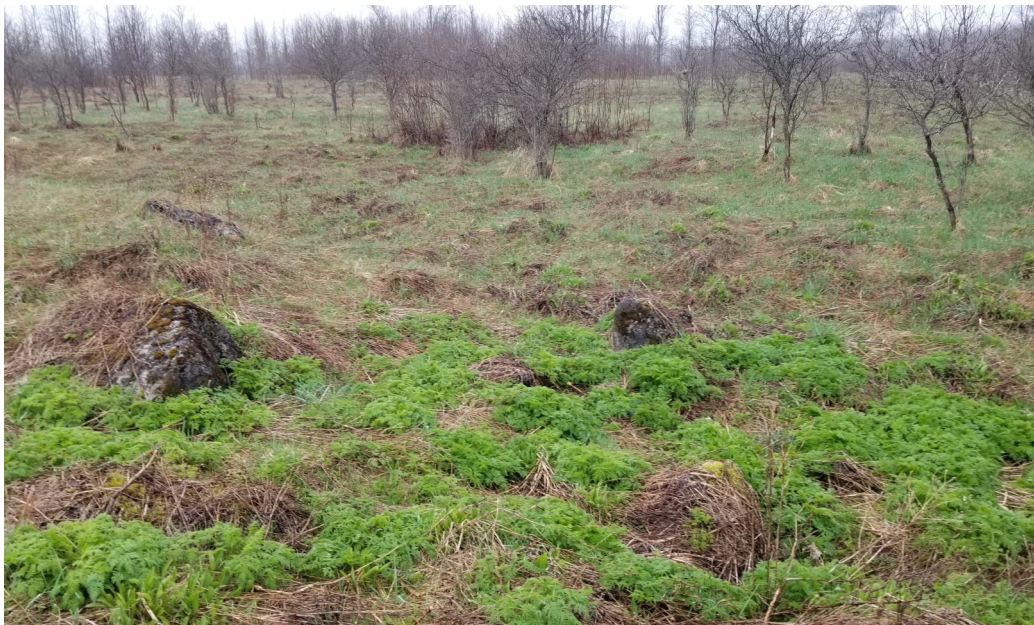
The surface in the vicinity of the study area was observed to consist of a few areas of fill. Outside of the fill, on the eastern portion of the property where the proposed development is located, the ground surface is generally flat and grass covered. Northwest of the proposed development areas, the ground surface consists of areas of significant subsidence and boulders at the surface (as shown in Figure 2). Additionally, an area of standing water with outflow to a swale was identified approximately 80 metres west of the proposed development area. This area is inferred to be associated with seasonal groundwater seepage.

Based on the onsite observations (i.e. areas of significant subsidence and a groundwater seep), the area west of the proposed area of development is inferred to have some degree of hydraulically active karstic features. However, it is noted that only a small portion of the northwestern extent of the area of proposed development lies in an area that was observed to show some evidence of potential subsurface karst features (i.e. numerous observed depressions and surface boulders), as shown on Figure 2. However, based on the current Site Plan, this area is proposed for truck and trailer parking and no structures are proposed on or near this location (see attached Site Plan). The remaining areas of the extents of commercial development on the Site do not exhibit surface evidence that would suggest hydraulically active karst features underlying the area.

**Photo 2:** View of surface depressions and boulders northwest of the proposed development area.

1. It is recommended that at the time of topsoil stripping in the far northwestern portion of the development area, that the subsurface be further investigated (via testholes) by a qualified geotechnical engineer to confirm the presence or absence of karst features that could require geotechnical considerations prior to placing fill. It is also recommended that a specific note reflecting this be added to the Site Plan for clarification during Site preparations / construction.
2. That at the time of construction, the bedrock surface be inspected in areas where it is exposed (if encountered) to confirm the nature of the bedrock and the presence or absence of any fractures or dissolution features that would pose structural limitations.
3. Development of the property beyond the limit of proposed development (Figure 2) may be subject to further study and inspection prior to approval.

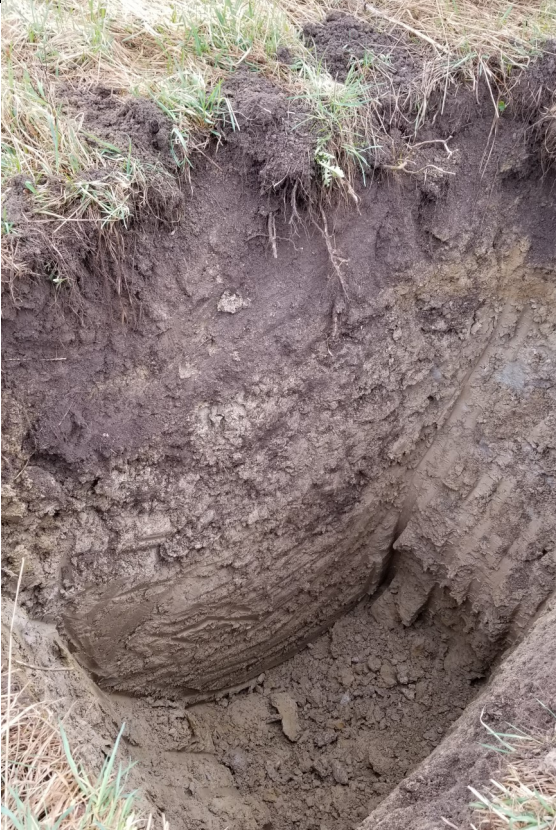
DEPTH (m)	SAMPLE TYPE NUMBER	GRAPHIC LOG	MATERIAL DESCRIPTION
			TOPSOIL, Dark Brown, Moist
		0.30	SAND and SILT with CLAY, Light Brown, Moist-to-Wet, Loose
0.5		0.57	CLAY, Grey, Moist, Firm
1.0			
1.5			
2.0		2.00	SILT with varying CLAY, Light Brown, Moist-to-Wet, Firm - Thinly laminated
2.5		2.50	No Bedrock Encountered

**Photo 3:** View of TH-6.

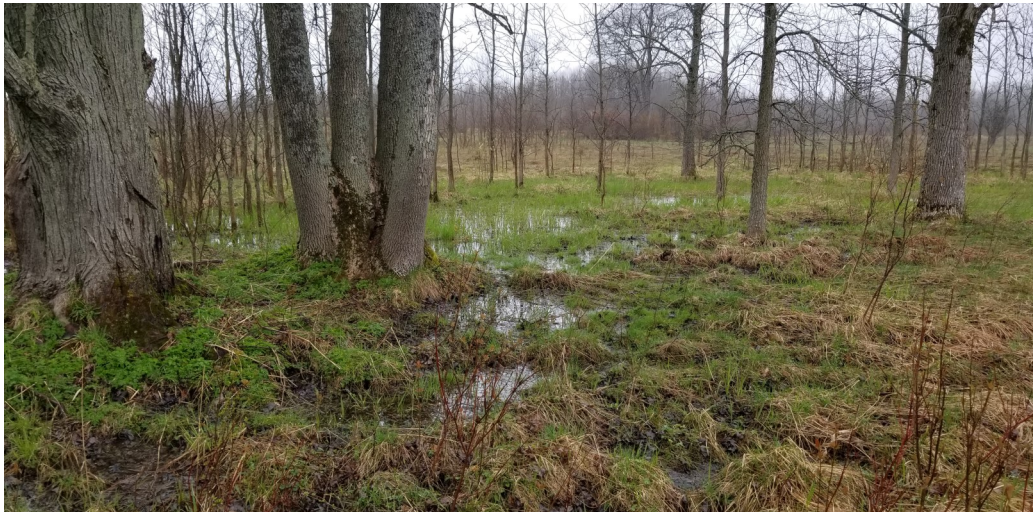
**Photo 4:** View of the groundwater seep west of the proposed development area.

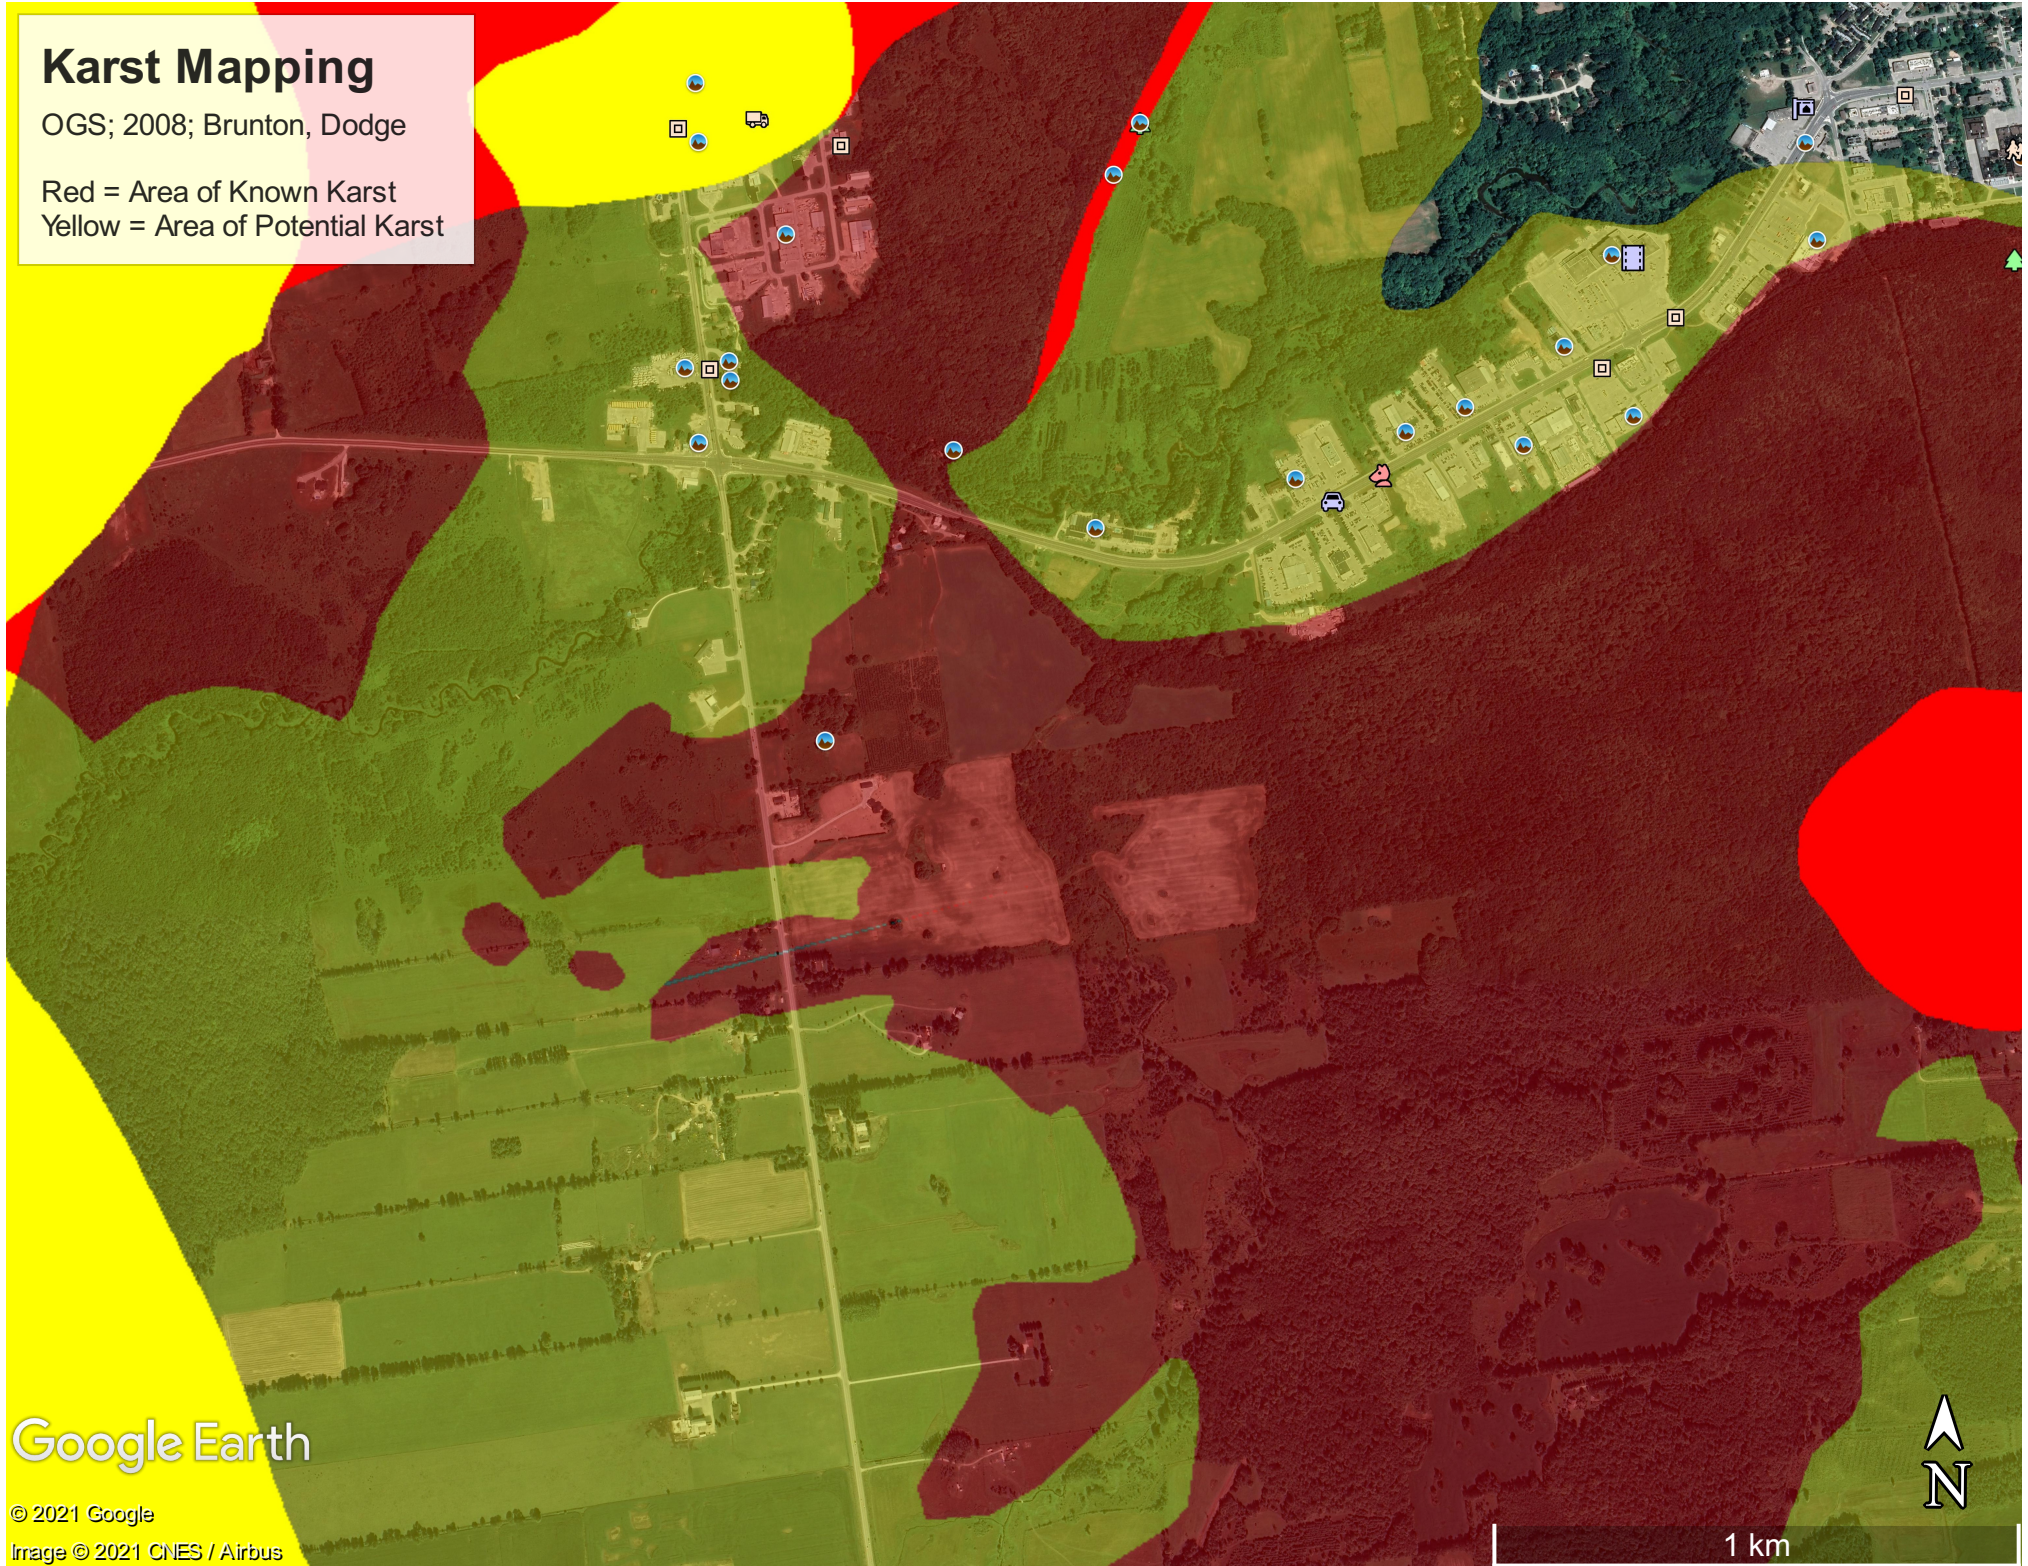
# Karst Mapping

Based on a review of the geologic setting, the potential for karstic features are considered to exist since the area is comprised of dolostone bedrock of the Amabel Formation (i.e., carbonate rock). Additionally, according to the *Karsts of Southern Ontario and Manitoulin Island* GIS Mapping (Ontario Geologic Survey, 2008; Brunton, Dodge), the area of the subject property is considered to be an area of known karst. The OGS Karst mapping is enclosed for reference.

Red = Area of Known Karst  
Yellow = Area of Potential Karst
