Hydrogeological Assessment, Thornbury Acres, Thornbury, Ontario

December 15, 2022

Prepared for:
Thornbury Acres Holding Inc.

Cambium Reference: 14266-002

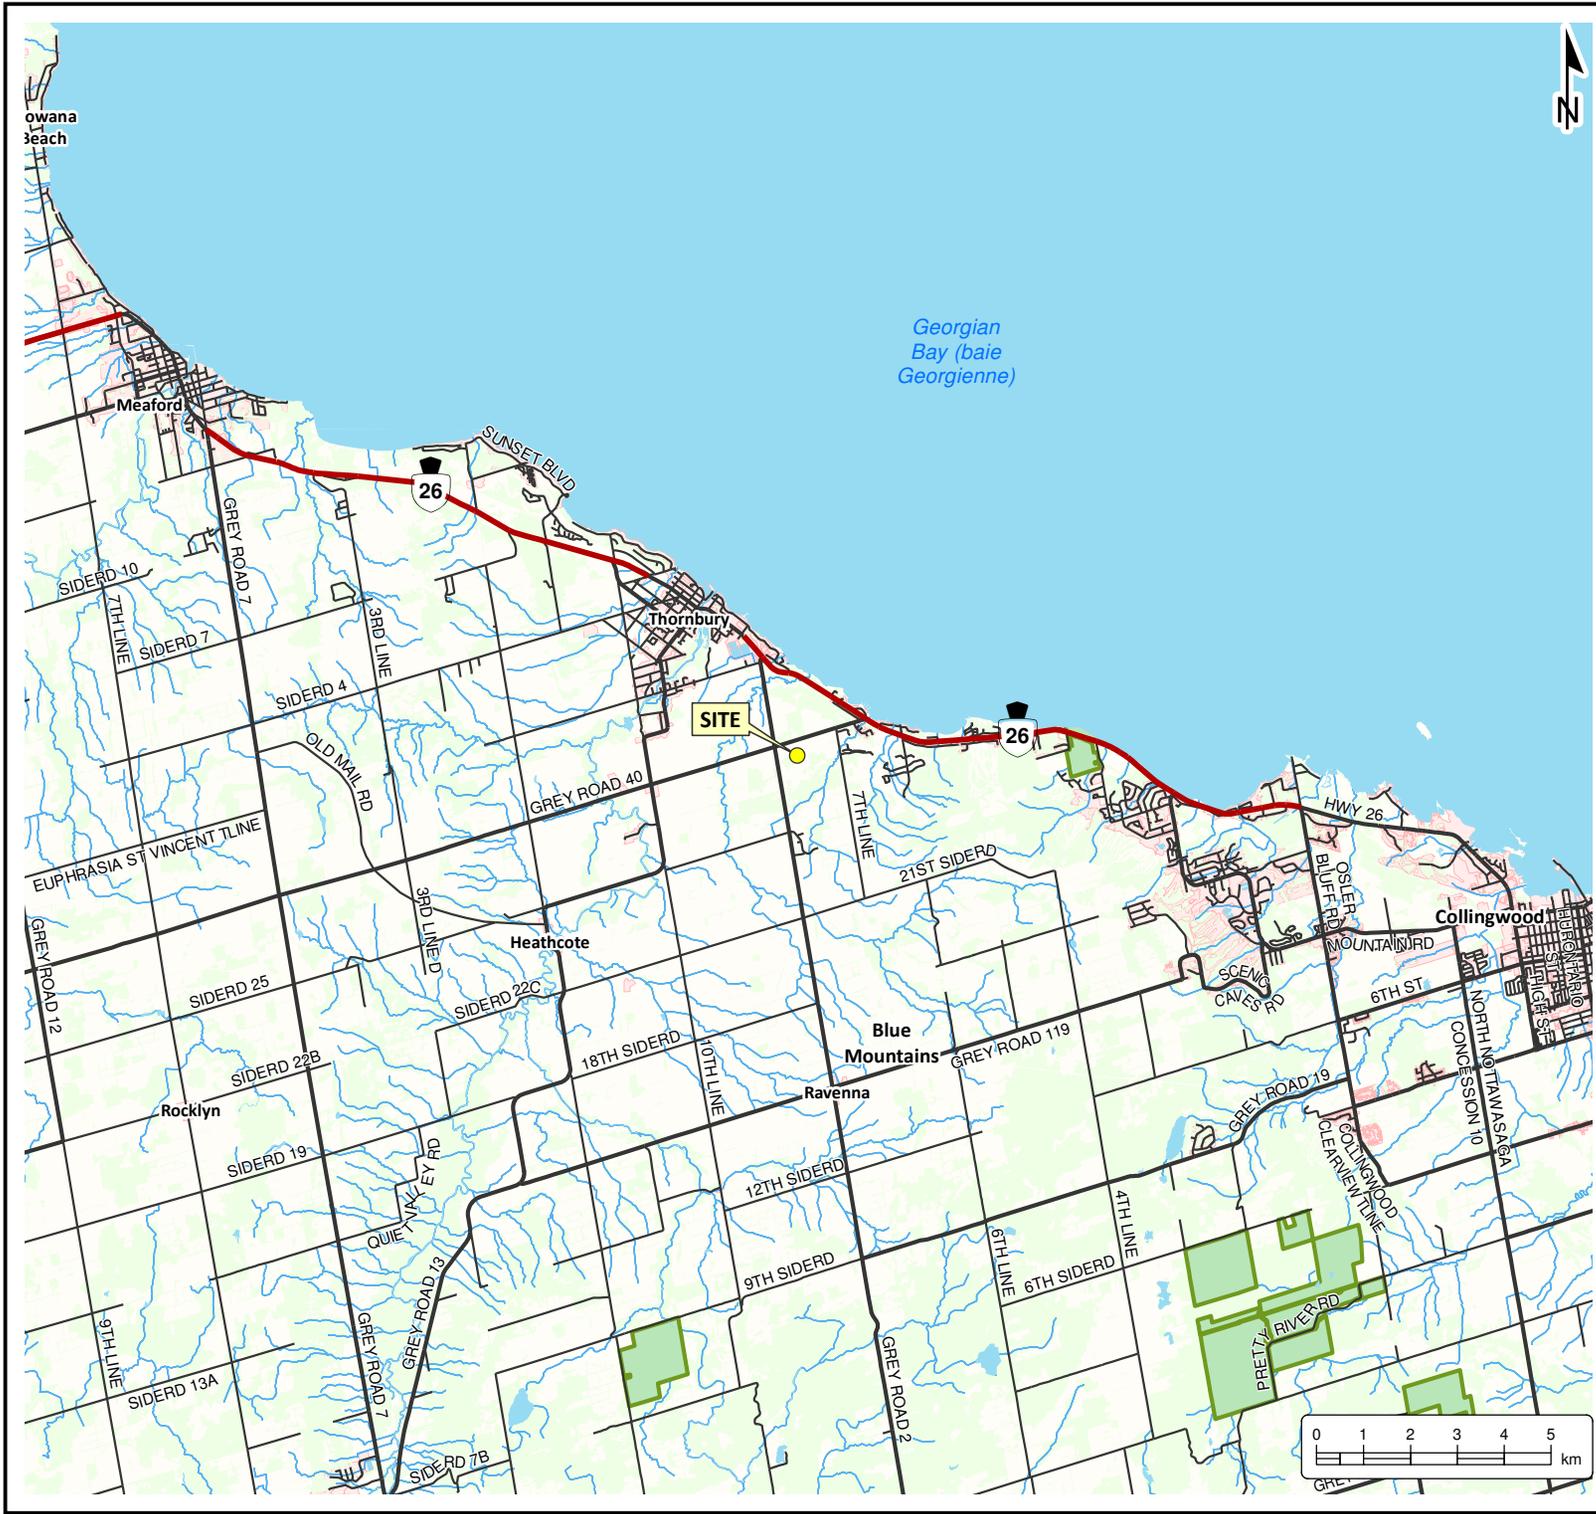
Project No.:	14266-002	Date:	November 2022
Scale:	1:7,500	Rev.:	
Created by:	DBB	Checked by:	KW
Figure:	2

O:\GIS\XDS\14200-14299\14266-002_Thornbury Acres Holdings - Hydrog - Thornbury Acres\2022-11-21 FIG 2 - Test Pit and Test Well Locations.mxd

The encountered soil units were logged in the field using visual and tactile methods, and samples were placed in labelled plastic bags for transport, future reference, laboratory testing, and storage. Borehole logs are provided in Appendix B and located are identified in Figure 2.

A test pit investigation was completed by Cambium on September 26th and 27th, 2022, to determine the shallow subsurface conditions across the Site. A total of 20 test pits, designated as TP101-22 through TP120-22, were excavated to a predetermined depth of 2 to 3 metres below ground surface (mbgs) using an excavator under the supervision of a Cambium technologist. Test pit logs are provided in Appendix B. Test pit locations are identified in Figure 2.

The residential component of the proposed development is less than 25 ha in size; therefore, four test wells (TW101-22, TW102-22, TW103-22, and TW104-22) were drilled at the Site to satisfy Section 4.2 of MECP Guideline D-5-5 Technical Guideline for Private Wells: Water Supply Assessment. All four test wells were installed by Stan Wright & Co. Well Drillers between October 25 and October 28, 2022. The locations of the wells are illustrated in Figure 2. A well record for each test well is included in Appendix D.

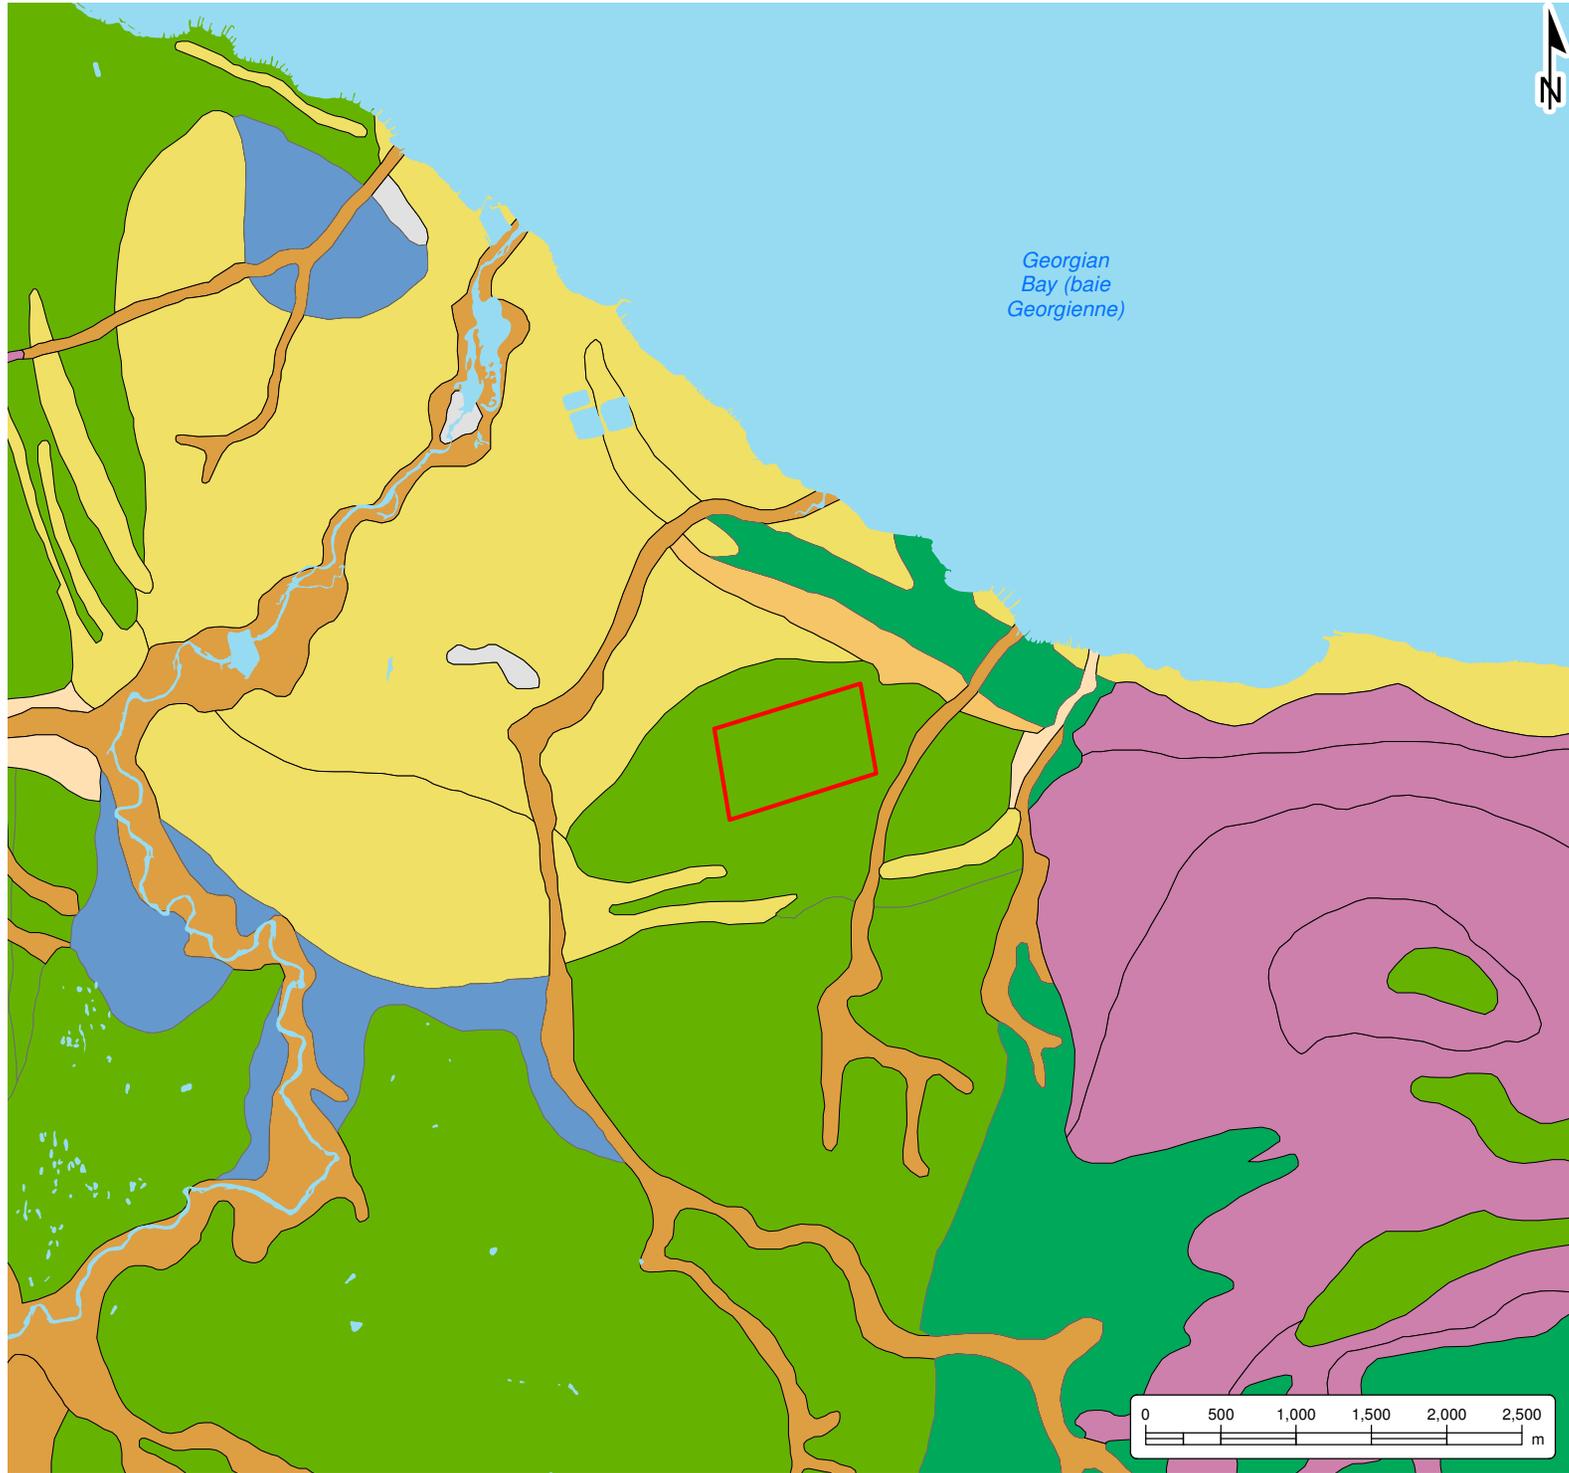
- Surficial Geology obtained from LIO online GIS database
- Base mapping features are © Queen's Printer of Ontario, 2019 (this does not constitute an endorsement by the Ministry of Natural Resources or the Ontario Government).
- Distances on this plan are in metres and can be converted to feet by dividing by 0.3048.
- Cambium Inc. makes every effort to ensure this map is free from errors but cannot be held responsible for any damages due to error or omissions. This map should not be used for navigation or legal purposes. It is intended for general reference use only.

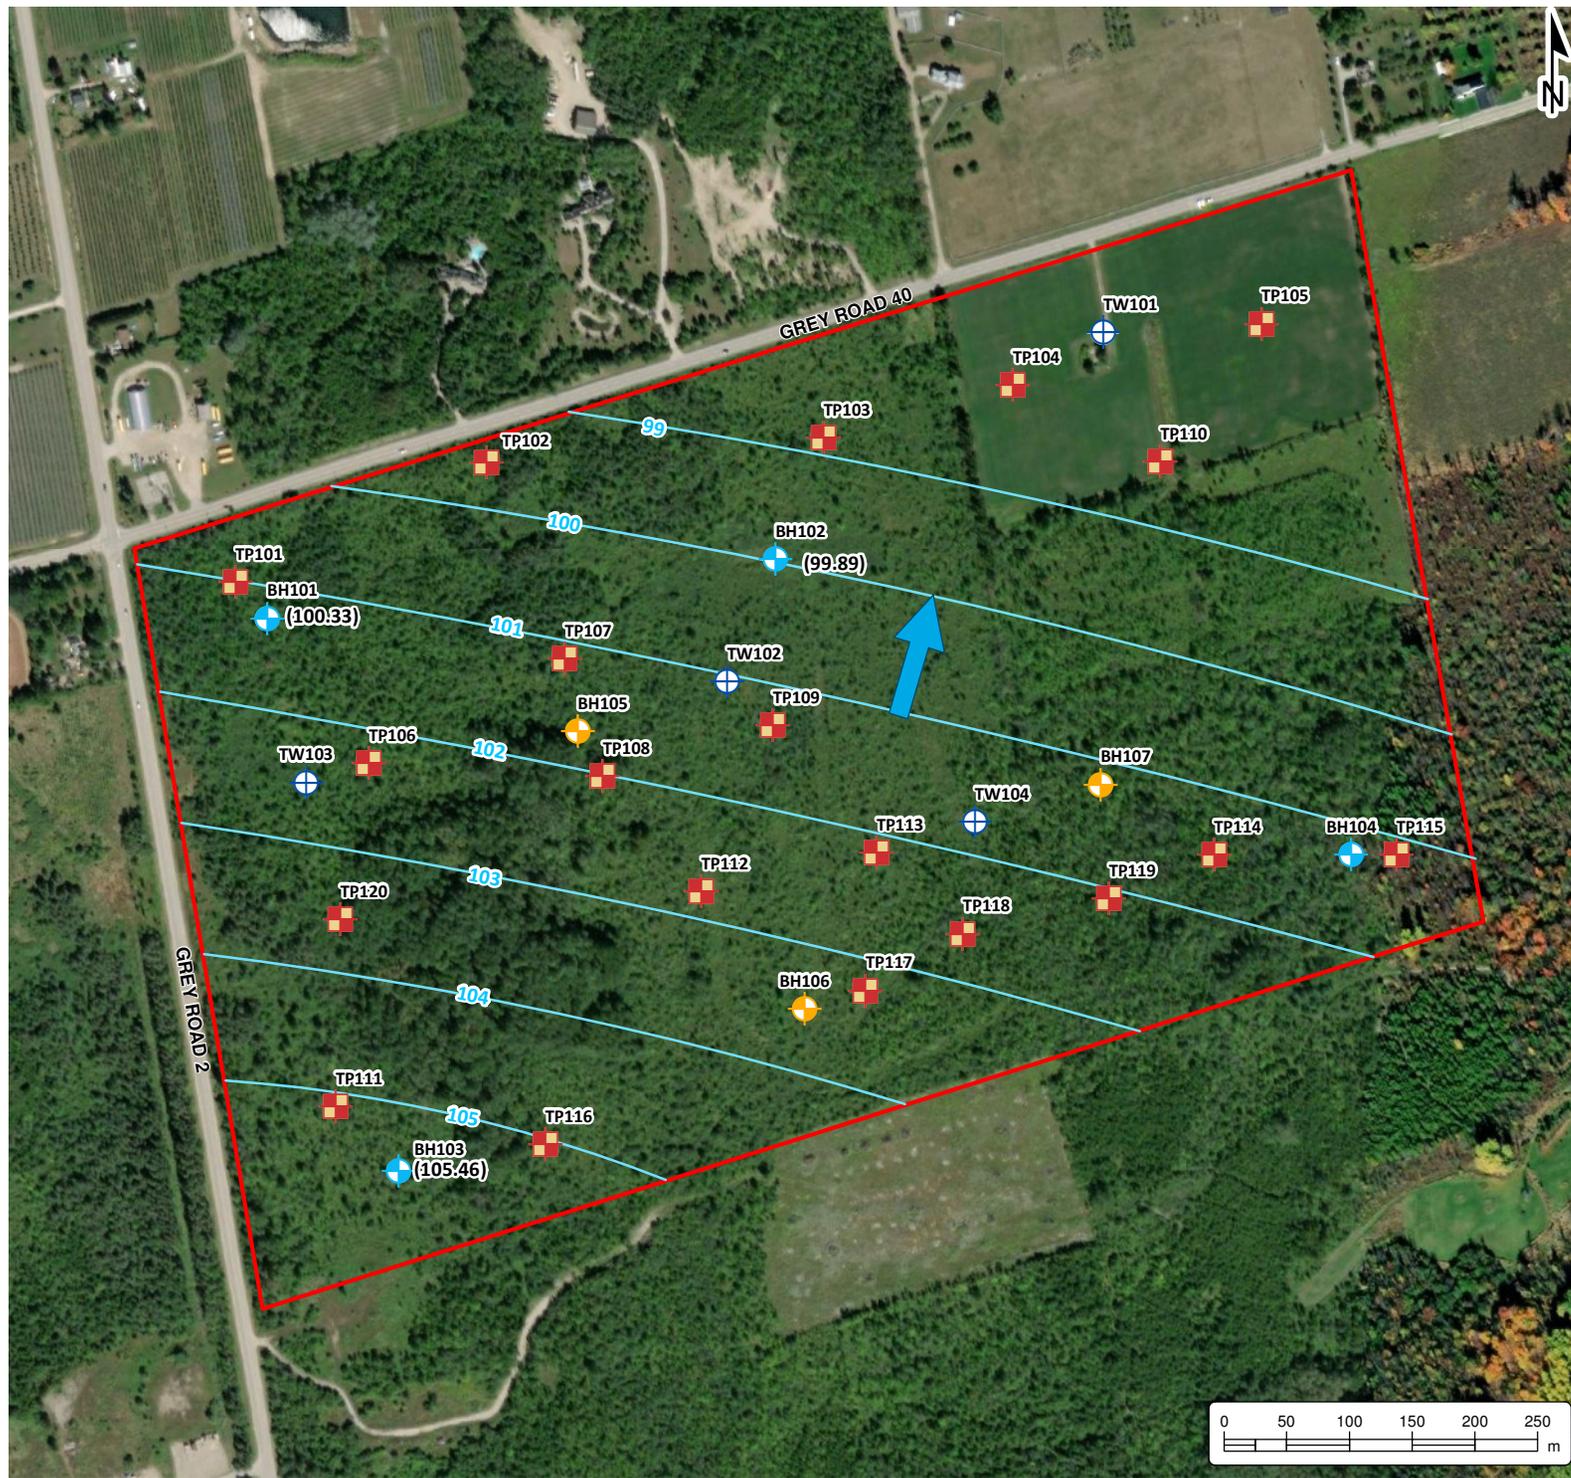
Project No.:	14266-002	Date:	November 2022
Scale:	1:6,000	Projection:	NAD 1983 UTM Zone 17N
Created by:	DBB	Checked by:	KW
			5

- LEGEND**
- Borehole
 - Monitoring Well
 - Test Pit
 - Test Well
 - Shallow Groundwater Contour (1m intervals)
 - Site (approximate)
 - Groundwater Flow Direction
 - (105.46) Shallow Groundwater Elevation (m.rel) (Nov 7, 2022)

**SHALLOW OVERBURDEN
 GROUNDWATER
 CONFIGURATION MAP**

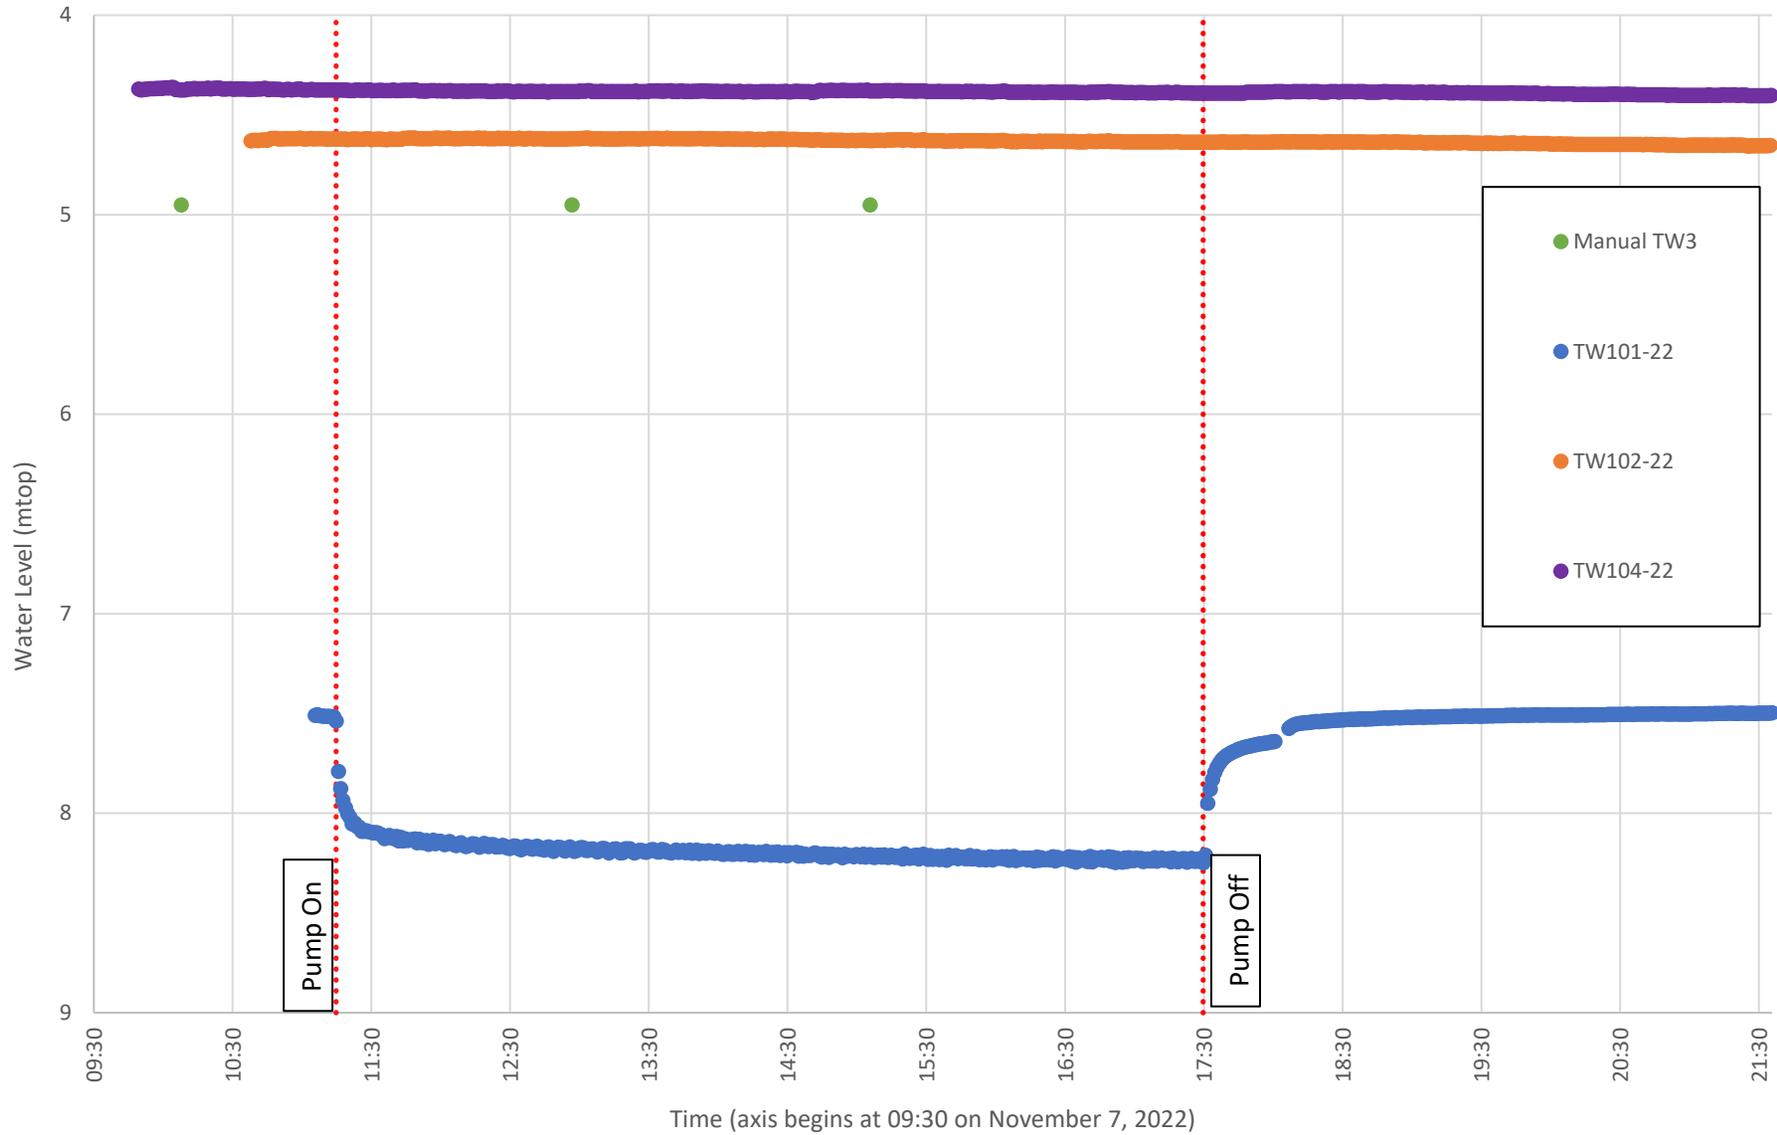
Figure 6. TW101-22 November 7, 2022 Pumping Test Hydrograph

On November 7, 2022, Cambium staff completed the pumping test at TW101-22. Disinfectant chlorine was added to the well water prior to testing. A submersible pump was installed at a depth of approximately 12 mbgs. A pressure transducer level logger was installed above this depth to measure water levels within the well. Water levels were also measured manually to mitigate against potential equipment failure.

The pump was shut off at 5:30 pm. Water level recovery was monitored manually until TW101-22 had regained approximately 95% of the total drawdown observed during the test. A total of approximately 7,875 L was discharged from TW101-22 during the pumping test.

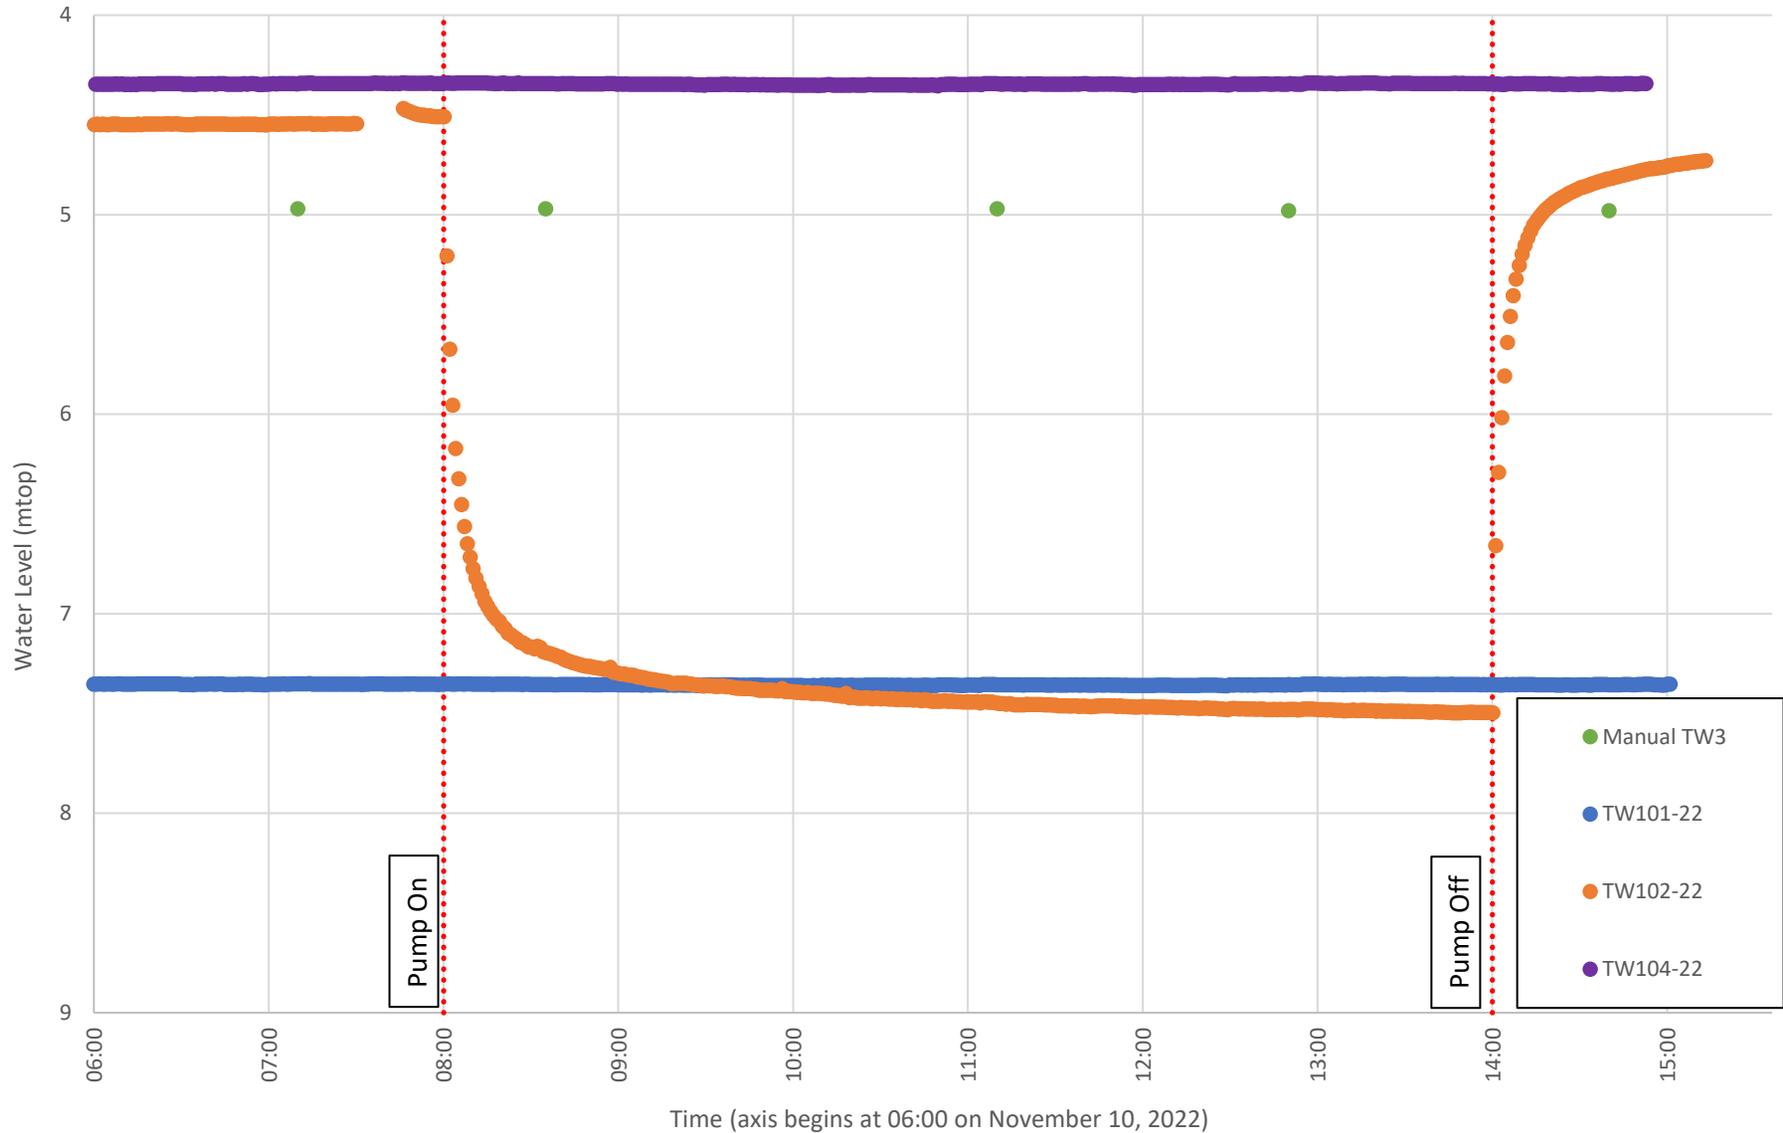
Figure 7. TW102-22 November 10, 2022 Pumping Test Hydrograph

On November 10, 2022, Cambium staff completed the pumping test at TW102-22. Disinfectant chlorine was added to the well water prior to testing. A disinfected submersible pump was installed at a depth of approximately 12 mbgs. A pressure transducer level logger was installed above this depth to measure water levels within the well. Water levels were also measured manually to mitigate against potential equipment failure.

The pump was shut off at 2:00 pm. Water level recovery was monitored manually until TW102-22 had regained approximately 95% of the total drawdown observed during the test. A total of approximately 7,560 L was discharged from TW102-22 during the pumping test.

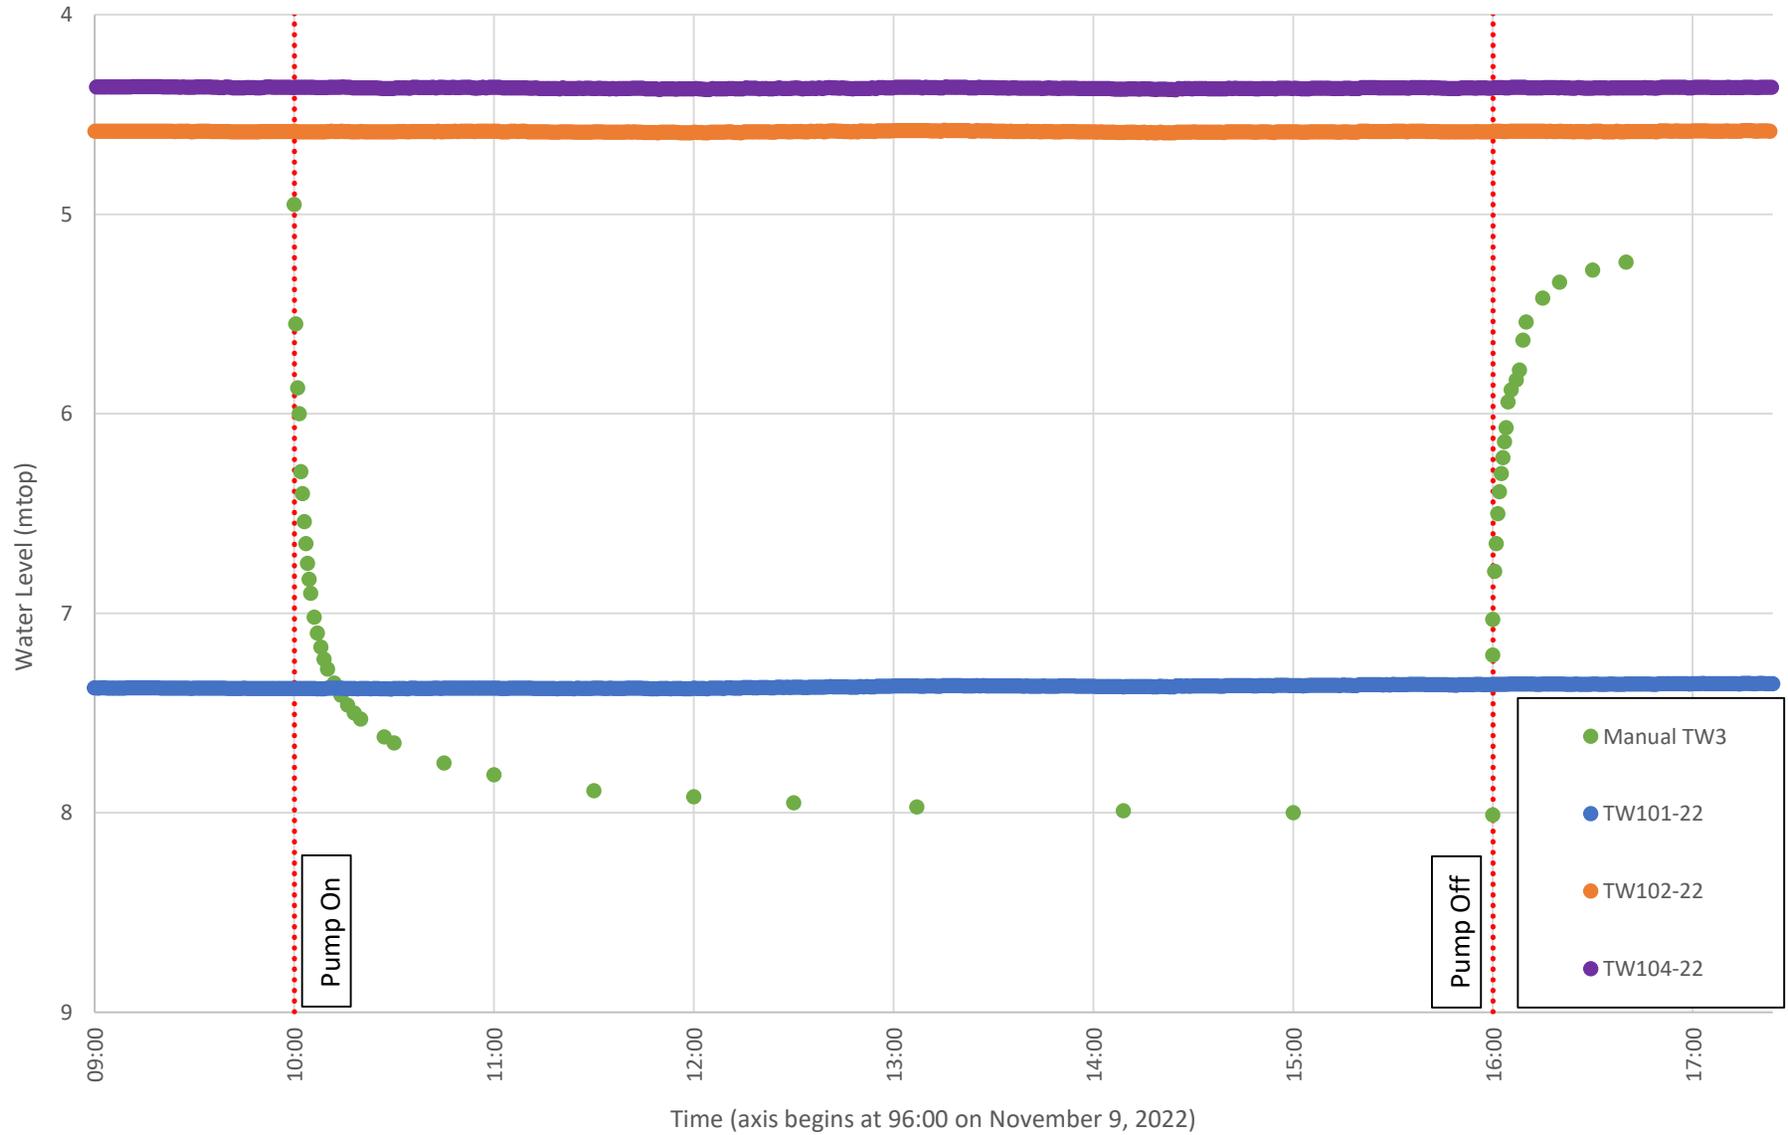
Figure 8. TW103-22 November 9, 2022 Pumping Test Hydrograph

On November 9, 2022, Cambium staff completed the pumping test at TW103-22. Disinfectant chlorine was added to the well water prior to testing. A disinfected submersible pump was installed at a depth of approximately 12 mbgs. A pressure transducer level logger was installed above this depth to measure water levels within the well. Water levels were also measured manually to mitigate against potential equipment failure.

The pumping test began at 10:00 am and continued for a total of 6 hours. The pumping rate was set at approximately 21 L/min for the duration of the test. The discharge outlet for the pump was placed approximately 10 m from the well in a downslope direction to minimize potential groundwater recharge. Groundwater was noted as being orange/rust coloured in the beginning of the test but ran clear within the first two hours; no odour was detected in the groundwater.

The pump was shut off at 4:00 pm. Water level recovery was monitored manually until TW103-22 had regained approximately 95% of the total drawdown observed during the test. A total of approximately 7,560 L was discharged from TW103-22 during the pumping test.

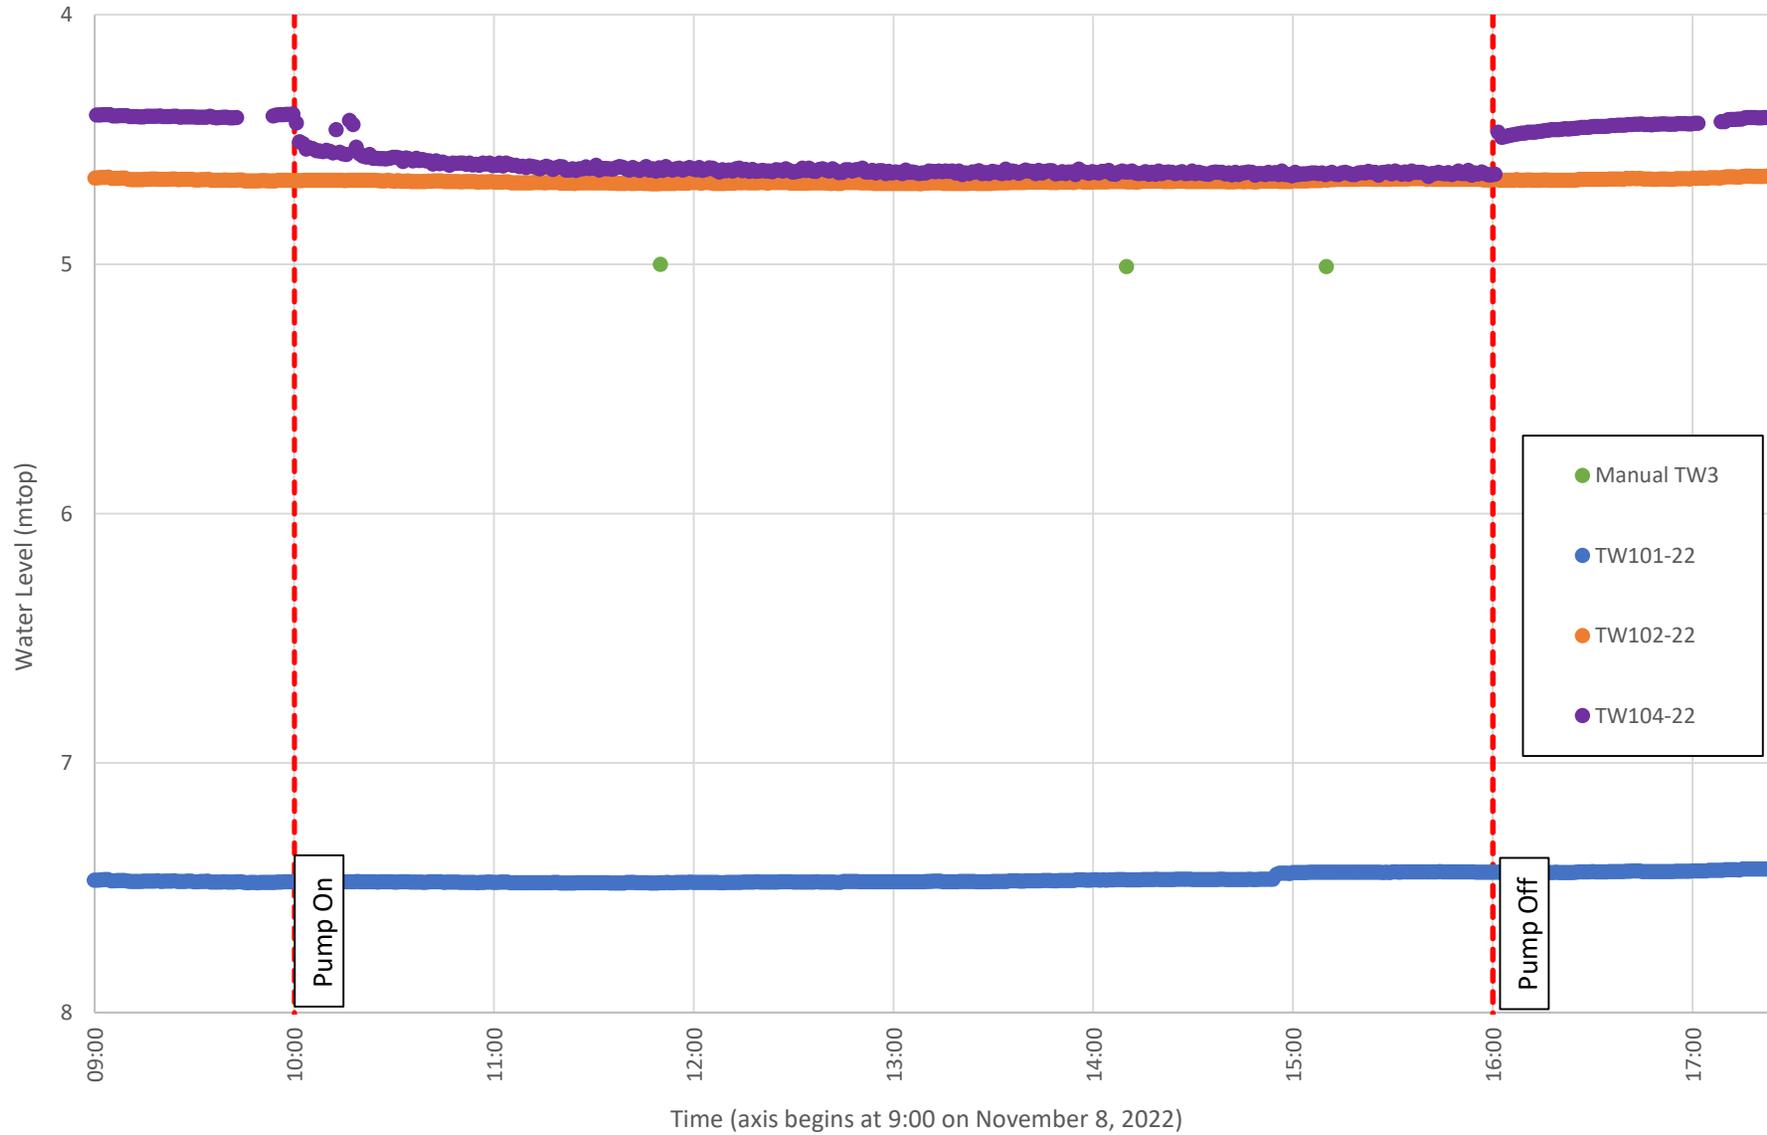
Figure 9. TW104-22 November 8, 2022 Pumping Test Hydrograph

On November 8, 2022, Cambium staff completed the pumping test at TW104-22. Disinfectant chlorine was added to the well water prior to testing. A disinfected submersible pump was installed at a depth of approximately 12 mbgs. A pressure transducer level logger was installed above this depth to measure water levels within the well. Water levels were also measured manually to mitigate against potential equipment failure.

The pump was shut off at 4:00 pm. Water level recovery was monitored manually until TW104-22 had regained approximately 95% of the total drawdown observed during the test. A total of approximately 7,560 L was discharged from TW104-22 during the pumping test.

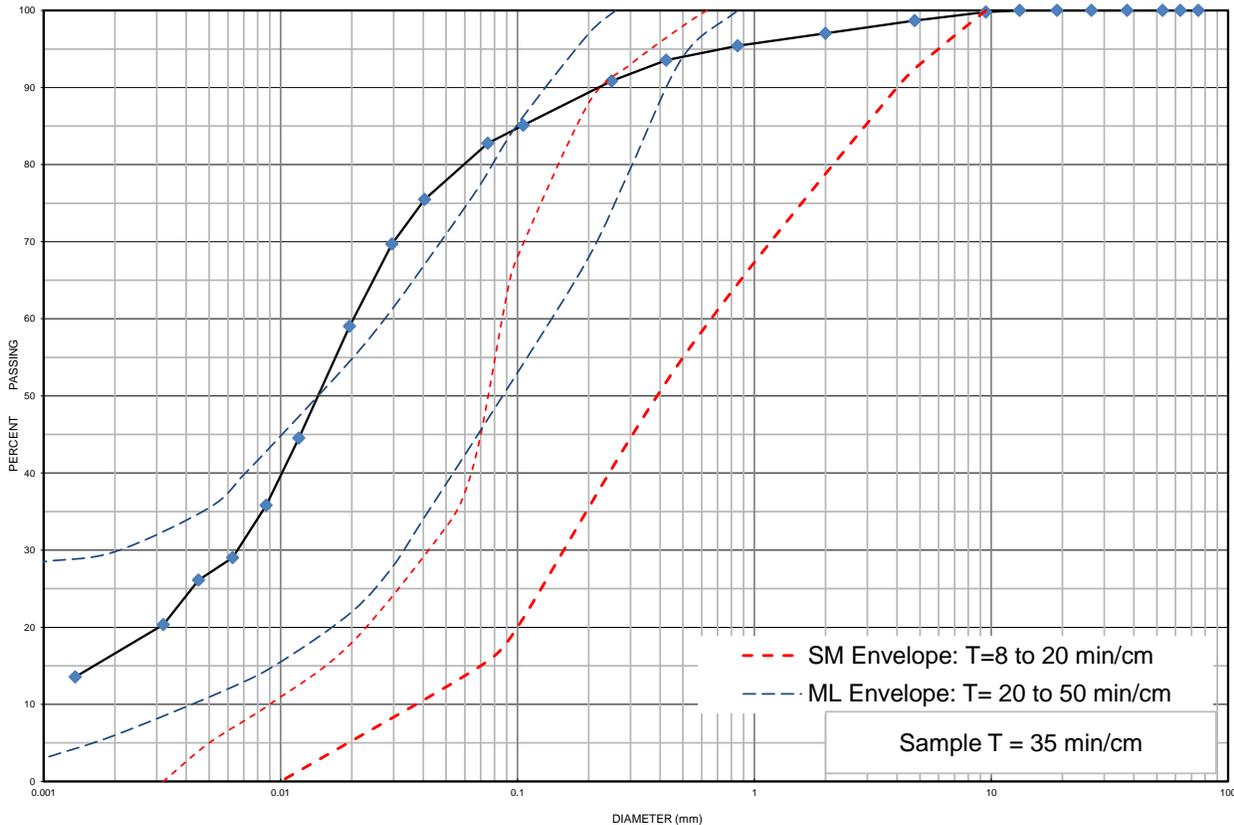
Borehole No.	Sample No.	Depth	Gravel	Sand	Silt	Clay	Moisture
BH 101-22	SS 4	2.3 m to 2.9 m	1	16	66	17	12.1
Description		Classification	D ₆₀	D ₃₀	D ₁₀	C _u	C _c
Silt some Clay some Sand trace Gravel		ML	0.0210	0.0066	-	-	-

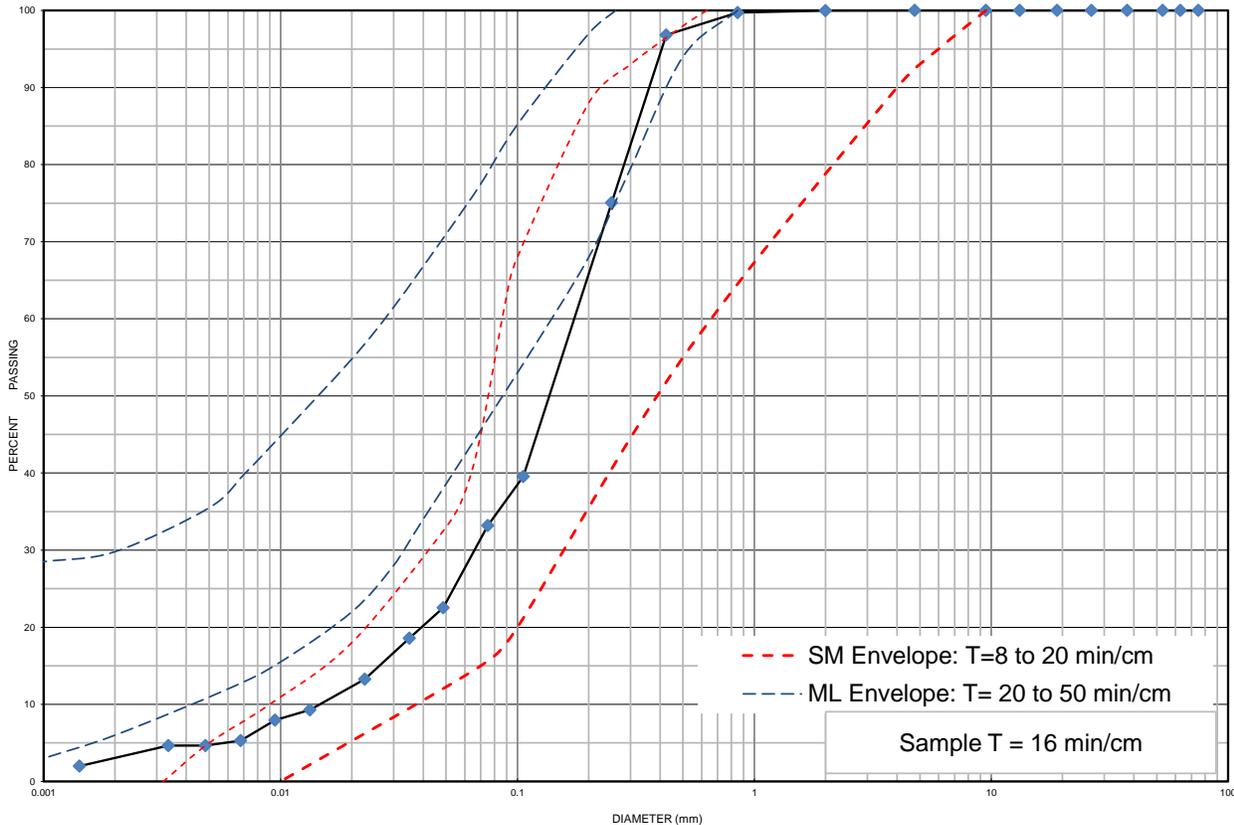
Borehole No.	Sample No.	Depth	Gravel	Sand	Silt	Clay	Moisture
BH 103-22	SS 3	1.5 m to 2.1 m	0	67	30	3	18.0
Description		Classification	D ₆₀	D ₃₀	D ₁₀	C _u	C _c
Silty Sand trace Clay		SM	0.170	0.066	0.016	10.63	1.60

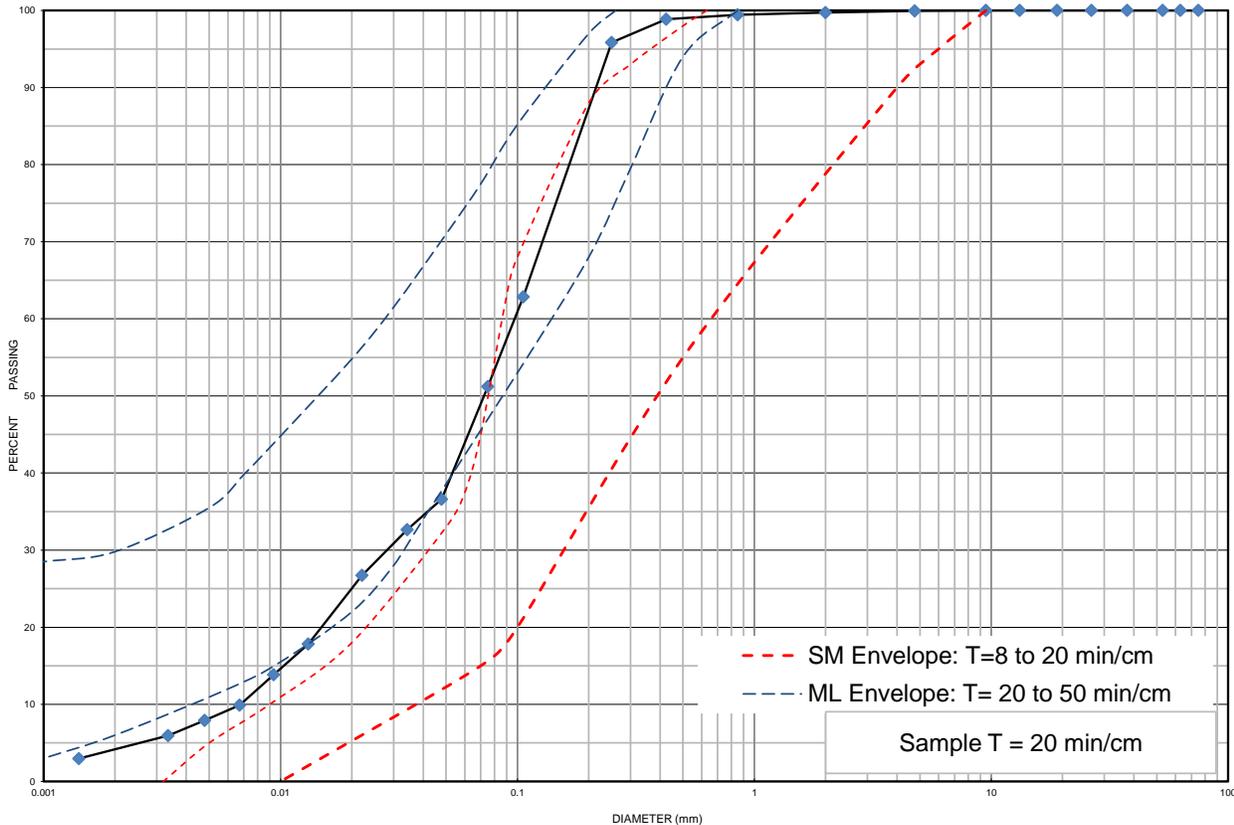
Borehole No.	Sample No.	Depth	Gravel	Sand	Silt	Clay	Moisture
BH 103-22	SS 5	3 m to 3.7 m	0	49	47	4	16.1
Description		Classification	D ₆₀	D ₃₀	D ₁₀	C _u	C _c
Sand and Silt trace Clay		ML	0.0990	0.0280	0.0069	14.35	1.15

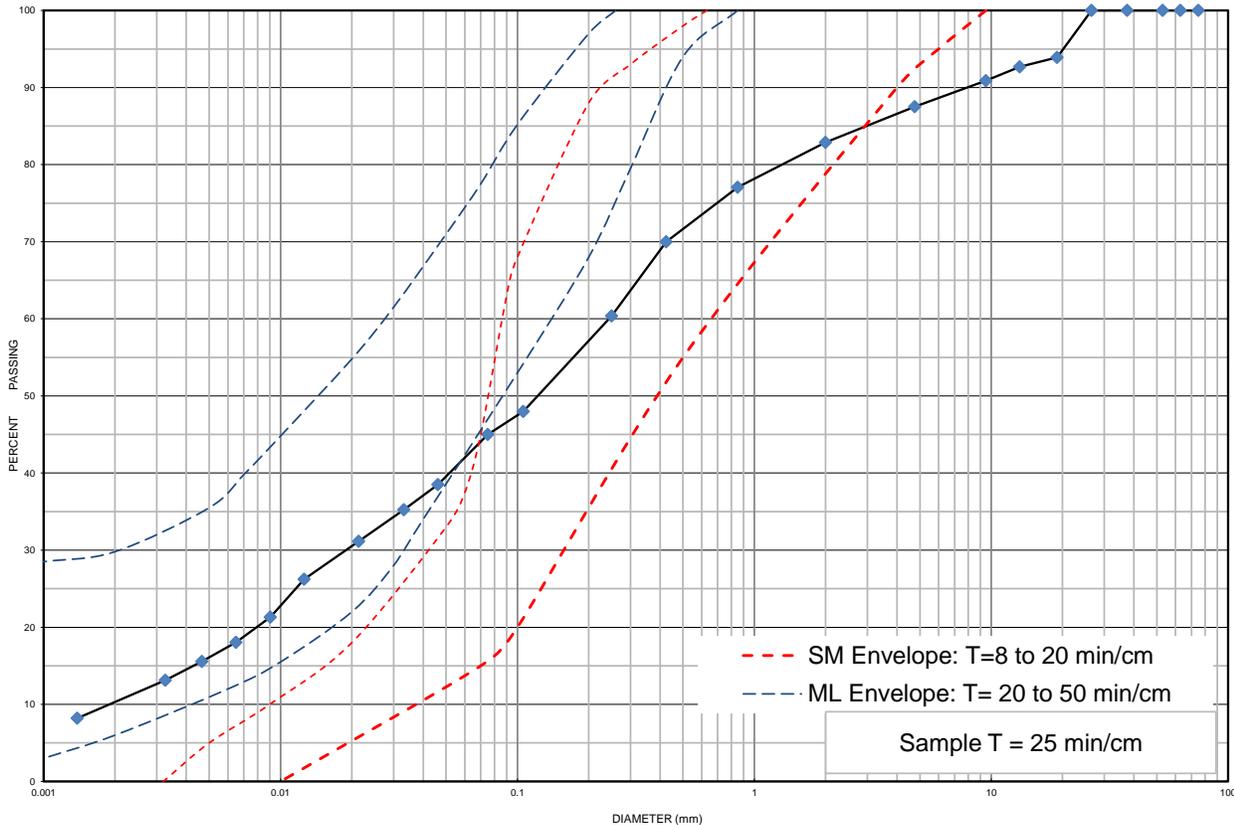
Borehole No.	Sample No.	Depth	Gravel	Sand	Silt	Clay	Moisture
BH 104-22	SS 4	2.3 m to 2.9 m	12	43	34	11	8.3
Description		Classification	D ₆₀	D ₃₀	D ₁₀	C _u	C _c
Silty Sand some Gravel some Clay		SM	0.2500	0.0190	0.0019	131.58	0.76

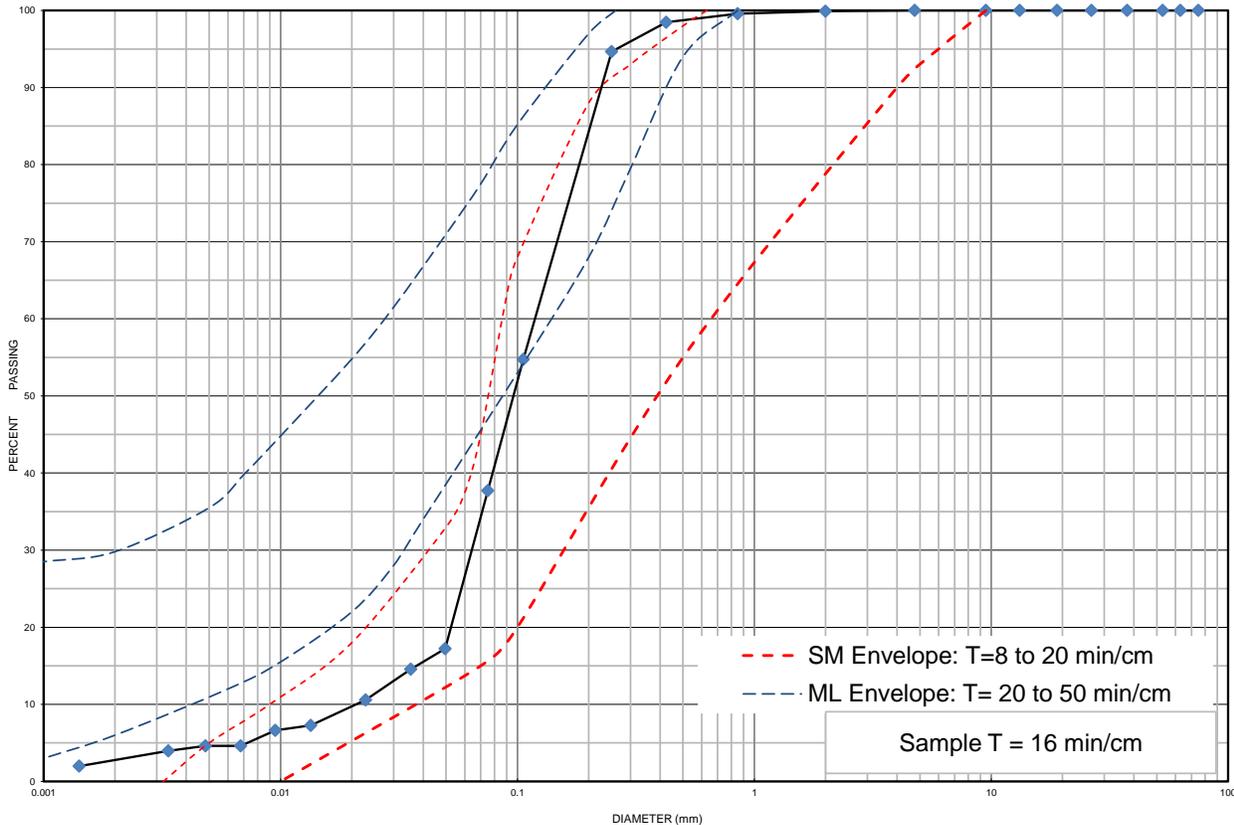
Borehole No.	Sample No.	Depth	Gravel	Sand	Silt	Clay	Moisture
BH 105-22	SS 4	2.3 m to 2.9 m	0	62	35	3	20.5
Description		Classification	D ₆₀	D ₃₀	D ₁₀	C _u	C _c
Sand and Silt trace Clay		SM	0.125	0.064	0.021	5.95	1.56
