Hydrogeological Assessment, Thornbury Acres, Thornbury, Ontario

December 15, 2022

Prepared for:
Thornbury Acres Holding Inc.

Cambium Reference: 14266-002

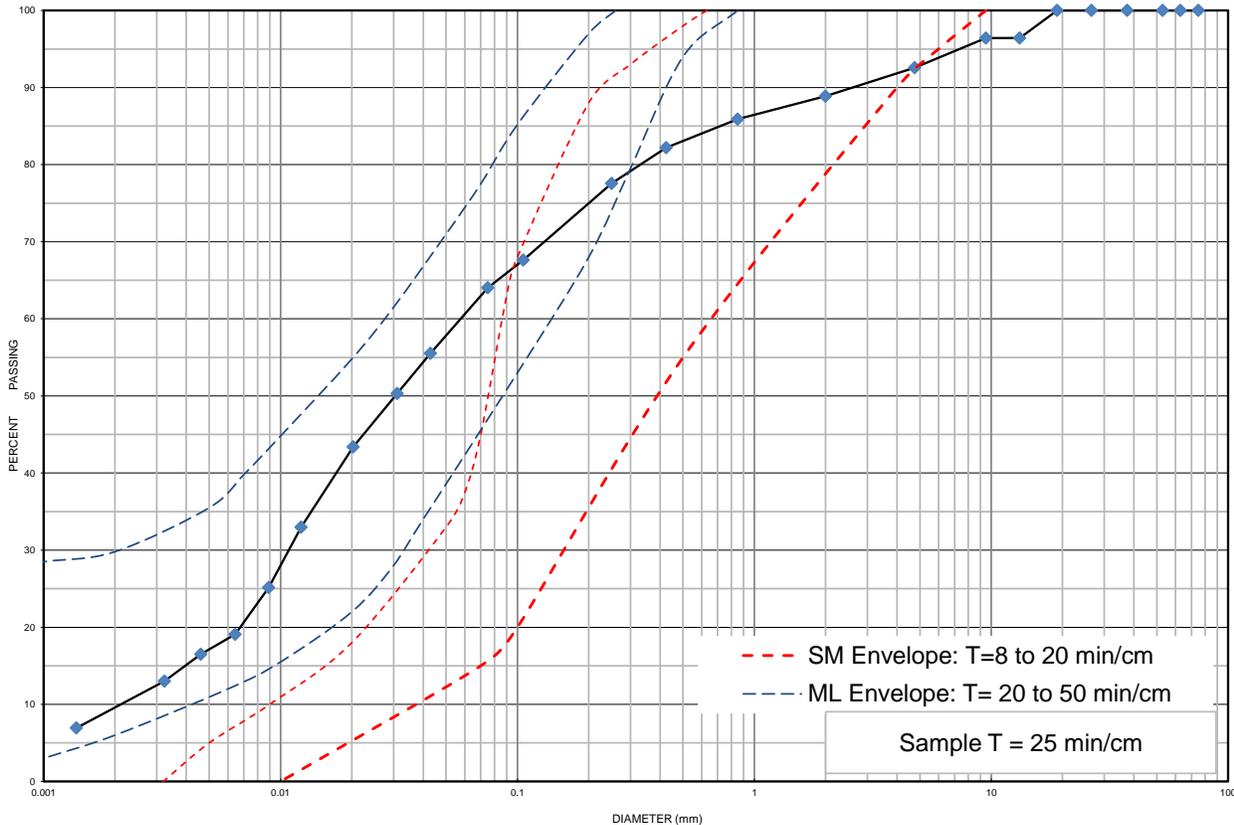
Borehole No.	Sample No.	Depth	Gravel	Sand	Silt	Clay	Moisture
BH 106-22	SS 4	2.3 m to 2.9 m	7	29	55	9	9.3
Description		Classification	D ₆₀	D ₃₀	D ₁₀	C _u	C _c
Sandy Silt trace Clay trace Gravel		ML	0.0590	0.0120	0.0022	26.82	1.11

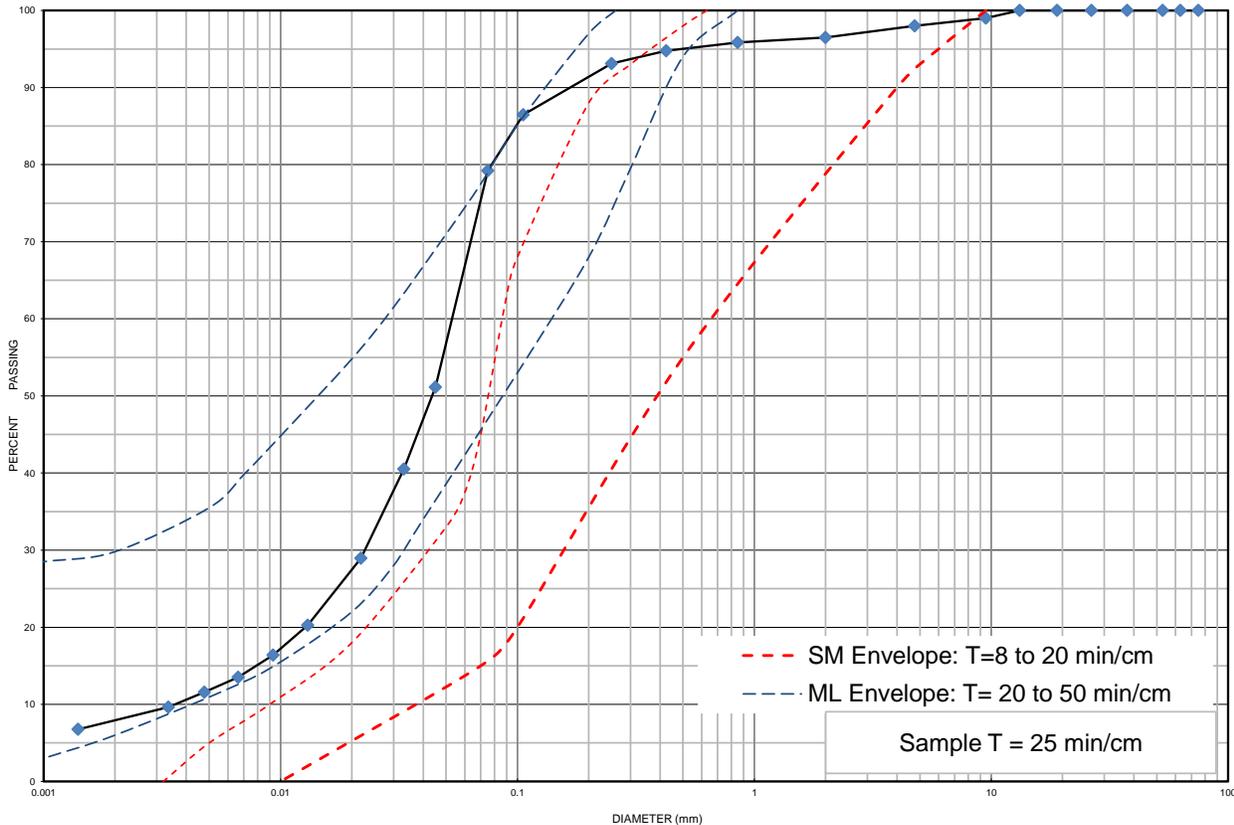
Borehole No.	Sample No.	Depth	Gravel	Sand	Silt	Clay	Moisture
TP 105-22	GS 1	1.1 m to 1.4 m	2	19	71	8	12.2
Description		Classification	D ₆₀	D ₃₀	D ₁₀	C _u	C _c
Silt some Sand trace Clay trace Gravel		ML	0.0530	0.0230	0.0035	15.14	2.85

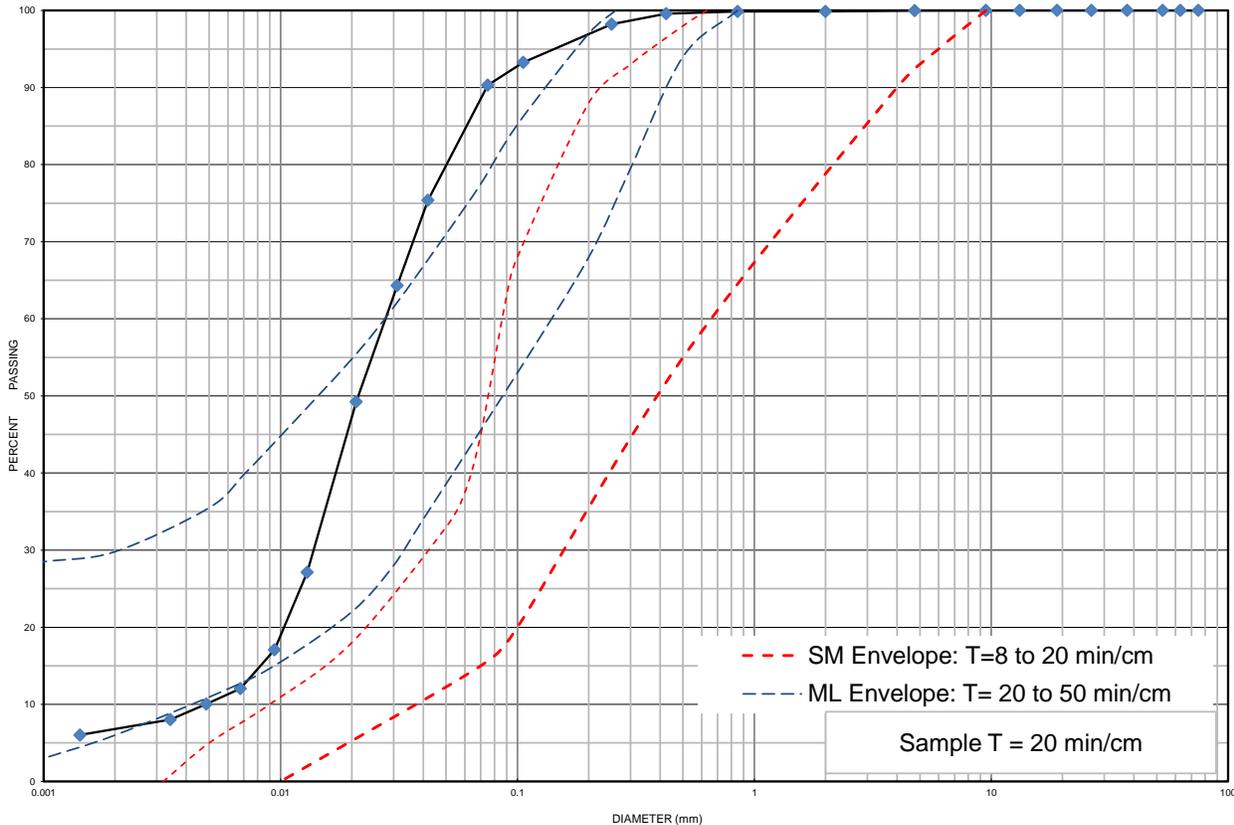
Borehole No.	Sample No.	Depth	Gravel	Sand	Silt	Clay	Moisture
TP 106-22	GS 1	0.6 m to 1.1 m	0	10	83	7	18.9
Description		Classification	D ₆₀	D ₃₀	D ₁₀	C _u	C _c
Silt some Sand trace Clay		ML	0.0270	0.0140	0.0049	5.51	1.48

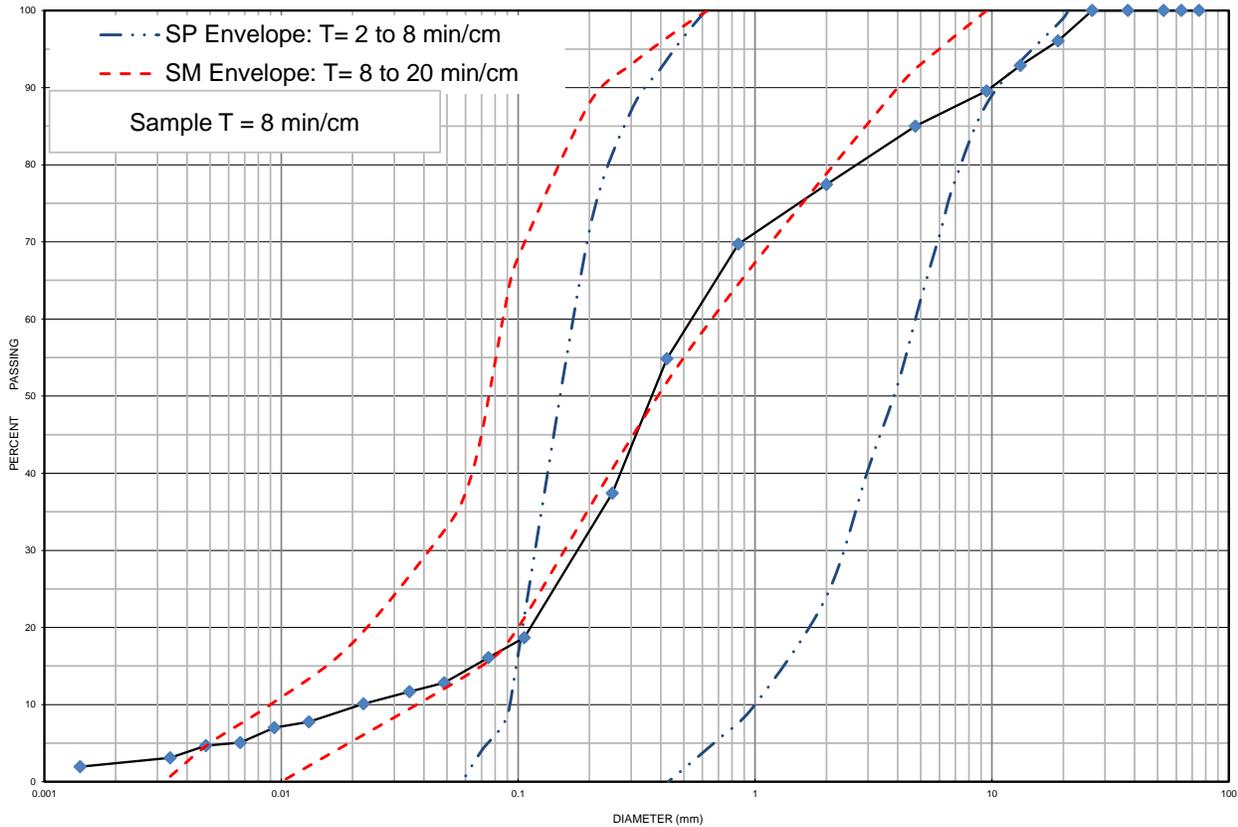
Borehole No.	Sample No.	Depth	Gravel	Sand	Silt	Clay	Moisture
TP 112-22	GS 1	2.7 m to 3 m	15	69	14	2	11.8
Description		Classification	D ₆₀	D ₃₀	D ₁₀	C _u	C _c
Sand some Gravel some Silt trace Clay		SM	0.540	0.175	0.021	25.71	2.70

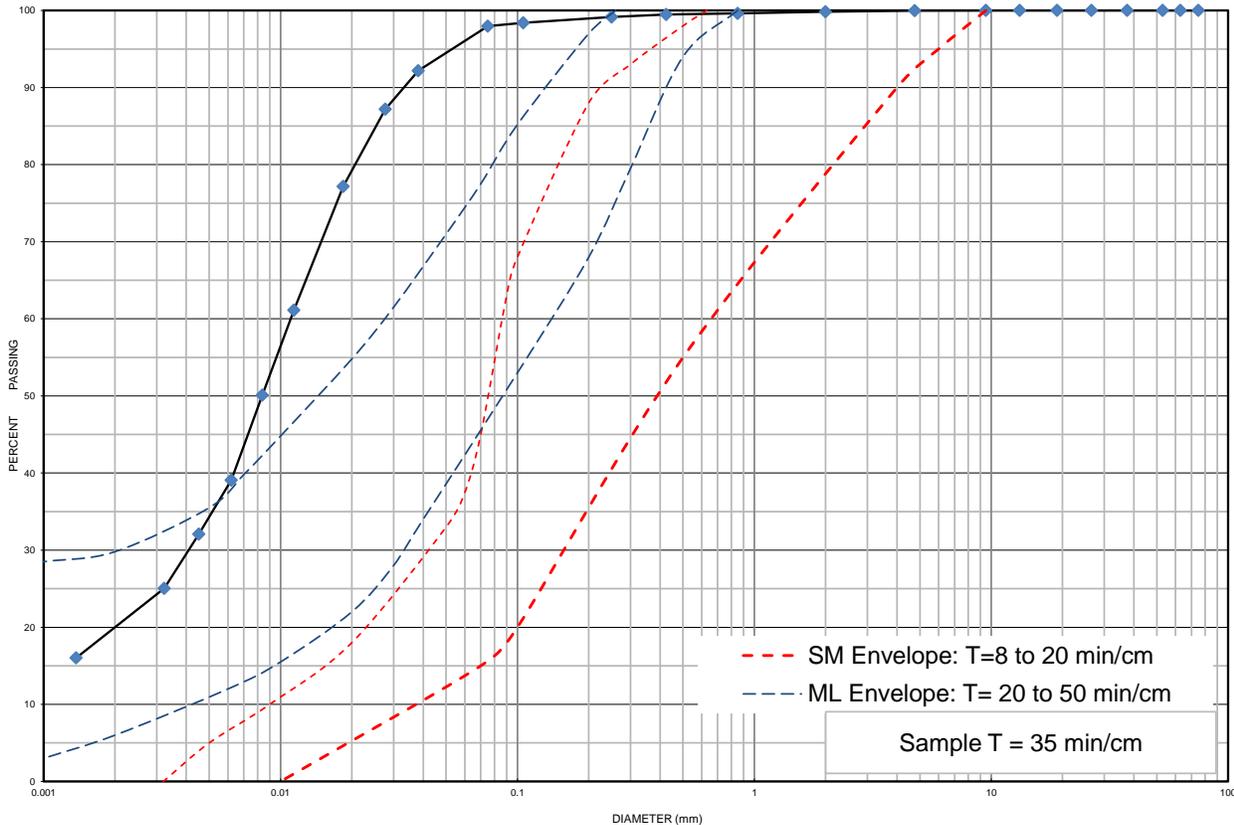
Borehole No.	Sample No.	Depth	Gravel	Sand	Silt	Clay	Moisture
TP 116-22	GS 1	1.5 m to 2 m	0	2	78	20	19.1
Description		Classification	D ₆₀	D ₃₀	D ₁₀	C _u	C _c
Clayey Silt trace Sand		ML	0.012	0.002	-	-	-
