Hydrogeological Report and Site Servicing Study

263512 Southgate Road 26, Southgate
Proposed Wilder Lake Subdivision
H.Bye Construction Ltd.

GMBP File: 218173

Revised: January, 2020

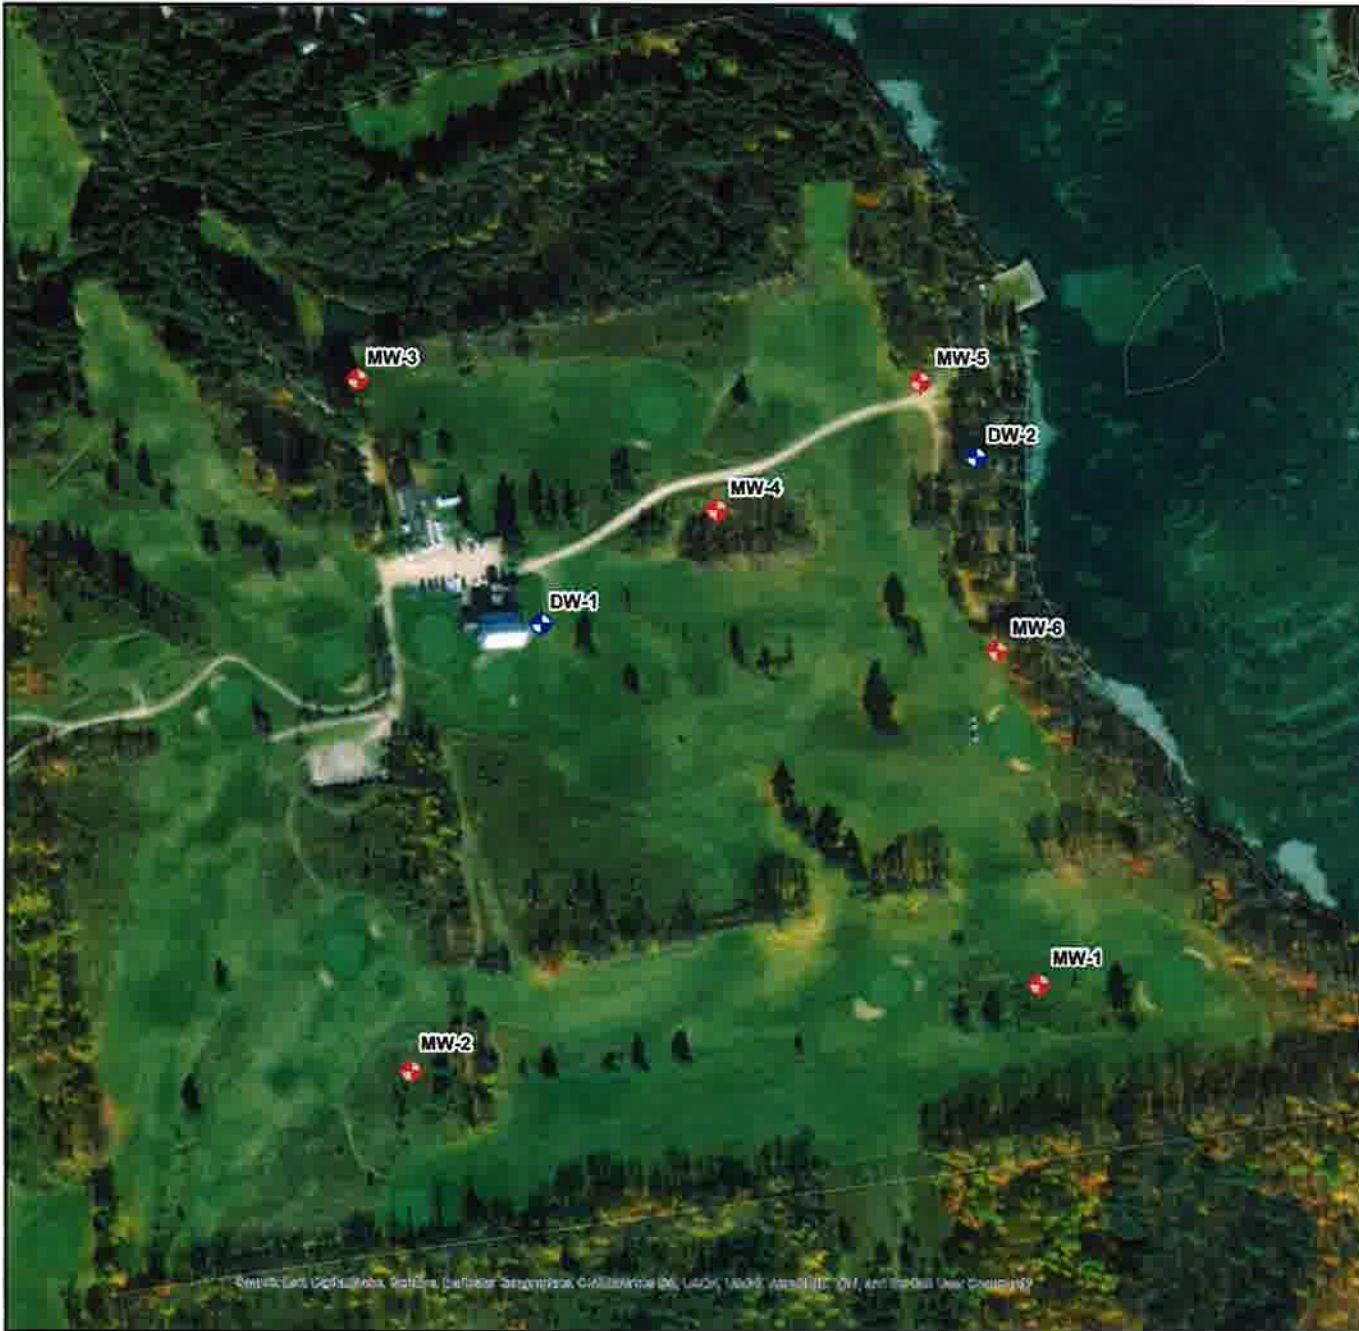
Figure No. 5

Figure 5 displays the results of a MECP Well Record search for a 500 m radius around the subject property. The search returned 10 water well records including the two wells on site. Three (3) wells were completed in the bedrock and the remaining seven (7) were completed in the deep overburden. The well records are provided in Appendix B. A summary of the well records is attached as Tables 1 & 2.

WELL LOCATION MAP

The map interface of the Ontario Water Well Information Service was used to list all of the registered water wells within 500 m of the site. The records for eight (8) wells were found, in addition to the two (2) wells located on site. The locations of the wells are presented on Figure 5 and the well records are provided in Appendix B. A summary of the well records, including stratigraphic and usage information, is provided in Table 1. The wells are all recorded as being used for private rural residential supply. Five (5) of the wells are drilled within the overburden to a depth of between 19.8 meters and 41.1 meters below ground surface (mbgs). Three (3) of the wells are drilled within the bedrock to a depth between 39.3 meters and 40.5 meters.

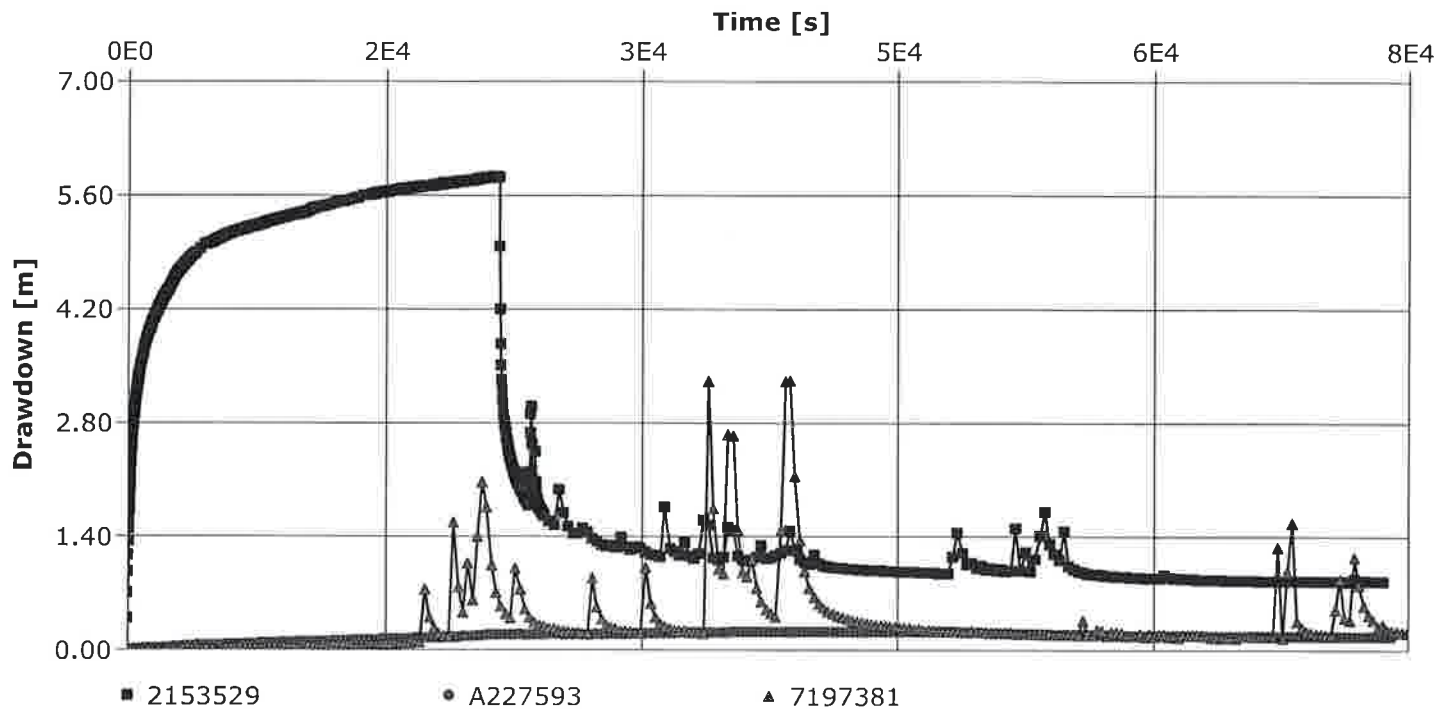
Aquifer Thickness: 40.00 m

Discharge: variable, average rate 1.081 [l/s]

AquiferTest software was utilized to calculate the aquifer properties. The wells were modelled using the Theis and Cooper and Jacob methods for confined aquifers. Well 2513529 pumping test response was also modelled using the pseudo-steady-state double porosity flow model developed by Warren and Root (1963) and the unconfined aquifer analysis developed by Neuman (1972). The analysis method was selected based on the hydrogeologic conditions observed at the site and the shape of the response curves. The estimation of aquifer properties utilizing the unconfined aquifer analysis systems is considered sufficient for the purposes of this study.

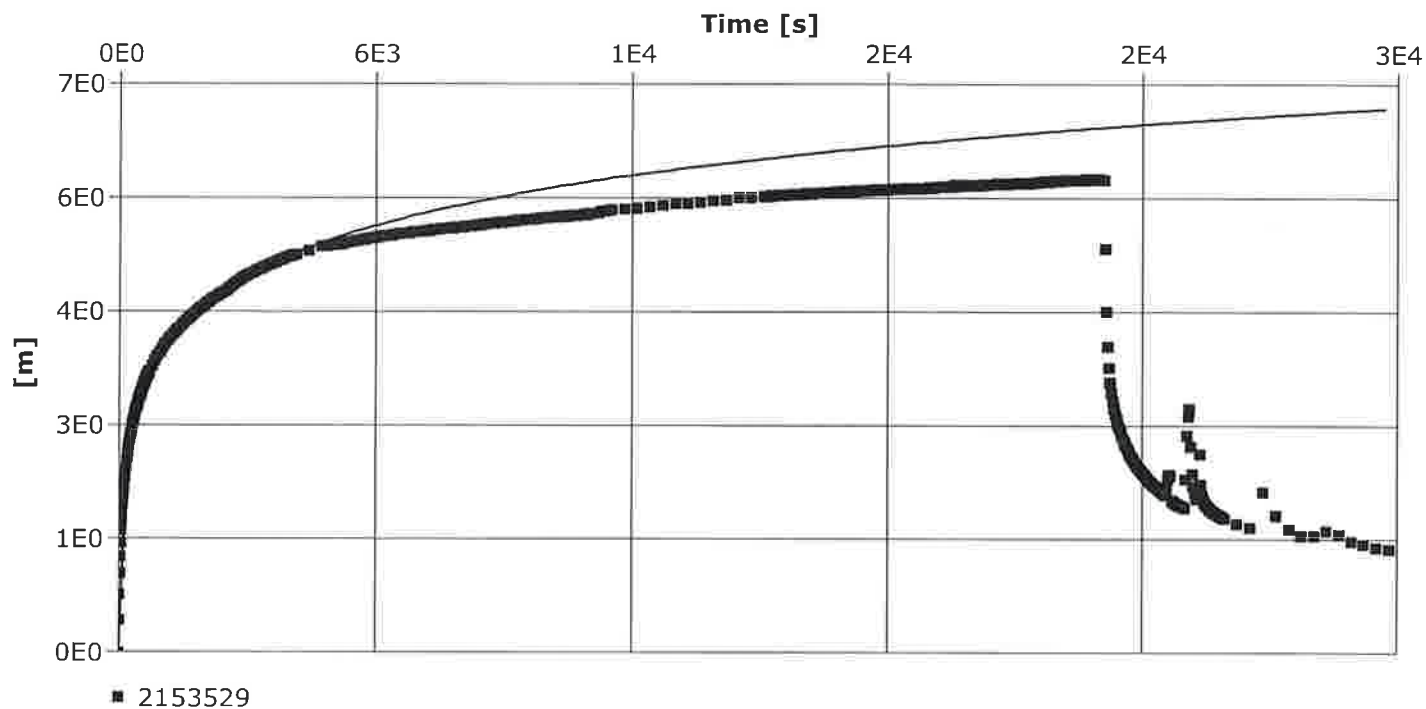
Calculation using Theis with Jacob Correction

Observation Well	Transmissivity [m ² /s]	Hydraulic Conductivity [m/s]	Storage coefficient	Radial Distance to PW [m]	
2153529	1.12×10^{-4}	2.80×10^{-6}	3.95×10^{-1}	0.08

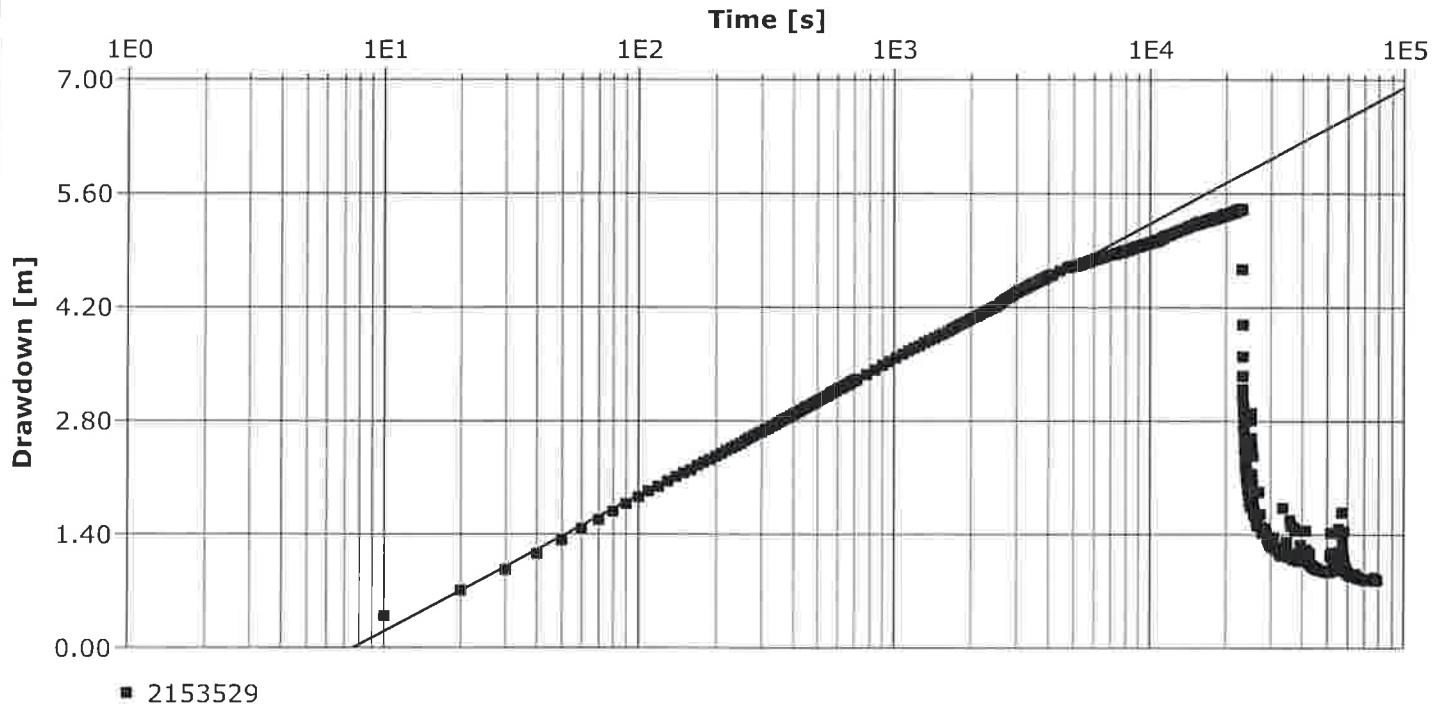
Calculation using COOPER & JACOB

Observation Well	Transmissivity [m ² /s]	Hydraulic Conductivity [m/s]	Storage coefficient	Radial Distance to PW [m]	
2153529	1.18×10^{-4}	2.95×10^{-6}	3.14×10^{-1}	0.08

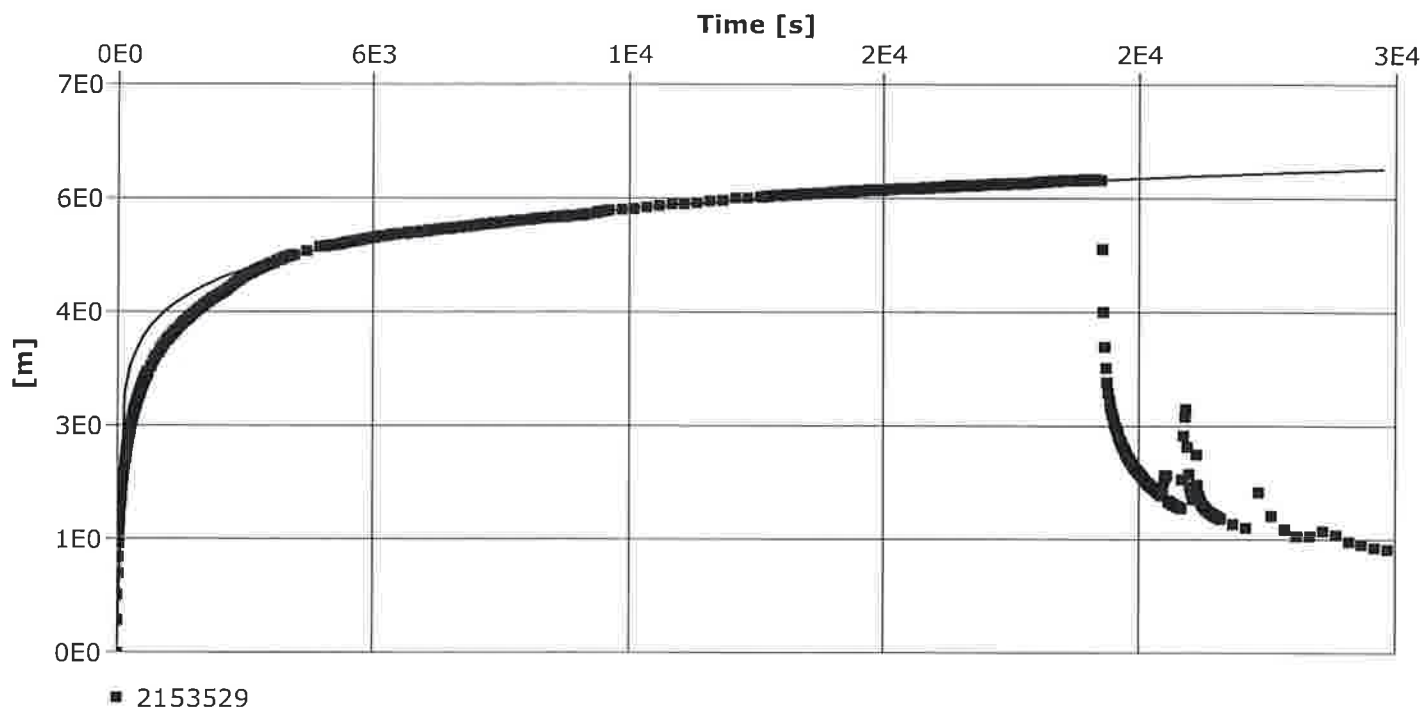
Calculation using Theis with Jacob Correction

Observation Well	Transmissivity [m ² /s]	Hydraulic Conductivity [m/s]	Storage coefficient	Radial Distance to PW [m]	
2153529	1.85×10^{-4}	4.62×10^{-6}	1.36×10^{-2}	0.08

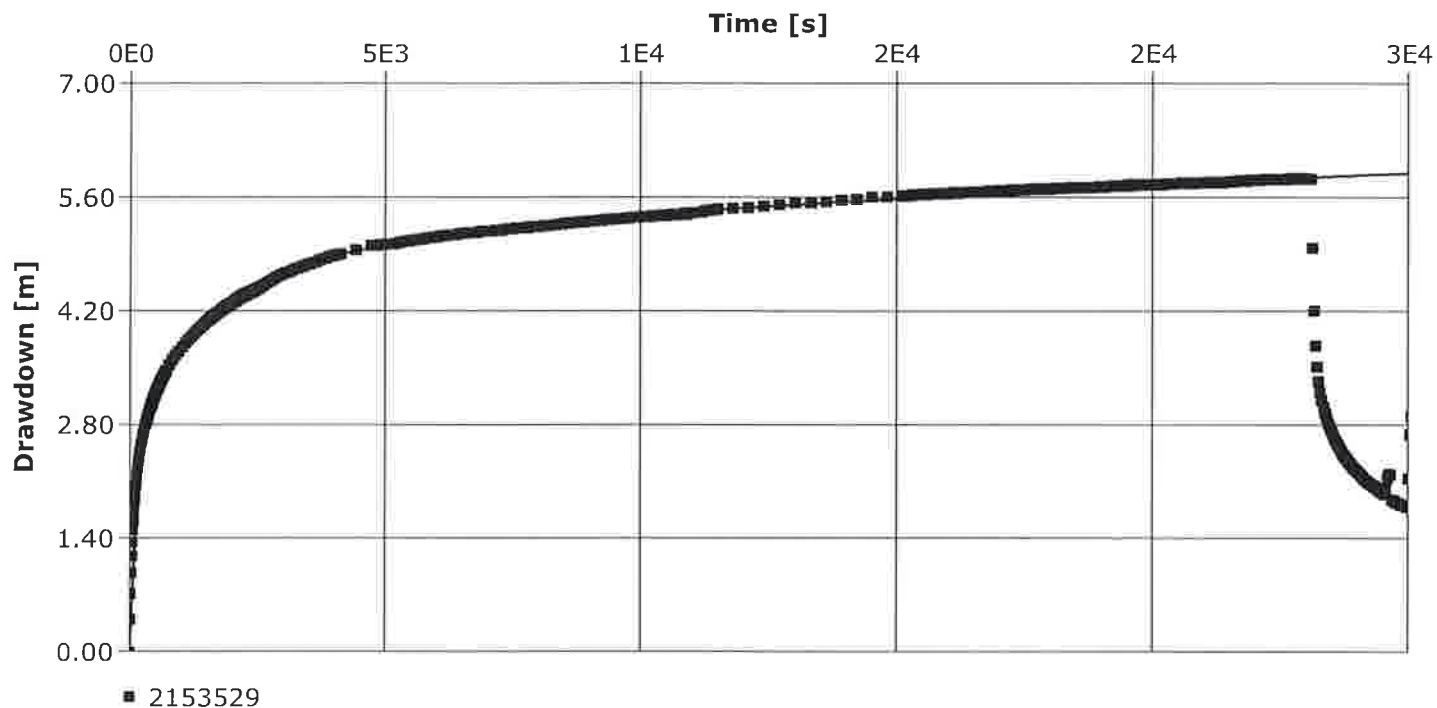
Calculation using Double Porosity

Observation Well	Transmissivity [m ² /s]	Hydraulic Conductivity [m/s]	Storage coefficient	Sigma	Lambda	Radial Distance to PW [m]
2153529	8.41×10^{-5}	2.10×10^{-6}	6.16×10^{-1}	3.49×10^0	7.47×10^{-3}	0.08

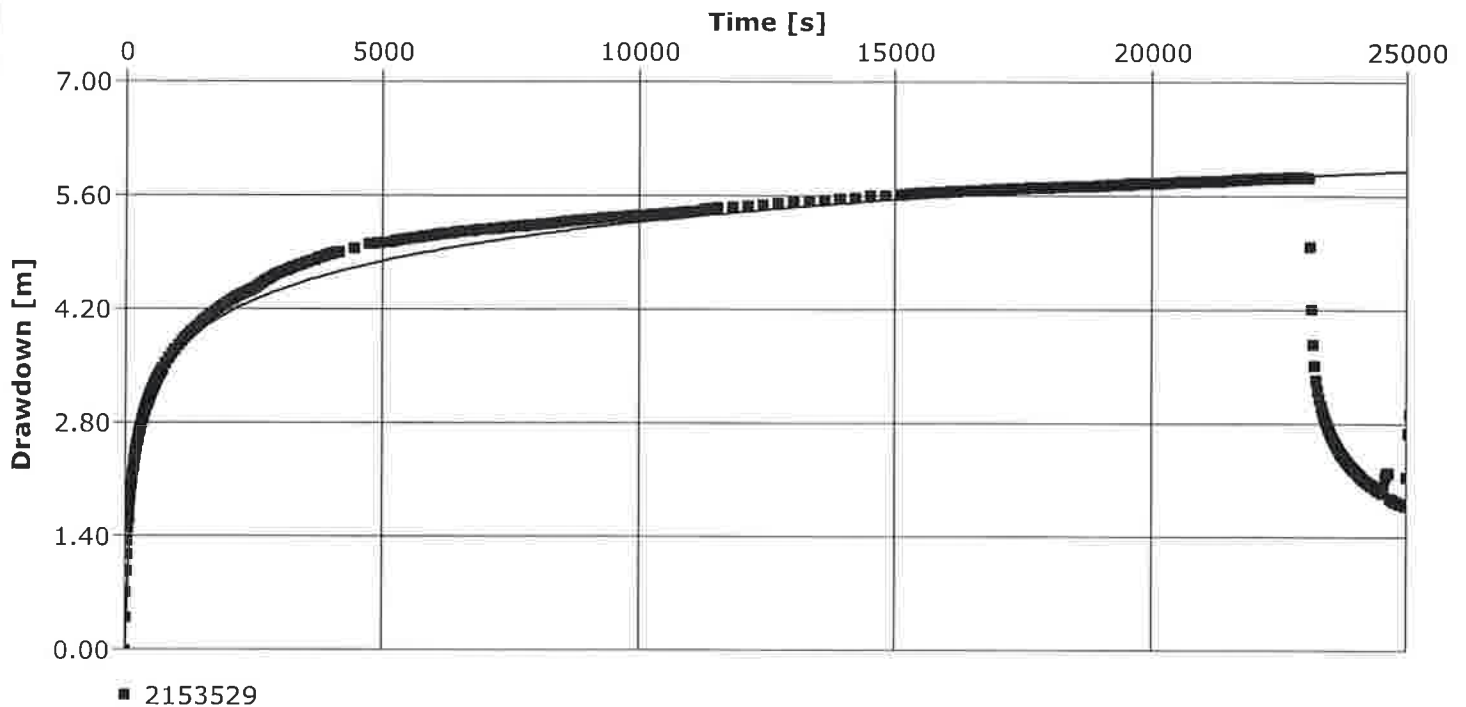
Calculation using Theis

Observation Well	Transmissivity [m ² /s]	Hydraulic Conductivity [m/s]	Storage coefficient	Radial Distance to PW [m]	
2153529	1.24×10^{-4}	3.10×10^{-6}	2.18×10^{-1}	0.08

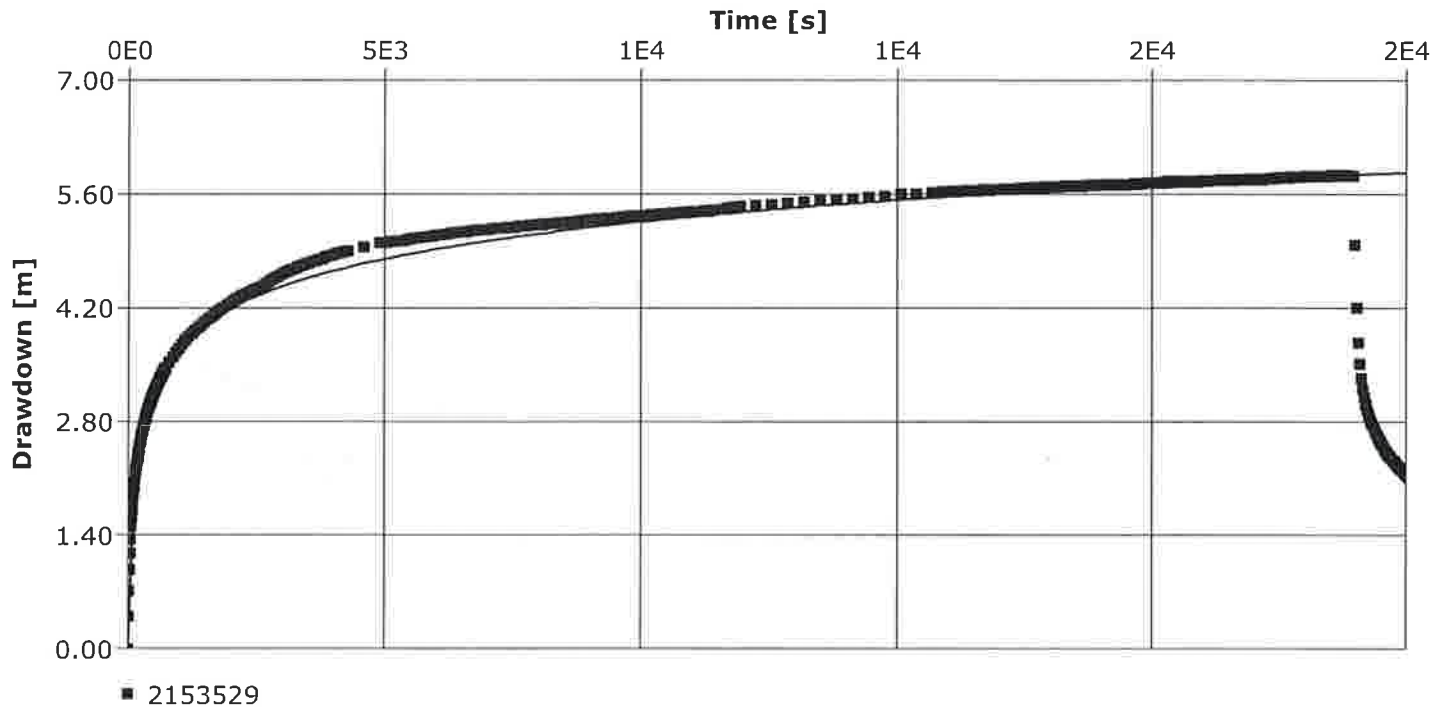
Calculation using Neuman

Observation Well	Transmissivity [m ² /s]	Hydraulic Conductivity [m/s]	Specific Yield	Ratio K(v)/K(h)	Ratio Sy/S	Radial Distance to PW [m]
2153529	1.30×10^{-4}	3.25×10^{-6}	1.96×10^{-3}	5.59×10^0	1.26×10^{-2}	0.08

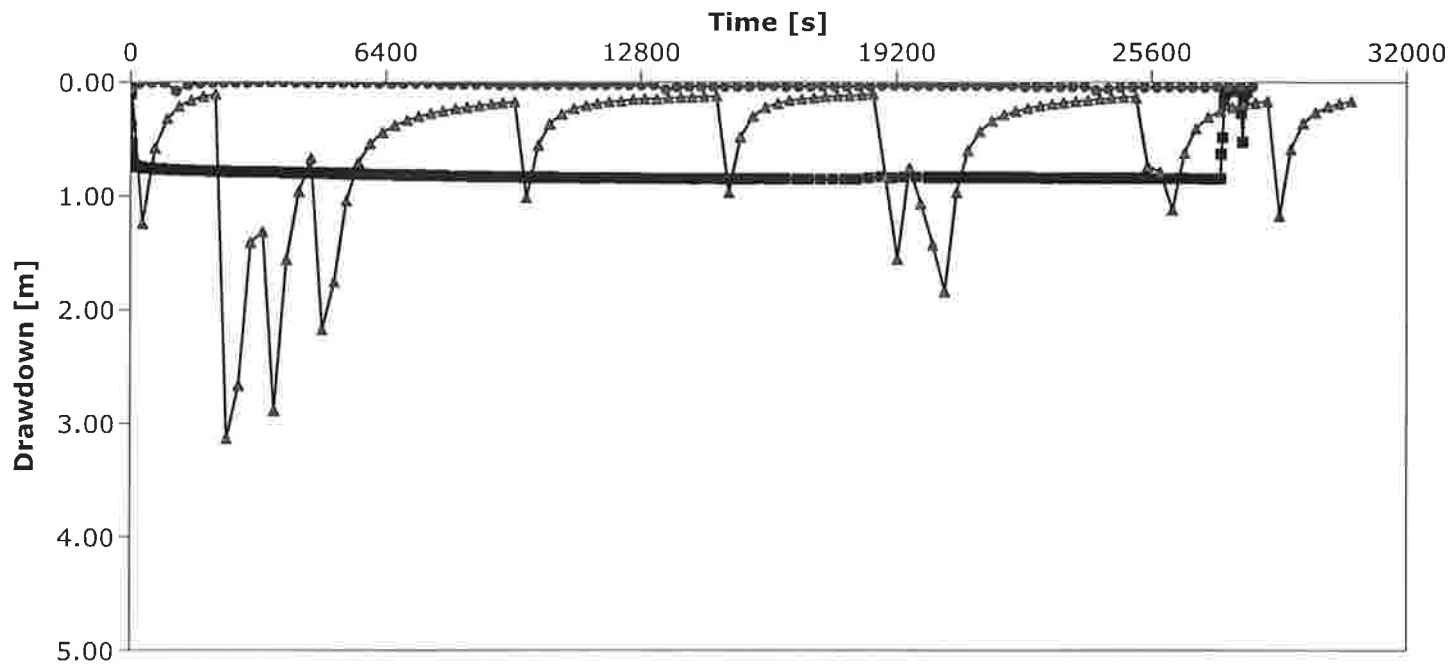
Location:	Pumping Test: Pumping Test 2	Pumping Well: A227593
Test Conducted by: J Swiger		Test Date: 1/8/2019
Analysis Performed by: J Swiger	Time - Drawdown	Analysis Date: 5/8/2019
Aquifer Thickness: 15.00 m	Discharge: variable, average rate 0,9167 [l/s]

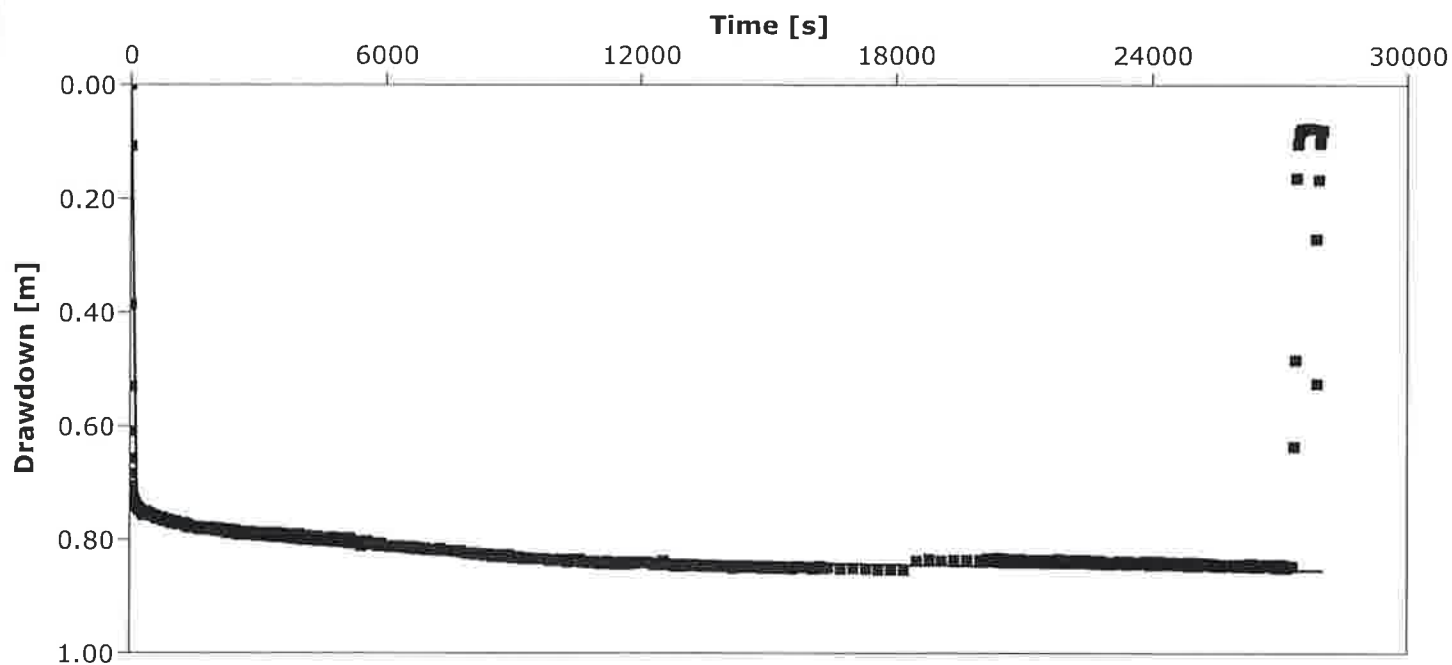
Calculation using Theis

Observation Well	Transmissivity [m ² /s]	Hydraulic Conductivity [m/s]	Storage coefficient	Radial Distance to PW [m]	
A227593	2.98×10^{-3}	1.99×10^{-4}	1.98×10^{-11}	0.08

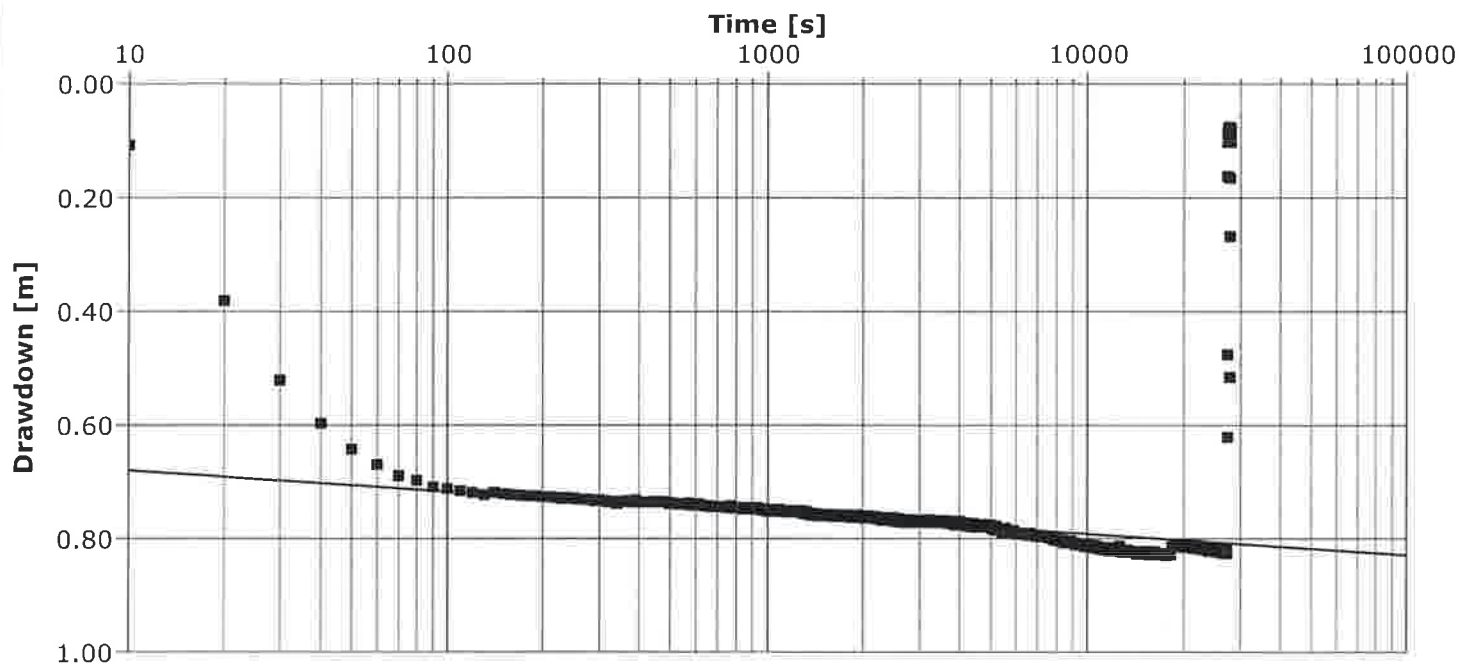
Calculation using COOPER & JACOB

Observation Well	Transmissivity [m ² /s]	Hydraulic Conductivity [m/s]	Storage coefficient	Radial Distance to PW [m]	
A227593	4.49×10^{-3}	2.99×10^{-4}	1.02×10^{-17}	0.08

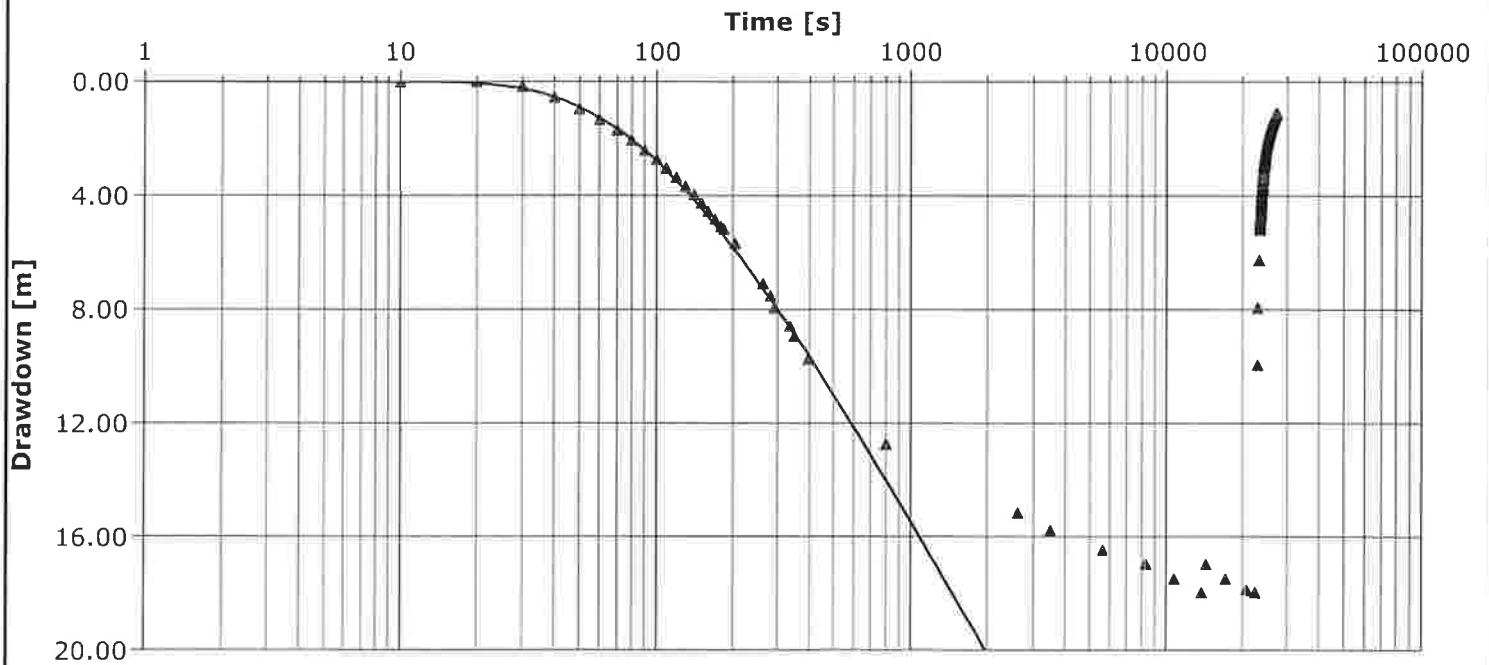
Location:	Pumping Test: Pumping Test 3	Pumping Well: 7197381
Test Conducted by: J Swiger		Test Date: 1/9/2019
Analysis Performed by: J Swiger	Theis	Analysis Date: 5/8/2019
Aquifer Thickness: 35.00 m	Discharge: variable, average rate 0.64845 [l/s]

Calculation using Theis

Observation Well	Transmissivity [m ² /s]	Hydraulic Conductivity [m/s]	Storage coefficient	Radial Distance to PW [m]	
7197381	7.29×10^{-6}	2.08×10^{-7}	3.07×10^{-1}	0.08

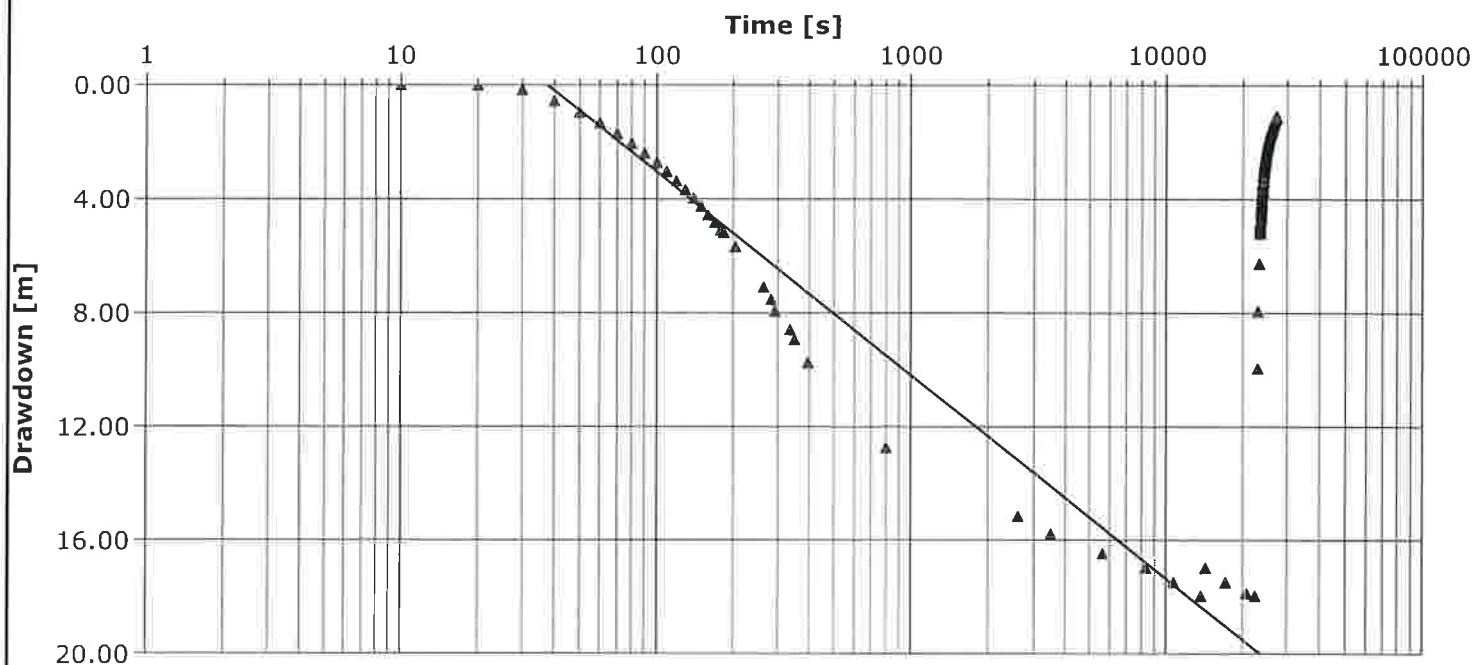
Location:	Pumping Test: Pumping Test 3	Pumping Well: 7197381
Test Conducted by: J Swiger		Test Date: 1/9/2019
Analysis Performed by: J Swiger	Cooper and Jacob (T-DD)	Analysis Date: 5/8/2019
Aquifer Thickness: 35.00 m	Discharge: variable, average rate 0.64845 [l/s]

Calculation using COOPER & JACOB

Observation Well	Transmissivity [m ² /s]	Hydraulic Conductivity [m/s]	Storage coefficient	Radial Distance to PW [m]	
7197381	1.66×10^{-5}	4.74×10^{-7}	2.20×10^{-1}	0.08

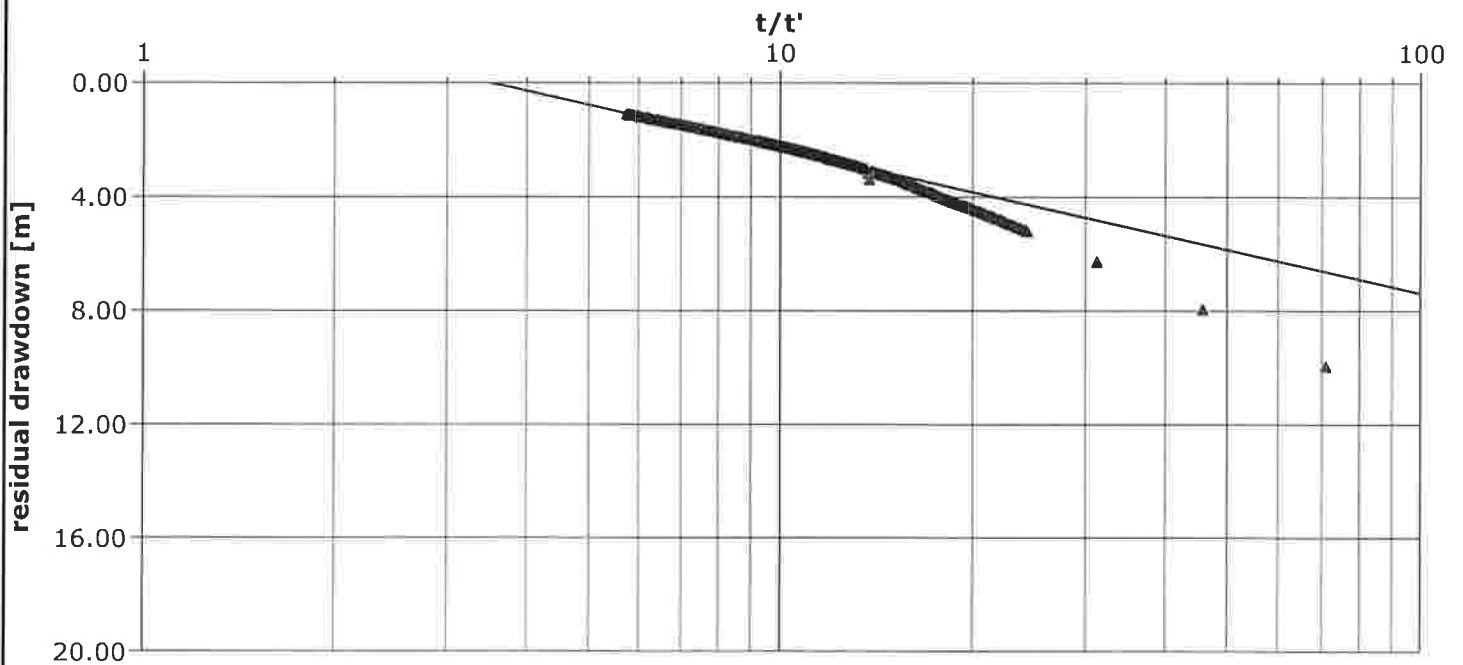
Calculation using THEIS & JACOB

Observation Well	Transmissivity [m ² /s]	Hydraulic Conductivity [m/s]	Radial Distance to PW [m]
7197381	2.34×10^{-5}	6.67×10^{-7}	0.08

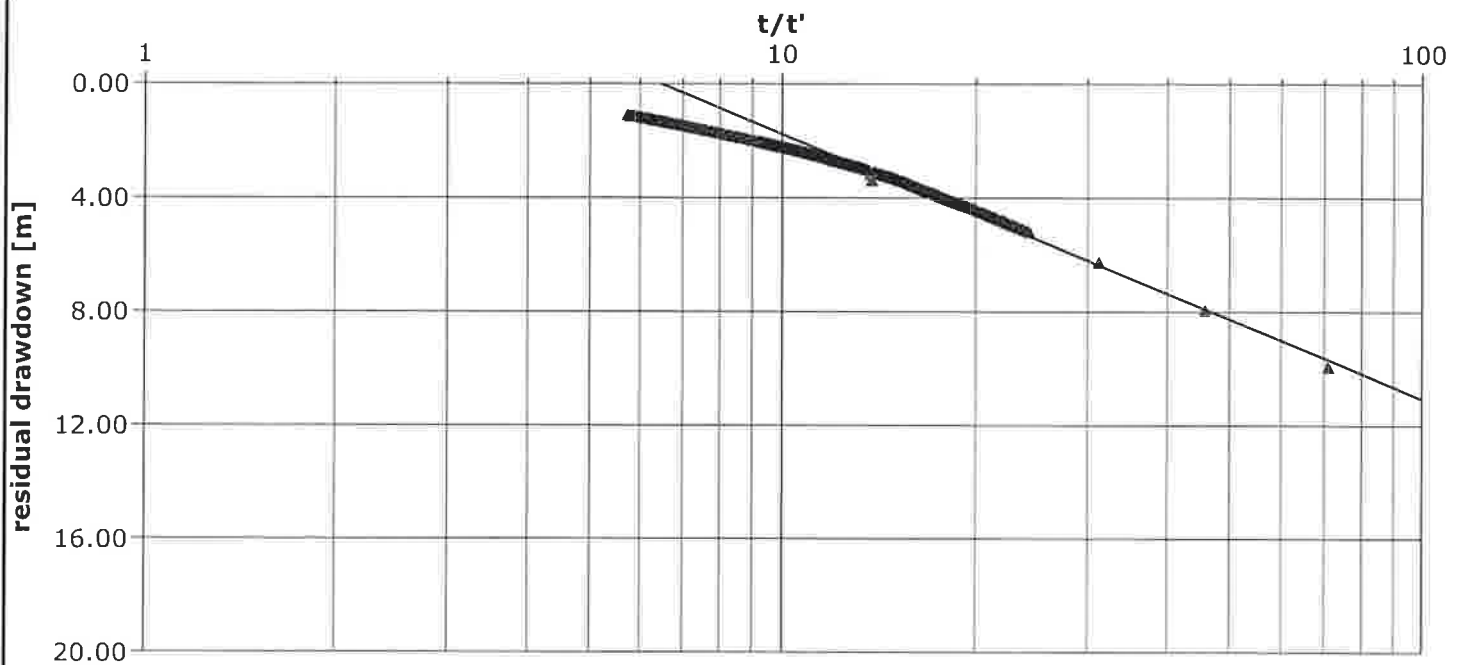
Calculation using THEIS & JACOB

Observation Well	Transmissivity [m ² /s]	Hydraulic Conductivity [m/s]	Radial Distance to PW [m]
7197381	1.27×10^{-5}	3.64×10^{-7}	0.08

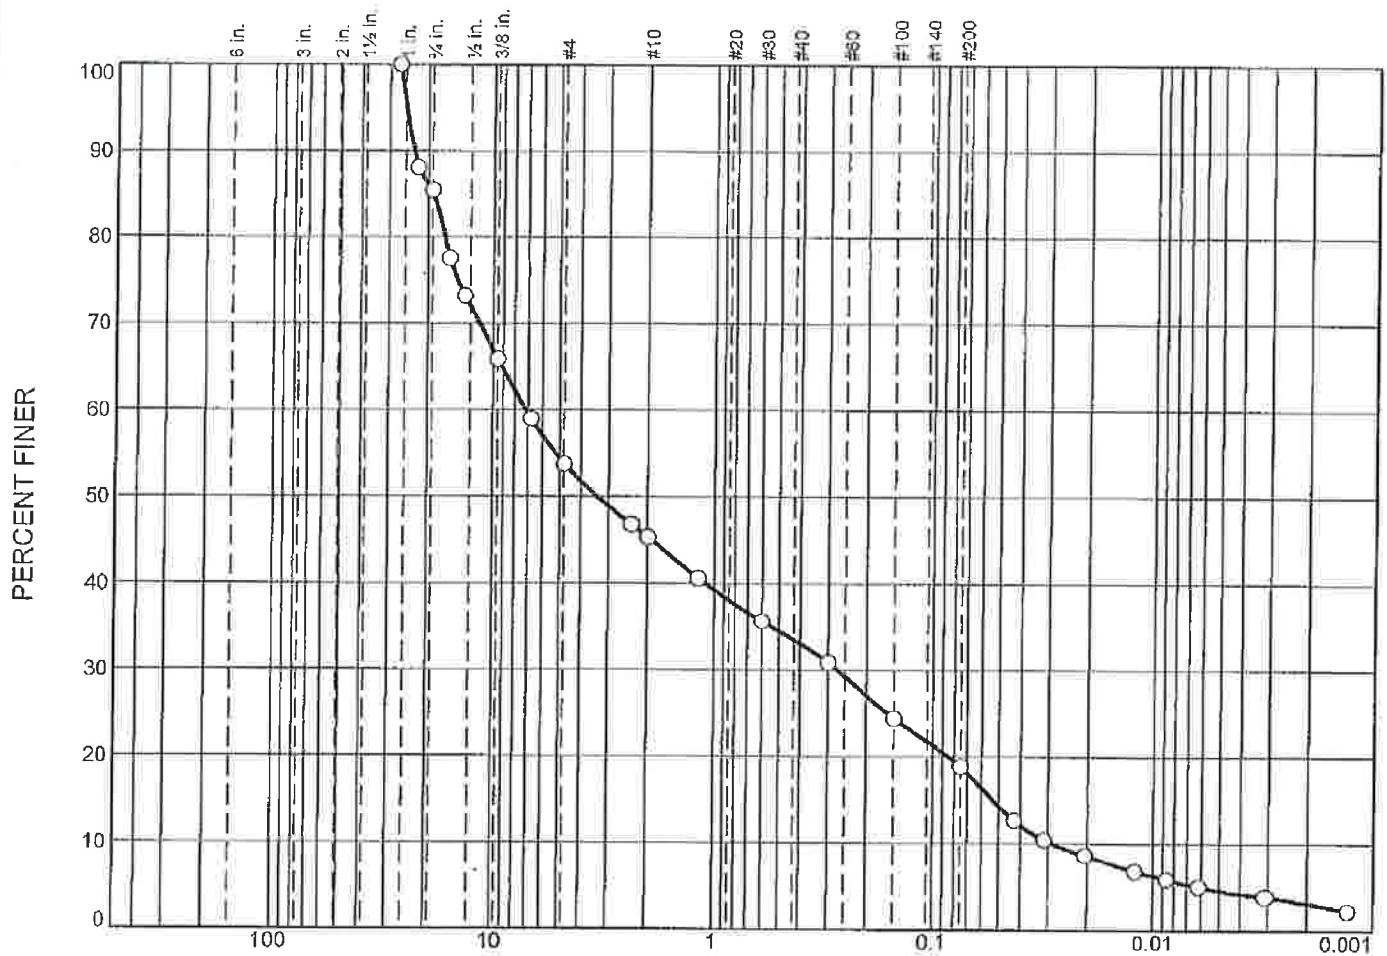
Figure 1

Particle Size Distribution Report

% Cobbles	% Gravel		% Sand			% Fines	
		Coarse	Fine	Coarse	Medium	Fine	Silt	Clay
○	0.0	14.5	31.8	8.4	11.9	14.6	15.7	3.1

Six samples were taken of the soil immediately below the organic layer and were analyzed for grain size distribution and percolation time. The soils of the near surface overburden were reported to be primarily sand (17% - 84% by mass), with some silt (8% - 28% by mass) and some gravel (2% to 71% by mass). The shallow samples were classified as SM (silty sand), GM (silty gravel), GW-GM (well-graded silty gravel), or GP-GM (poorly graded silty gravel) under the Unified Soil Classifications System (Terzaghi *et al* 1996). The average percolation time was found to be $T = 10$ min/cm.

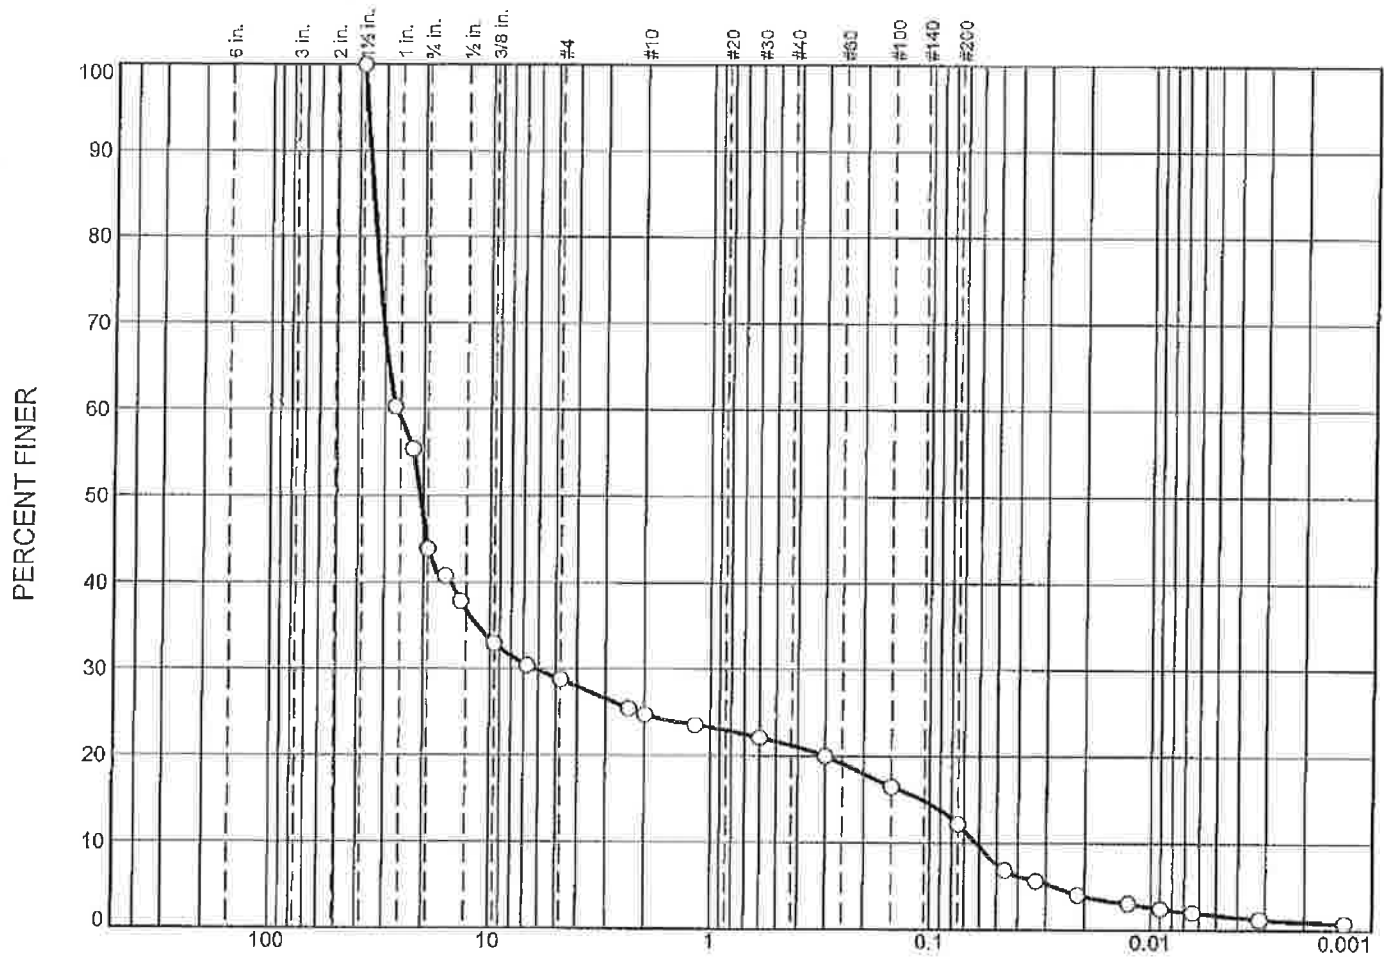
Figure 2

Particle Size Distribution Report

% Cobbles	% Gravel		% Sand			% Fines	
		Coarse	Fine	Coarse	Medium	Fine	Silt	Clay
○	0.0	56.1	15.1	4.1	3.5	9.0	11.3	0.9

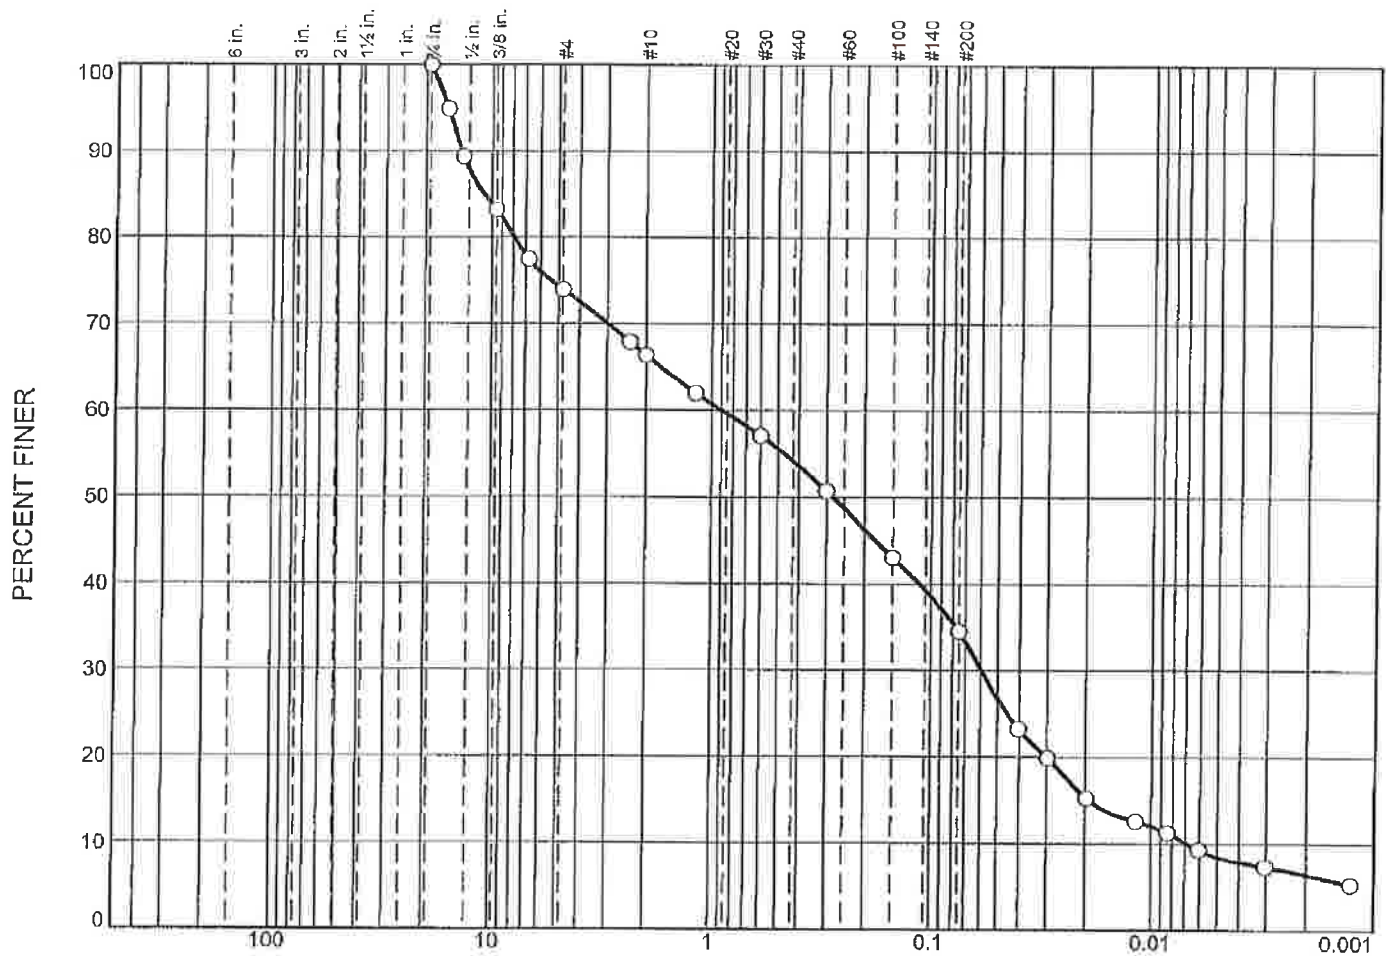
Figure 3

Particle Size Distribution Report

% Cobbles	% Gravel		% Sand			% Fines	
		Coarse	Fine	Coarse	Medium	Fine	Silt	Clay
○	0.0	0.0	26.1	7.5	12.3	19.7	28.0	6.4

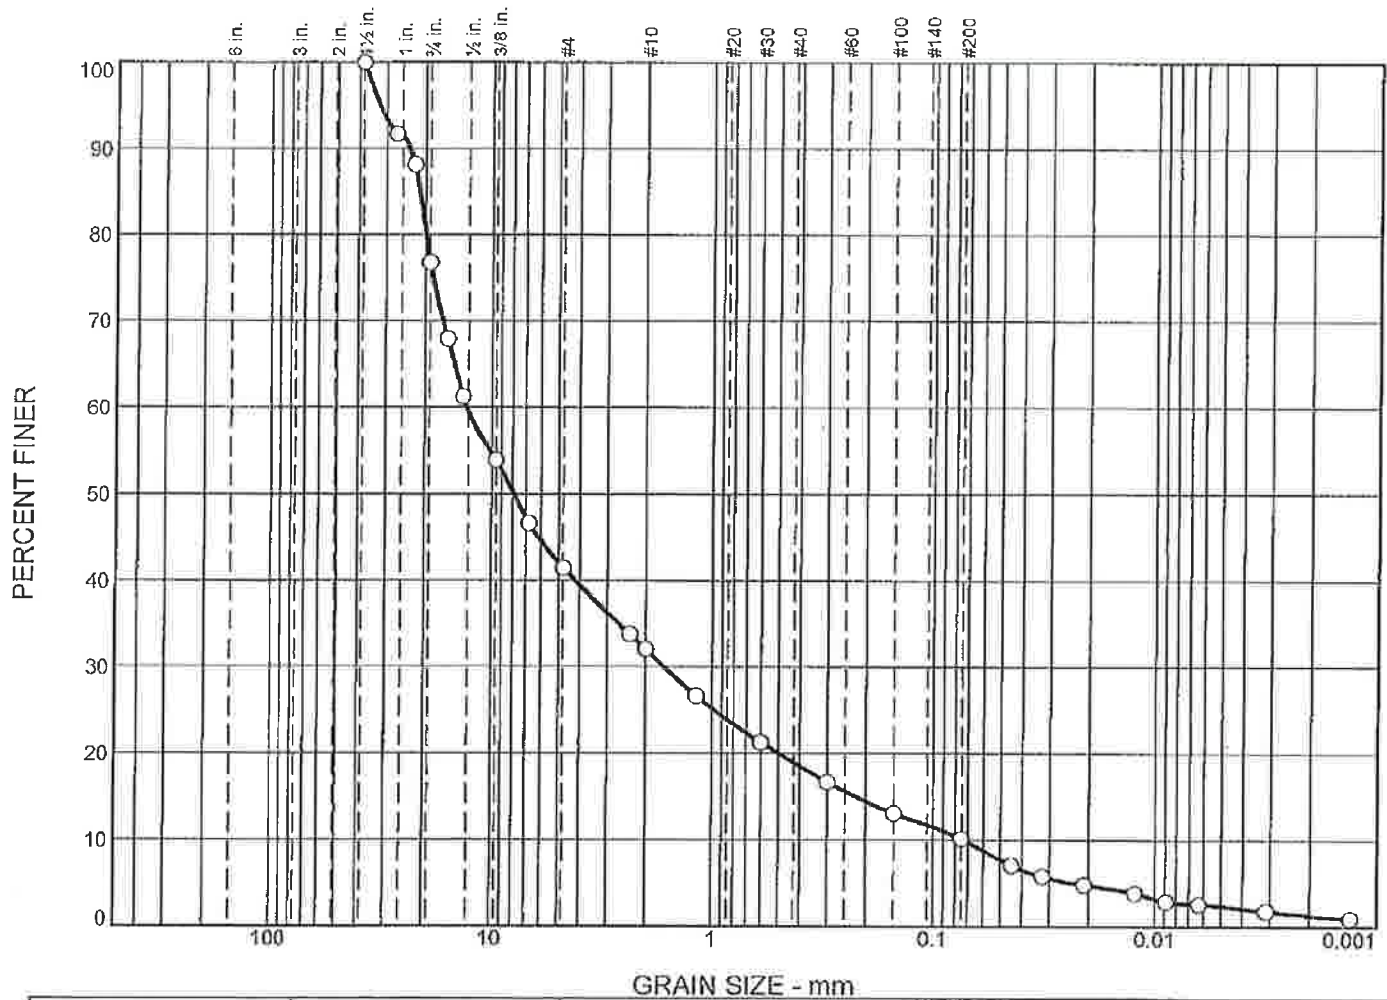
Figure 4

Particle Size Distribution Report

% Cobbles	% Gravel		% Sand			% Fines	
		Coarse	Fine	Coarse	Medium	Fine	Silt	Clay
○	0.0	23.2	35.4	9.4	13.1	8.7	8.9	1.3

SOIL DATA					
SYMBOL	SOURCE	SAMPLE NO.	DEPTH (ft.)	Material Description	USCS
○	BH5	2	0.76-1.37m	sandy gravel, trace silt and clay	GW-GM
				Estimated Percolation Rate; T = 8 min/cm	
				Estimated Coefficient of Permeability; k = 5.3 x 10 ⁻³ min/cm	
				Tested by JM of CMT Engineering Inc., August 1, 2018
