Subject: Karst Hazard Assessment of HSCL's Sarawak Quarry Proposed Expansion Area, Part Lot 36, Concession 2, Township of Georgian Bluffs.

Karst Hazard Assessment of HSCL's Sarawak Quarry Proposed Expansion Area, Part Lot 36, Concession 2, Township of Georgian Bluffs.

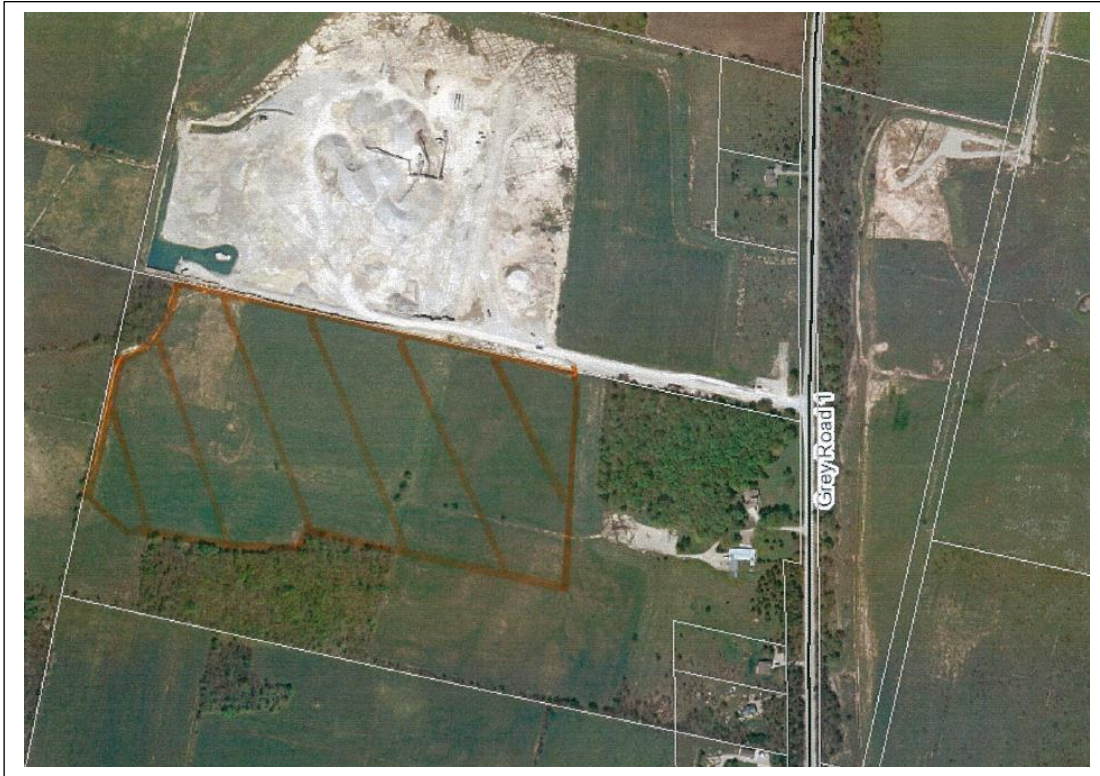
Figure 2. Existing Sarawak quarry showing area of proposed expansion (hatched area).

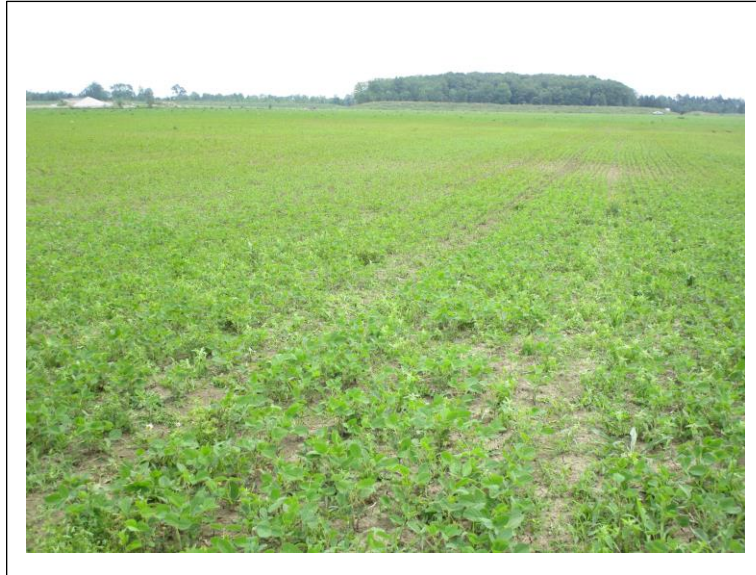
Photo 1. Looking east toward Grey Road 1 across proposed expansion area. Aggregate piles from the existing quarry can be seen in the upper left.

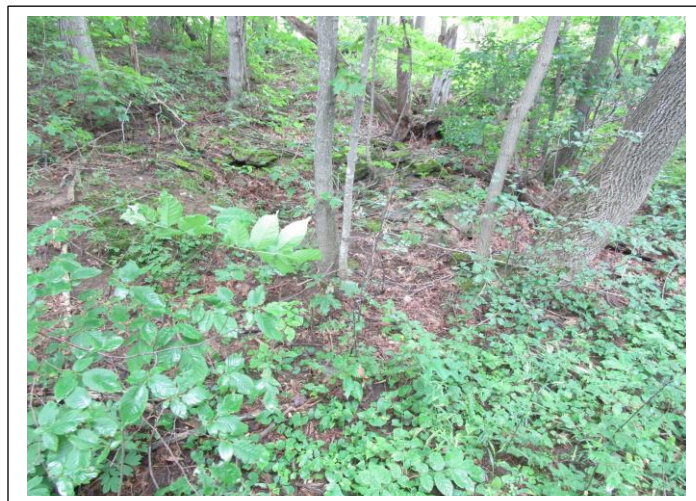
Photo 2. Shallow depression (center) in forested area to west of the site.

No significant karst features were observed on or adjacent to the expansion lands. Several small very shallow depressions were observed in the forested areas surrounding the site (Photo 2). These are most likely locations of local diffuse recharge to the bedrock via partially open joint planes.
