**Home Farm Property
Blue Mountains, Ontario**

Phase I Environmental Site Assessment Report

**PHASE I ENVIRONMENTAL SITE ASSESSMENT
Home Farm Property
Blue Mountains, Ontario**

SLR PROJECT 209.40019.00000

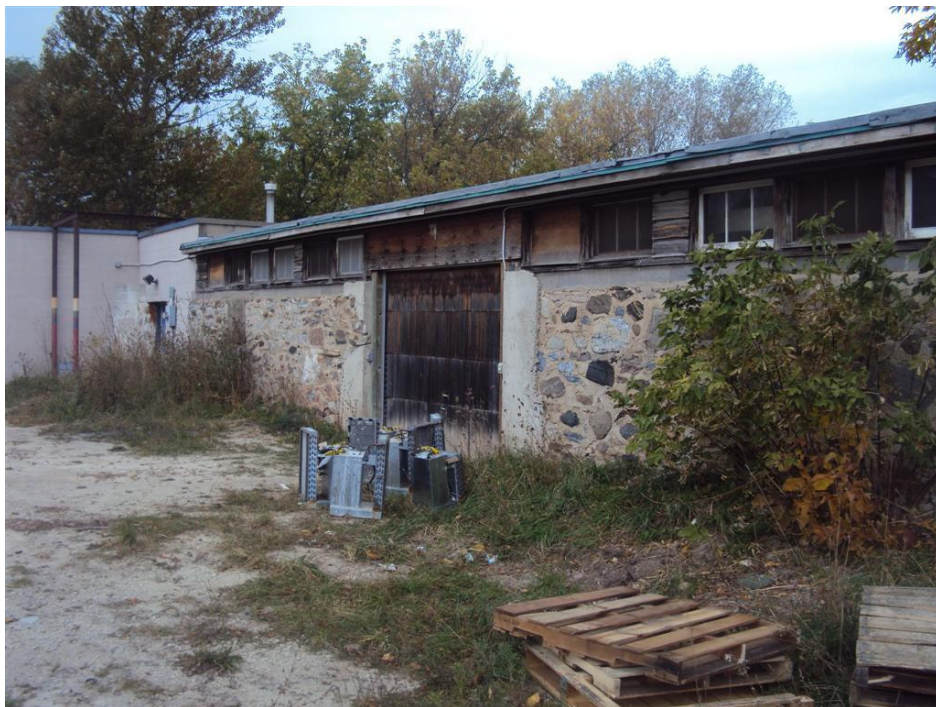
Photo 2: Site building (concrete block and stone construction), facing northeast.

- A small concrete block and stone building is located near the western entrance of the property (off Helen Street). The exact age of the building is unknown, however, it has been suggested that the building was on the site since at least the early 1950s. The heating source of the building is unknown. SLR observed no evidence of USTs during the site visit, however, access to the on-site building was not made available to SLR and access to the northern and eastern portions of the outside of the building was limited due to vegetation overgrowth. Therefore, there is a possibility that a heating oil tank could exist on-site and as such, the soil and groundwater quality in the vicinity of a potential heating oil AST/UST is unknown.

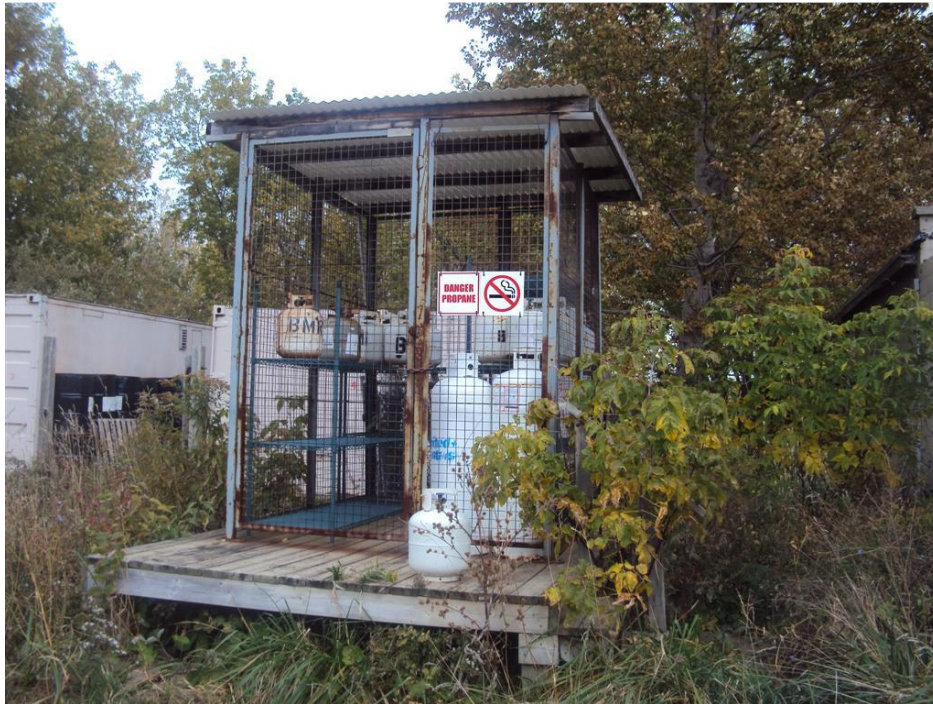
Photo 3: Propane storage adjacent to the Site building.

No designated areas of chemical storage were observed at the time of the site visit, however, a propane storage area was identified to the north of the building and empty glycol drums were stored between shipping container 3 and shipping container 4. A small area of used paint cans and drums was identified directly north of the access road.

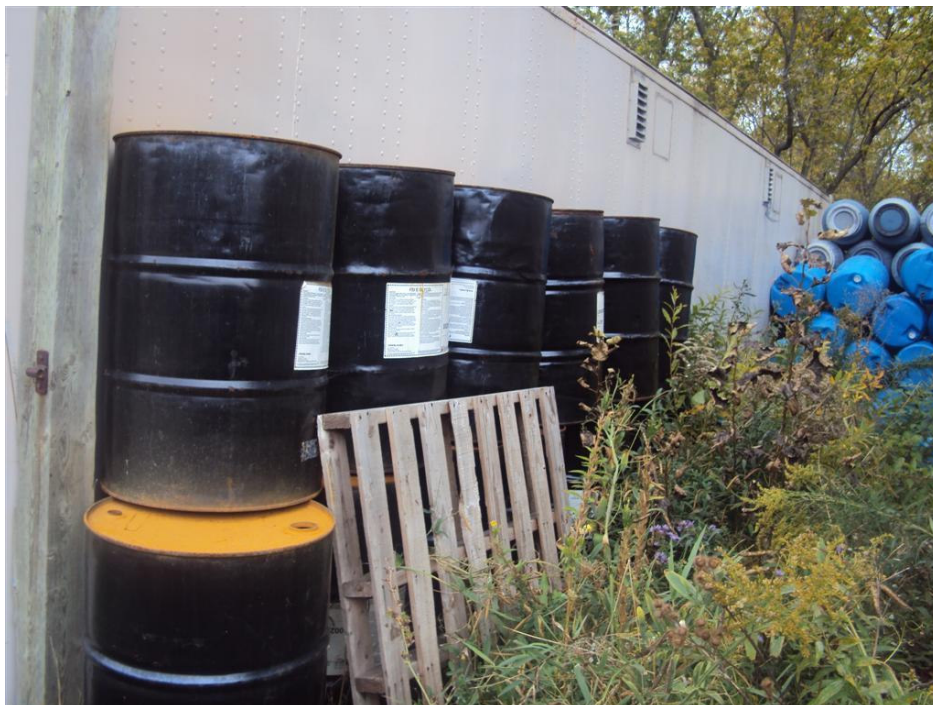
Photo 4: Empty glycol drum and blue water barrel storage between shipping containers 3 and 4 adjacent to the site building.

Empty glycol drums which were observed between shipping containers 3 and 4 adjacent to the site-building were made known to Mr. Skelton, and he re-iterated that no hazardous material storage occurs, or should be occurring, on the property and that the empty drums must have been transferred to the site in error, possibly during the movement of empty water drums (used as weights for testing the ski lifts) to that same area of the subject property.

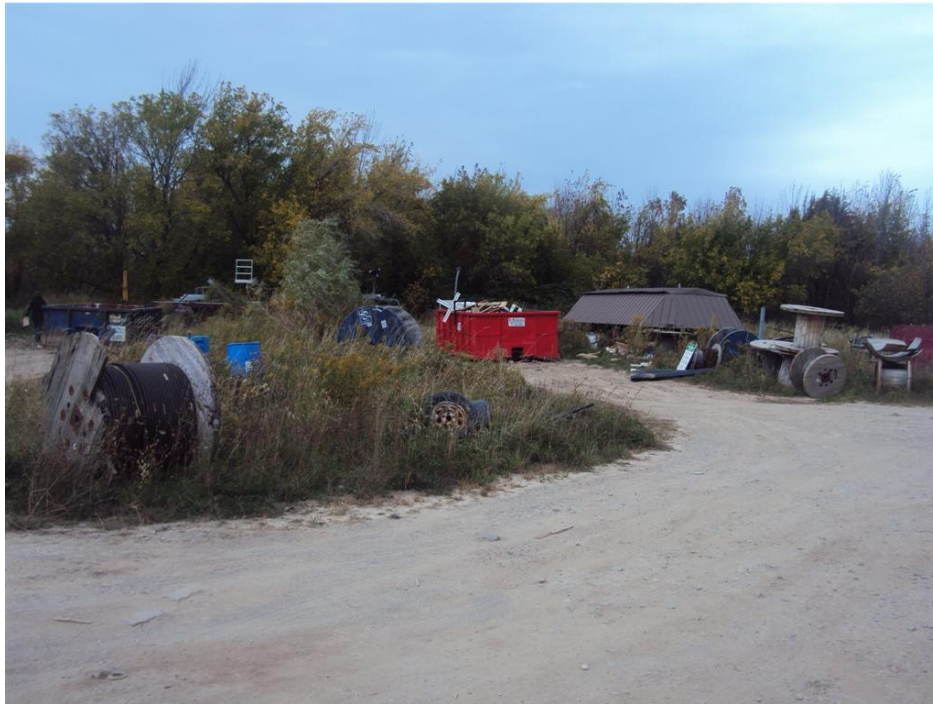
Photo 7: Waste storage (including two dumpsters) located in the front clearing, facing north.

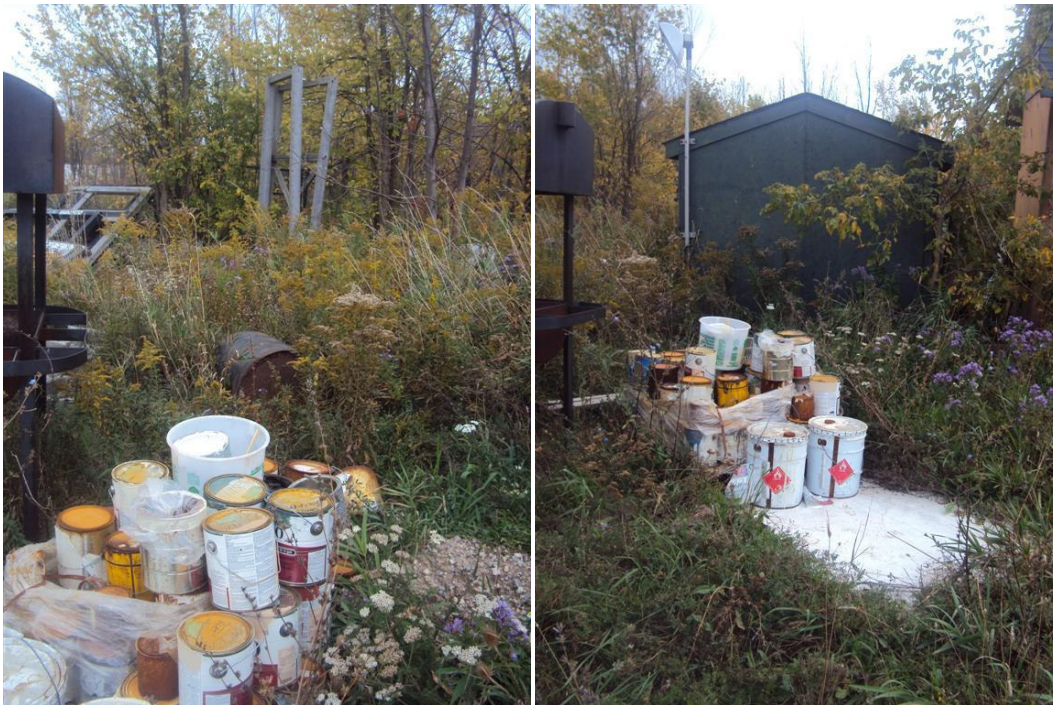
Photo 8: Paint can and drum storage in the front clearing.

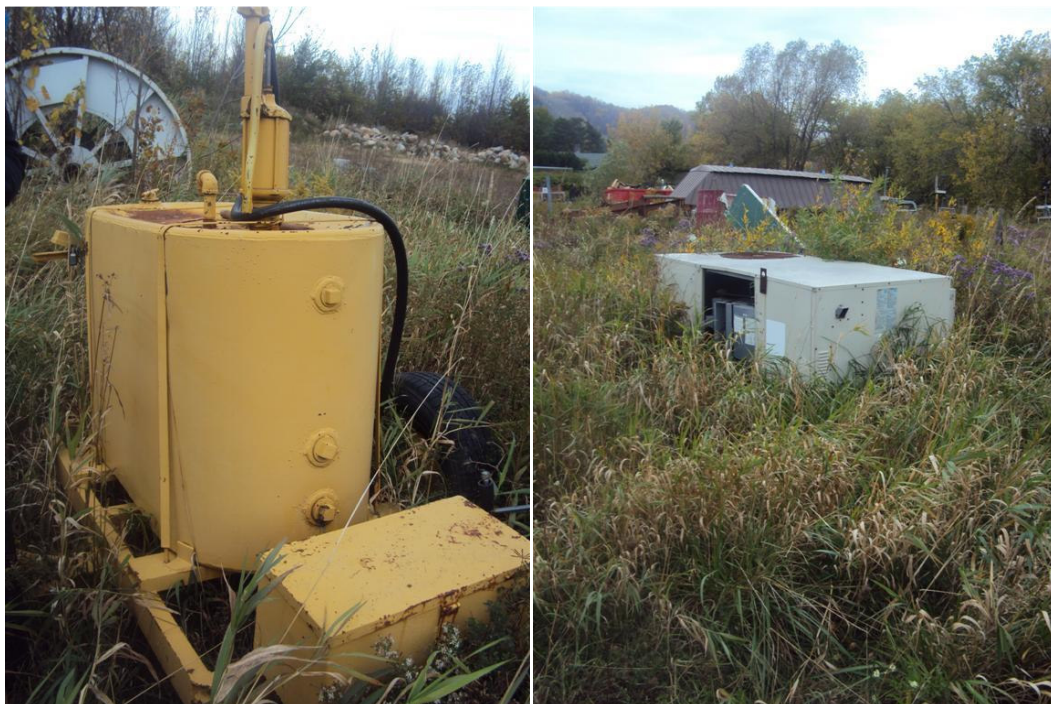
Photo 9: Portable fuelling unit and heating and cooling system located in the front clearing.

A portable fuelling unit, heating and cooling system, empty glycol drums, and a small area of used paint cans/drums were observed by SLR in the area surrounding the site building and front clearing.

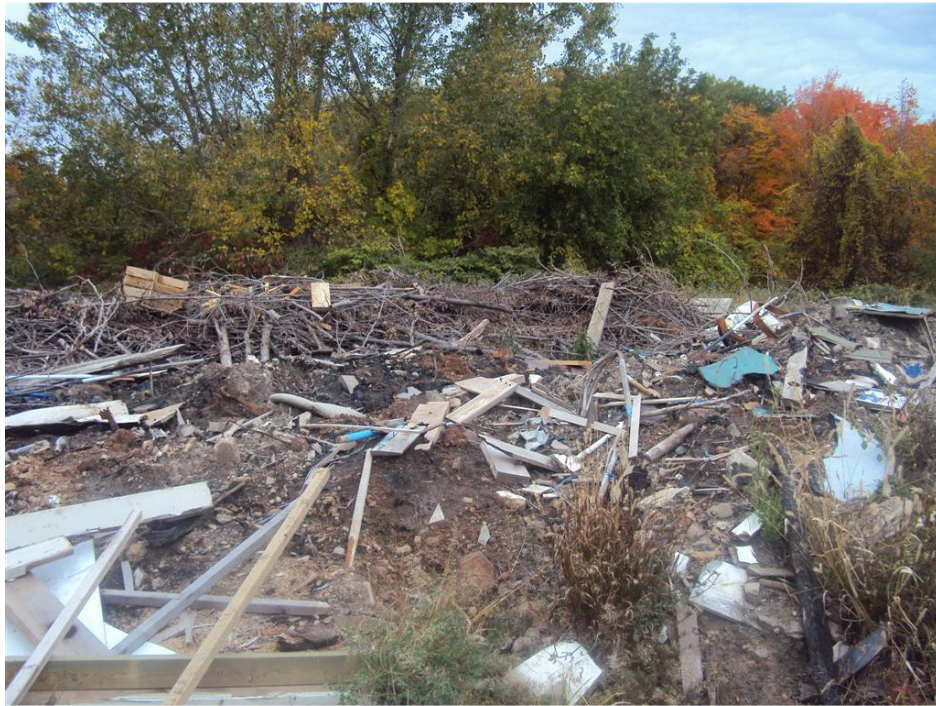
Photo 11: Burn pile located in the central clearing.

- A second clearing is centrally located in the property, approximately 500 m northeast from the main entrance point at Helen Street. This clearing is also used for storage of surplus materials/equipment. A low-lying area of the clearing is currently utilized as a wood/brush burning pit. Evidence of electrical equipment and other construction debris within the burning pit was identified during the site visit. As such, given the unknown nature of the ashes and debris with the burning pit, the soil and groundwater quality in the vicinity of the burning pit is unknown.

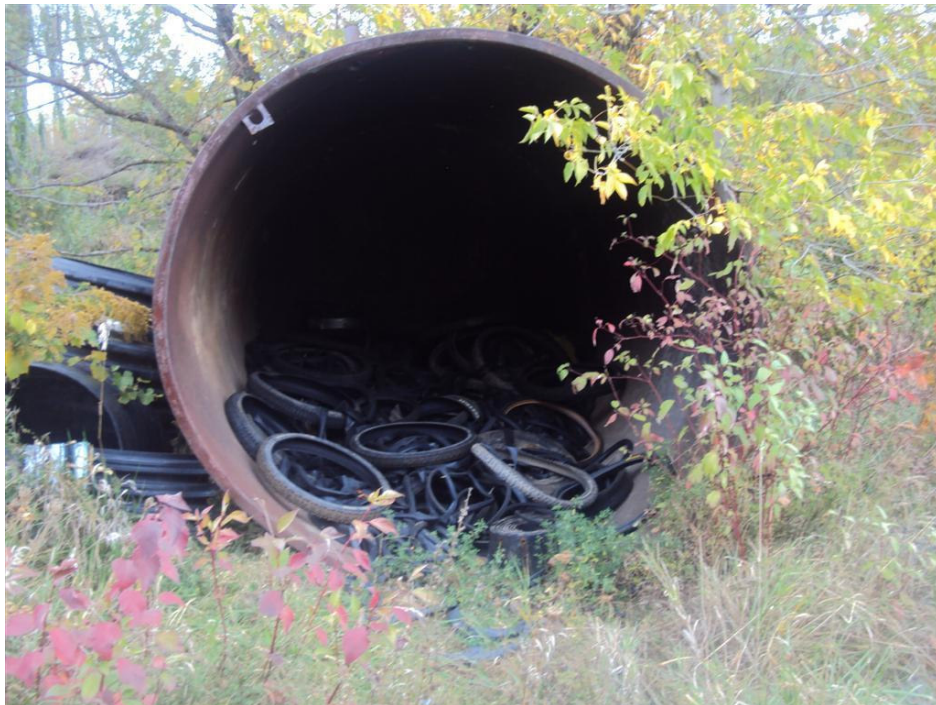
Photo 12: Tire storage in a former AST located at the west end of the central clearing.

No ASTs were observed on the subject property during the site reconnaissance with the exception of the AST noted in the central clearing (see **Section 6.2**). According to Mr. Skelton, the AST was originally located offsite and had been used in the 1970s for a snow-making experiment. The AST is currently used to store tires from Blue Mountain Resort prior to off-site disposal.

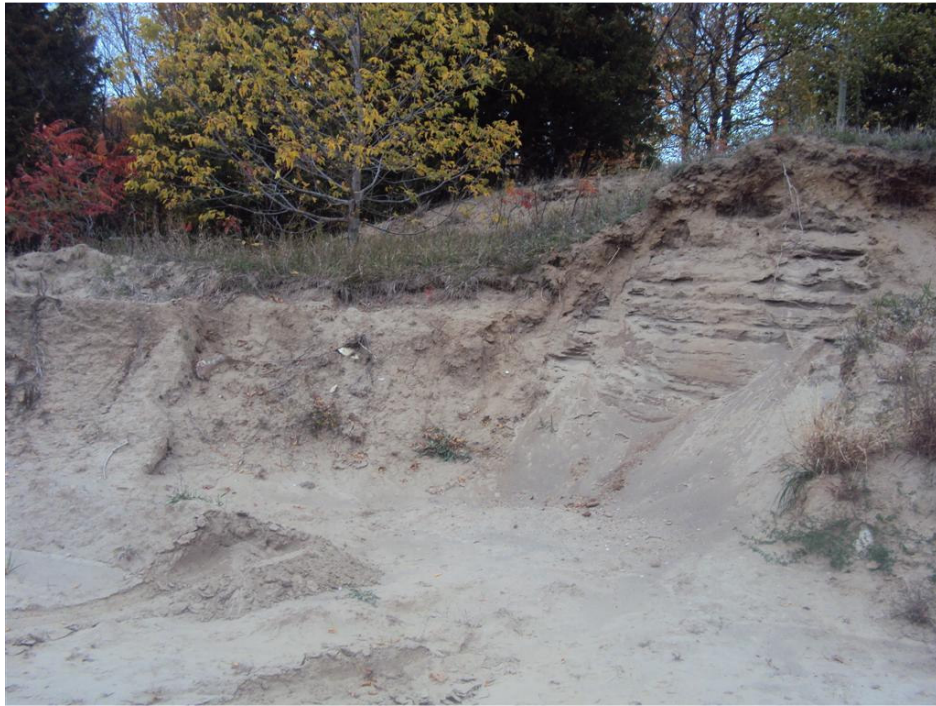
Photo 13: Sand extraction berm at the eastern end of the central clearing.

During the site visit, sand berms were identified to the north of the brush burning pit located in the central clearing and as such, historical earth moving activities at the subject property were suspected. Mr. Weider confirmed that material was removed in the areas of the berms – the material was used for sanding at the Blue Mountain Resort.
