**Third Party Karst Peer Review
Proposed Bumstead Gravel Pit
584015 Sideroad 60 Township of Chatsworth**

**Daryl W. Cowell & Associates Inc.
27 Rita Crescent, RR1 Tobermory ON**

May 7, 2015

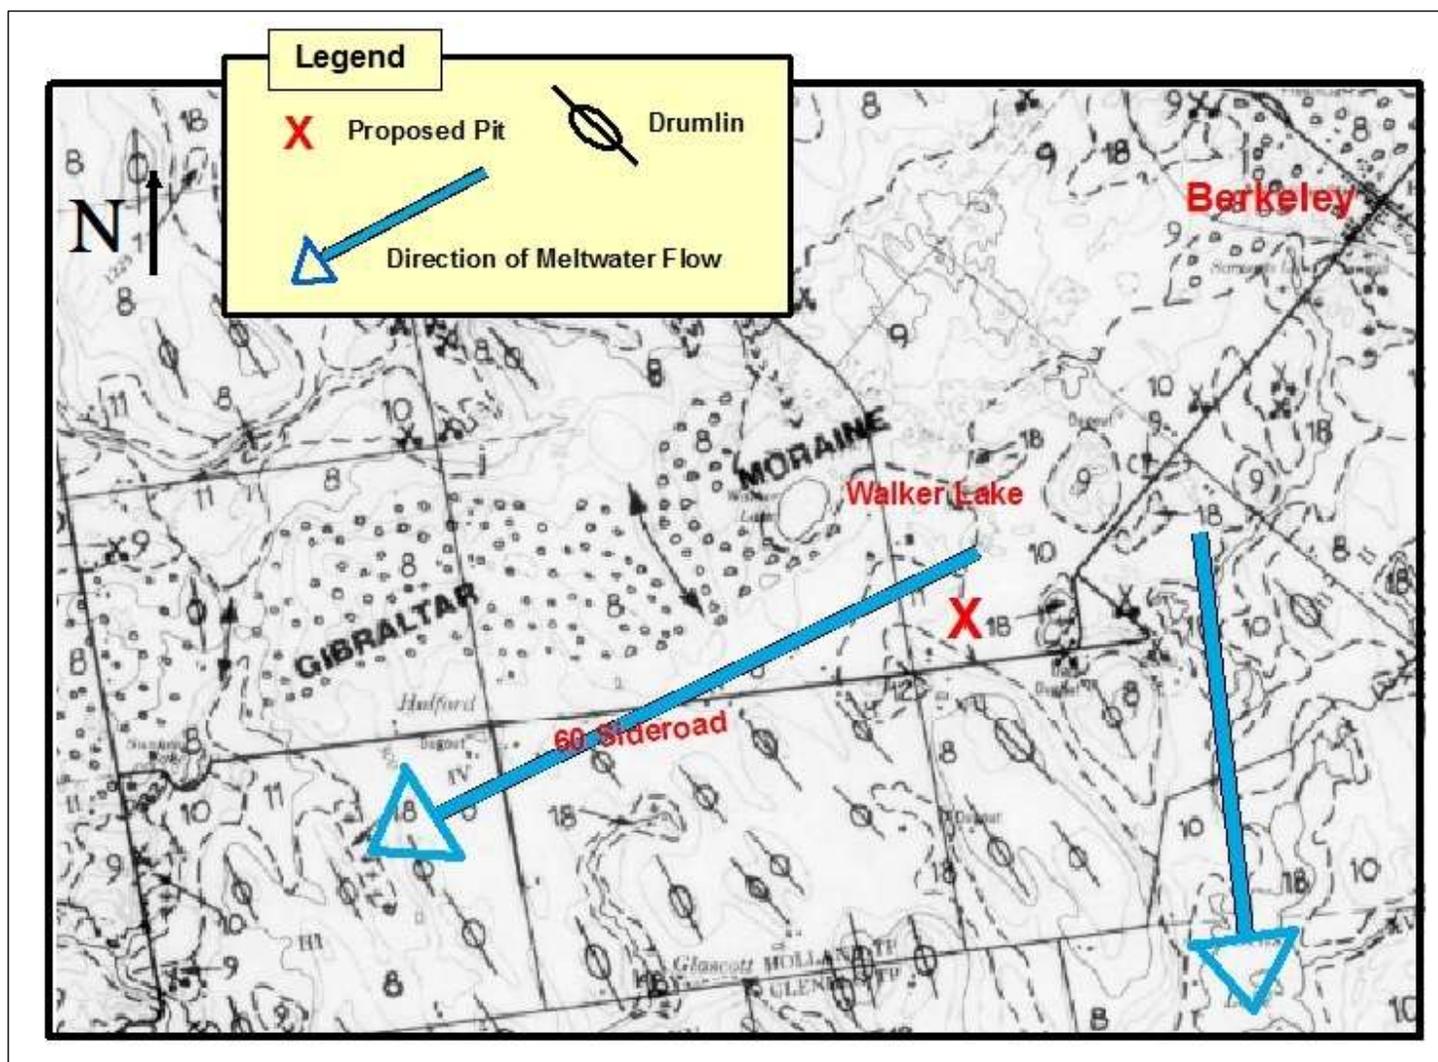
The ground surface at proposed monitoring well location TH-1A is flat, revealing no indication of draping or sloping of surficial material over a bedrock high or rock knob. The nearest test hole (TH-A) was dug to a depth of over 6 m below ground surface with no indication of bedrock (Gamsby and Mannerow 2013, Figure 3 and Appendix B).

Figure 3, Unit 12). Although the upper glaciolacustrine deposit is also fine-grained, surface water could leak along the interface of the two deposits.

Figure 3. Section of Ontario Geological Survey Map P3251 (Markdale Sheet, Feenstra 1994) showing major surficial geology features. The number legend is as follows: 8 = undifferentiated till (sandy/silt, bouldery); 9 & 10 = glaciofluvial sand and gravel; 12 = glaciofluvial sand and silt; and 18 = peat and muck (wetlands).
